**PRESERVING A TERRA COTTA CORNICE BY MAKING EVERY UNIT COUNT:  
PEASE AUDITORIUM CASE STUDY**

- Eastern Michigan University, Ypsilanti, MI
- National Register listed in 1974

- Constructed in 1914
- Architects: Smith, Hinchman & Grylls
- Live performance and campus events, excellent acoustics
- Renovated in 1959 and 1994; exterior work deferred...

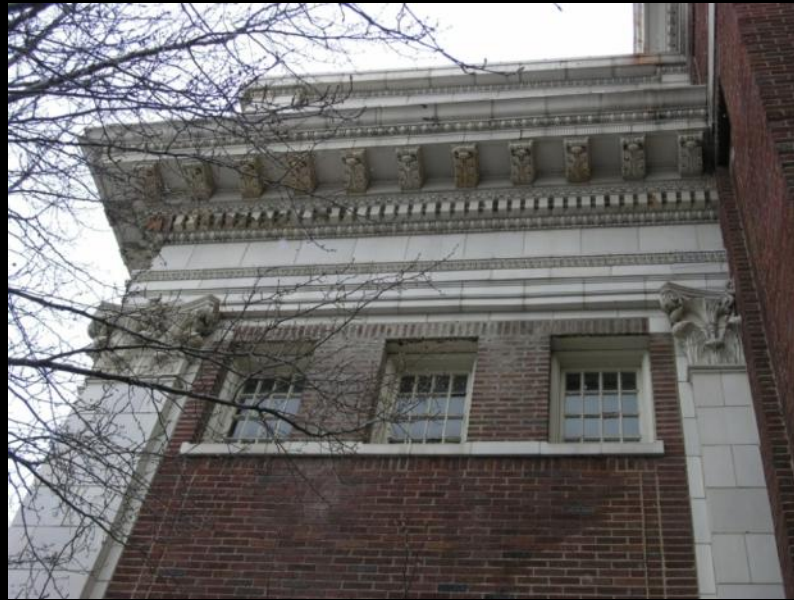
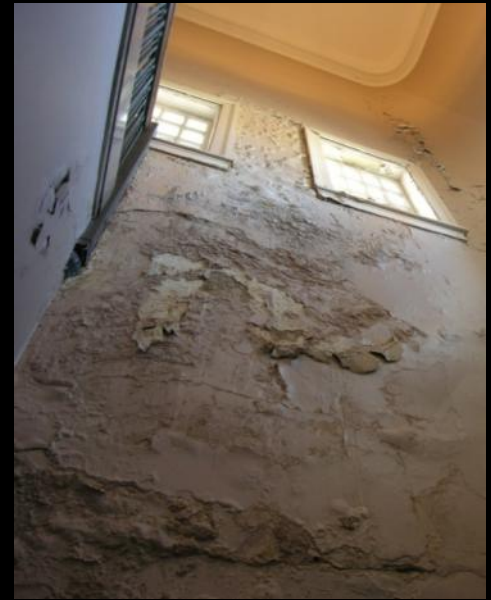
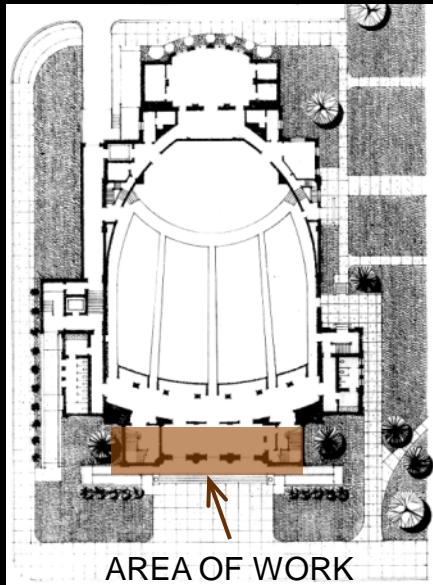
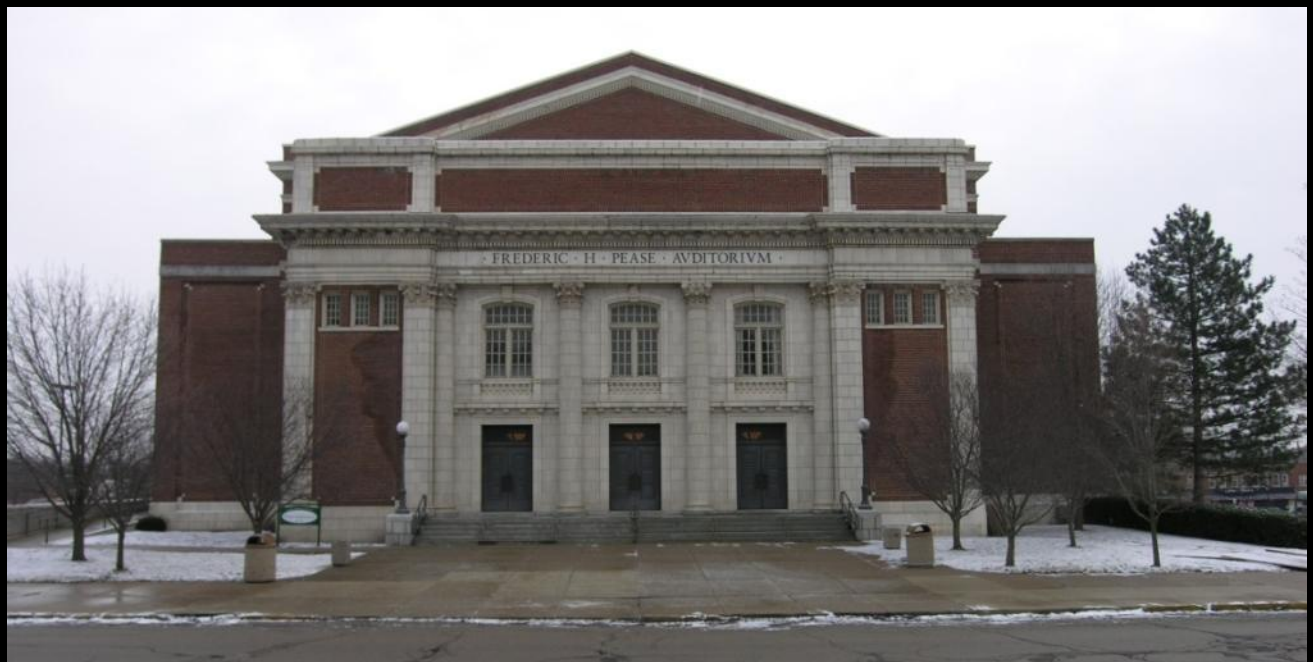
- Water infiltration damaged interior plaster
- Quick fixes and bad repairs
- Concerns about public safety

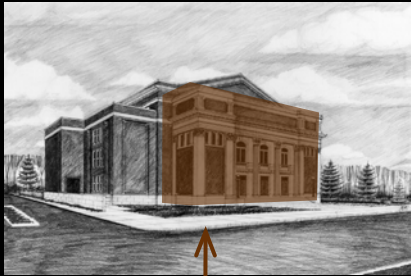
AREA OF WORK

- Large piece of Terra Cotta cornice fell to the ground

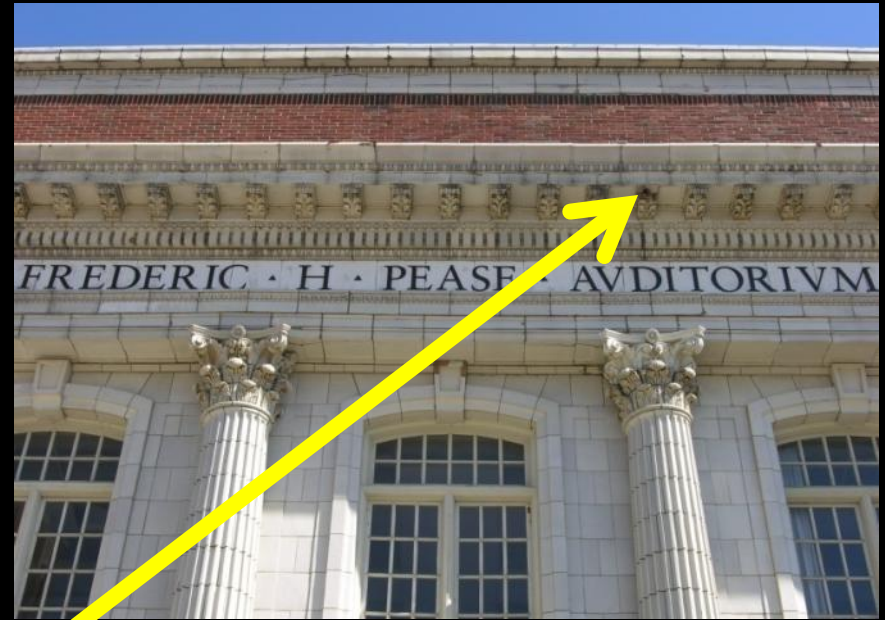
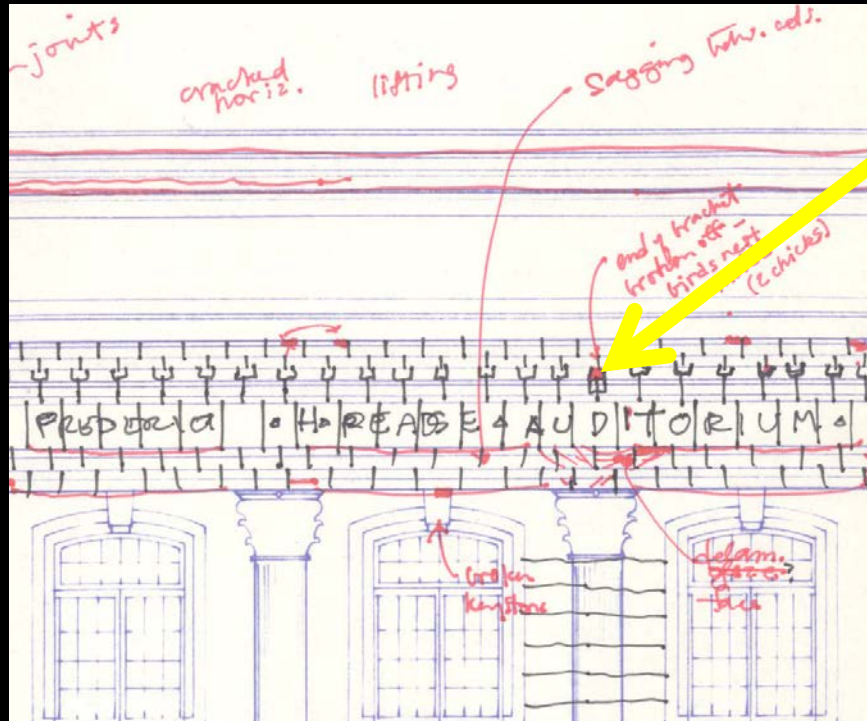
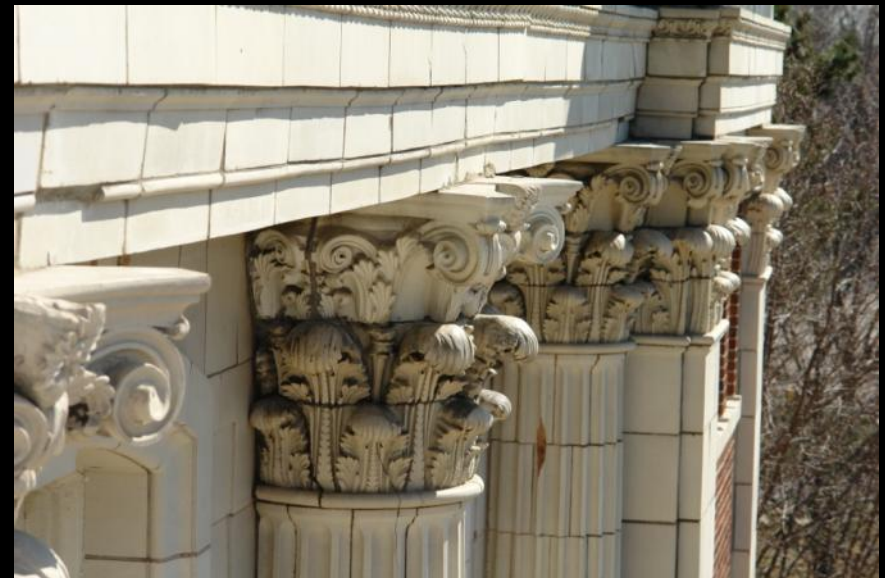
- Visual survey
- Investigation of structure and anchoring
- Investigation of areas of water infiltration
- Detailed survey of unit types
