HISTORIC STRUCTURES REPORT THE FISHER MANSION

PREPARED BY:
Kent Brough
Soon-Ju Kwon
Shalae A. Larsen
Paul Nielsen
Sara Staffanson

UNIVERSITY OF UTAH
COLLEGE OF ARCHITECTURE +
PLANNING

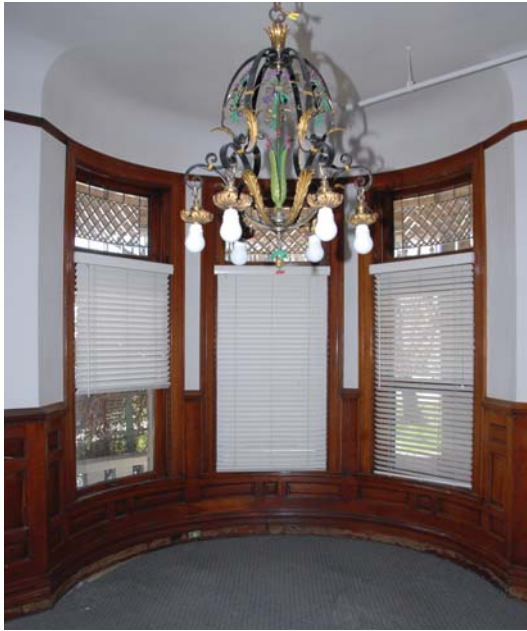
10.

Walls – The original wood wainscoting is intact. Its condition is fair with some scratches, and the baseboard is heavily scuffed. Above the wainscoting the wall surface is painted over embossed paper. Samples would have to be removed to determine the total layers of wall surface, and what the original wall surface would have been.

Doors & Windows – The room has three windows located in a curved bay in the southeast corner of the room. The windows are curved to match the curvature of the bay. The hardware and cords appear to be intact except the middle window that is missing its pulleys. The pulleys may have been removed, or simply covered over. All the doors and door hardware are intact and in good condition.

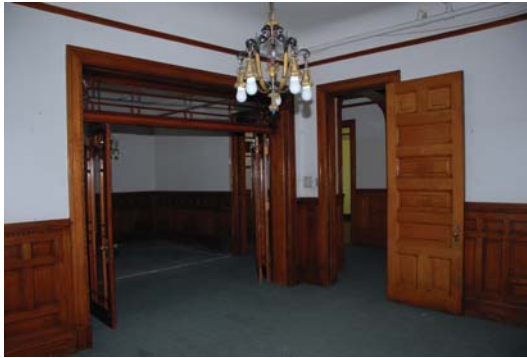
16.

Ceiling - A fire protection system has been added to this room and visible pipes and sprinkler heads hang just below the ceiling surface.

Doors & Windows - The room has three windows located on the east wall. All three windows have a bottom sash that is operable. The upper sash appears to be a fixed transom. All the doors and door hardware are intact and in good condition.

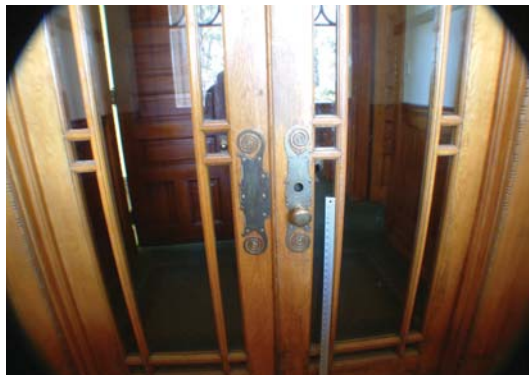
19.

Floor – The floor surface of the entry is covered in decorative tile work, which appears to be original, and is in good condition.

Walls – The original wood wainscoting is intact. Its condition is fair with some scratches, and the baseboard is heavily scuffed. There is evidence of water damage along some of the baseboards where snow and water from shoes has collected.

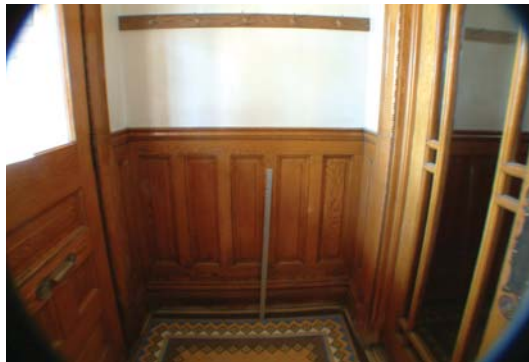
20.

Doors & Windows – The double-entry doors are wood, with beveled glass in the upper panels. They appear to be original and are in good condition. The interior double doors are also wood with larger areas of glass. These doors mimic the character and design of the entry doors. Both sets of doors appear to be original and in good condition. The doors appear to have their original hardware, including a unique lockset and matching hinges, which were designed with a unique metal scrollwork pattern. Transoms are located above each set of doors.

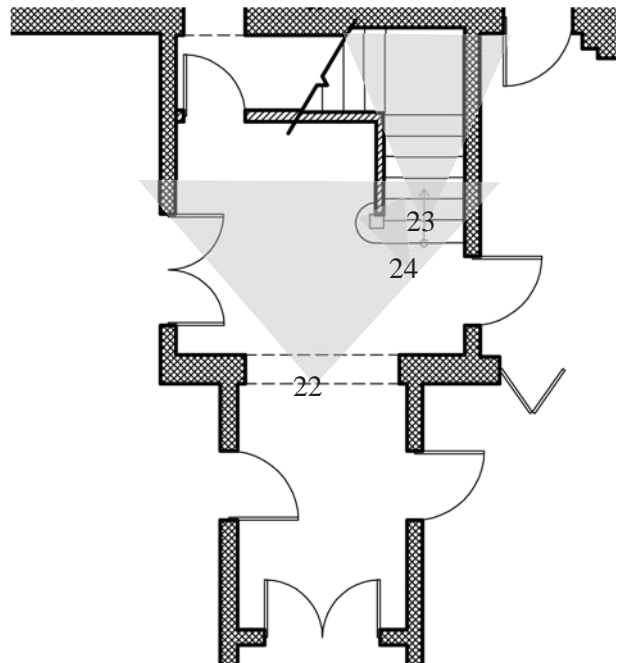
Other – The foyer opens up onto the staircase. The balustrade and stairwell opening have been enclosed by gypsum wallboard. The original carved wood newel post is intact and in good condition. A hole on the top of the newel post, suggests that a light fixture was mounted on top of the post at some point in time, and has since been removed. The wood stair treads and risers appear to be original and in good condition.

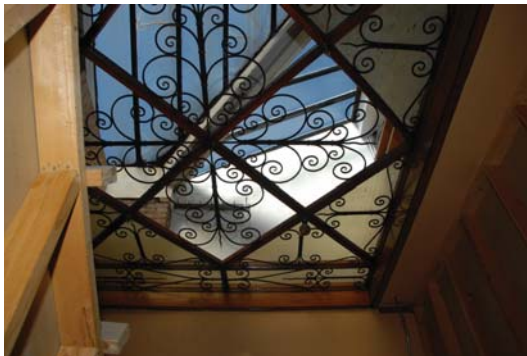
65.

Walls – The original wood wainscoting is intact. In this room, the wainscoting is about 32" high. Its condition is fair with some scratches, and the baseboard is heavily scuffed. Above the wainscoting the wall surface is painted over a paper-like material. Samples would have to be removed to determine the total layers of wall surface, and what the original wall surface would have been. The load bearing wall near the hall's pocket door has cracked plaster. The walls around the grand stair are made of gypsum wallboard and replaced an original railing system. Looking through a hole in this wall, an original skylight is visible above the staircase (image 65).

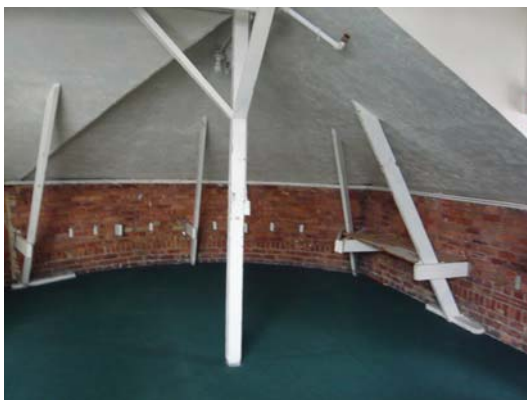
71.

Walls – The existing wall is the original brickwork (image 71). The white wooden projections extend to the exterior as the eaves of the roof. Some project into the room to meet supporting rafters. It is unclear if the other beams projected further into the room originally or if they have always been cut flush with the brick wall. There are many loose bricks and some are missing. The mortar is also coming loose in several areas throughout the wall.

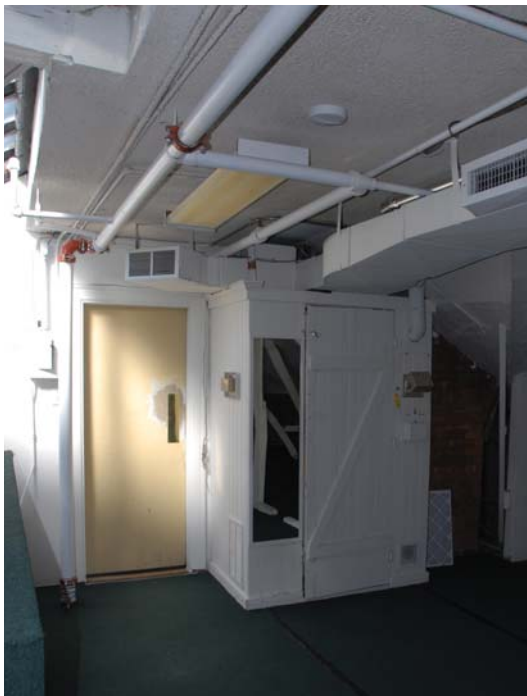
72.

Doors & Windows – The main entry door into this space is made of a metal and is not original to the home (image 72). Its paint is worn away around the push side of the door. The emergency exit door was a later addition when the building use changed. There is a fire escape that was added to the other side of this door.

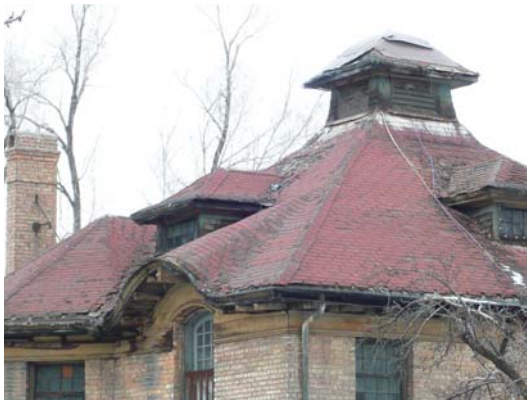
78.

The roof appears to be an asphalt shingle applied directly over the original cedar shingles. The roof surface is seriously deteriorated and is no longer water tight. Large holes in the roof are allowing moisture and animals to enter the building.

The exterior brick is deteriorating, beginning with mortar failure, which is allowing water to penetrate into the wall.

The watetable around the foundation of the building is also showing signs of weather damage., especially where site concrete sits adjacent to the exterior walls.
