# Replicating the John J. Earley Concrete Mix to Restore the Nashville Parthenon

ILENE R. TYLER

**Laboratory analysis and prototype testing determined an accurate match of the materials used to restore the Nashville Parthenon.**

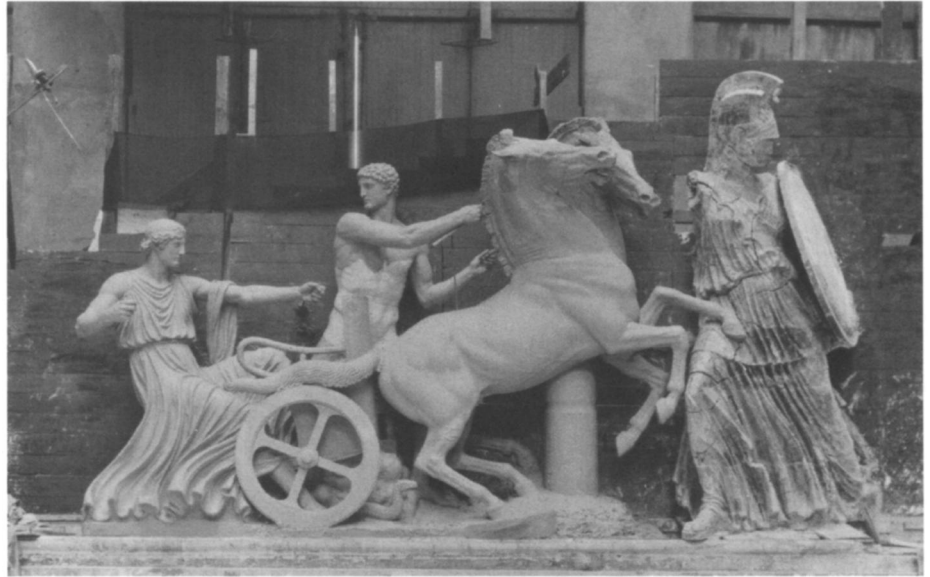
Fig. 3. Erecthonius and Hermes from the west pediment prior to 1925, being modeled in clay for recasting. The figure of Athena to the right of Hermes is thought to be salvaged from the 1897 version and stands ready for repairs. Photograph courtesy of the Parthenon.

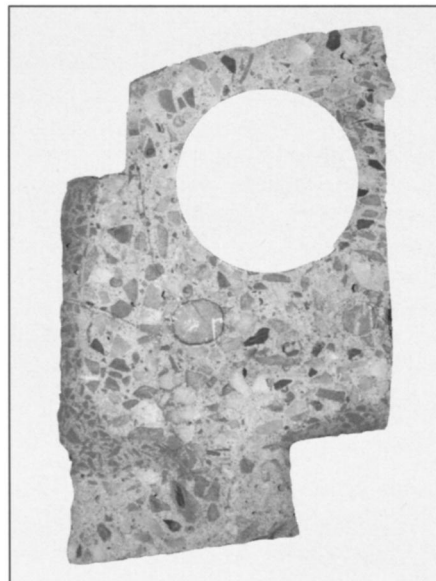
The coarse and fine aggregates were set in a beige-colored cement matrix of Portland cement and minute amounts of pigment. The coarse aggregates are exposed and gap graded. Typically, the samples were found to have high cement content (between 6 and 7.5 bags per cubic yard of concrete) and a moderately low water-cement ratio (about 0.44 to 0.48). All samples were non-air entrained and contained only about 1 to 2.5 percent of entrapped air, inadequate for protection against cyclic freeze-thaw damage. Because of the great variety in the samples that were tested, an exact mix design was not determined in the analysis, focusing primarily on identification of the components and their performance (Fig. 4).

Chloride levels (<0.007 at most samples) in the analyzed specimens were considered low. Compressive strengths ranged from 6,320 pounds per square

Fig. 4. Cross-section of regula piece with mutule. The hole is where a core sample was taken for laboratory testing. The step-graded buff mix is visible in the section, as is the steel bar reinforcing. A dark line around the steel bar indicates slight corrosion, also indicated by hairline cracks radiating outward from the bar. Courtesy of Wiss, Janney, Elstner Associates, Inc.

inch (psi) to 9,140 psi for the face mix and the body mix respectively. Most original pieces were cast with a conventional concrete mix as the body or base material and recast with the Earley mix for the visible outer 1-2 inches. Visual observations of the freeze-thaw test results showed slight deterioration after 100 cycles up to severe cracking and falling apart when the cycles were discontinued at 300 cycles.

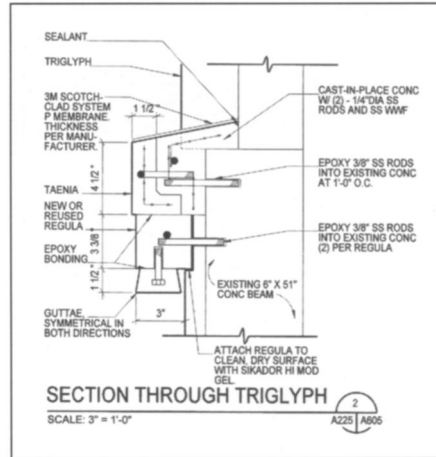
Fig. 5. Section through triglyph shows typical anchoring of pre-cast elements. Drawing by Quinn Evans | Architects.

After receiving visual and technical approval, each piece had to be attached securely to the building using a method that did not compromise the aesthetic of the original design. The drawings indicated the intended location of the cut line where each new sculpture piece would be mated to sound extant material (Fig. 8). Sound existing steel was retained, but new reinforcing, a combination of welded stainless-steel mesh and threaded rods, was added. Sketches were used to describe the unique conditions for each piece and its eccentric loading that could support the weight of the new cast-concrete elements. The approved concept for inserting the reinforcement was executed in the field and installed by the general contractor, Western Waterproofing.

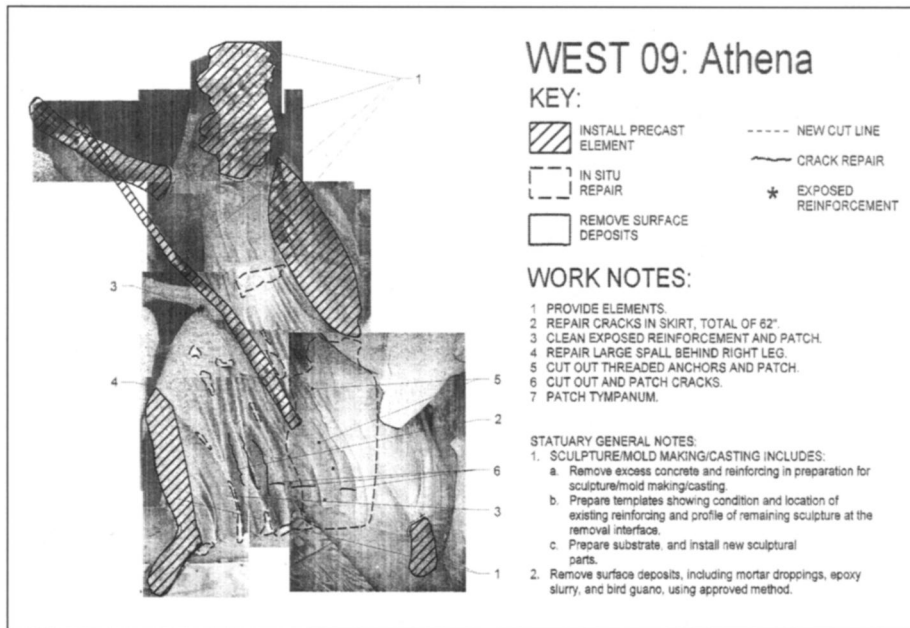
Fig. 8. A drawing of Athena in the restoration of the west pediment sculpture illustrates repairs and the extent of replacement elements. Drawing by Quinn Evans | Architects.

**Phase IV: west pediment and west, north, and south entablature.** Work continued around the building without interruption and with the continuation of the same construction team, except that Dr. Kreier's crew performed all of the modeling and reproduction of the sculptural pieces. As a final tour de force, Dr. Kreier produced the floral and gryphon acroteria for the roof. The extant gryphons from the Parthenon's four corners were beyond use but were very important for modeling the new pieces. The biggest challenge was figuring out how to cast and assemble the large pieces. After completing the modeling in clay, the large forms were cut into smaller sections, which were cast separately, then reassembled with reinforcing into one piece.

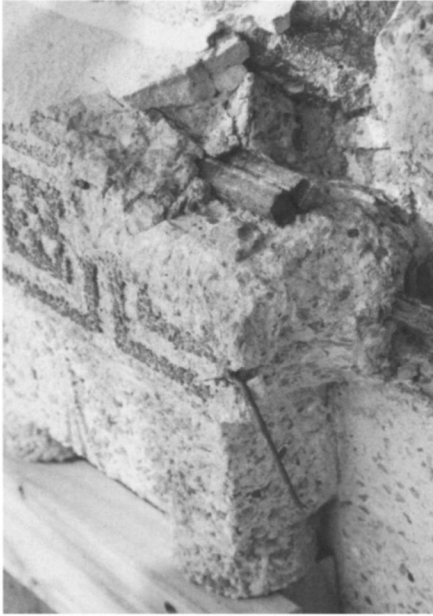
Fig. 9. Cutaway view of taenia, regula, and guttae shows the "before" condition of the decorative surface and corrosion of the embedded steel reinforcing. Photograph by the author.

Flat sections of the entablature were originally poured in place over a concrete substrate. Loss of adhesion or water intrusion had caused isolated delamination of the decorative surface. Where inspection detected areas that were hollow-sounding, and therefore delaminated from the substrate, they were pinned with stainless-steel helix anchors and injected with epoxy to stabilize the composite surface; patch holes were filled with the buff patch mix to blend with the aggregate surface.

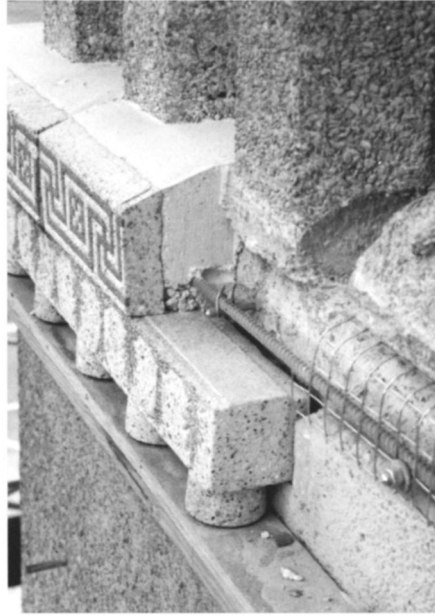
Fig. 10. Mock-up of taenia, regula, and guttae cast-in-place and pre-cast concrete repairs. This work was executed under the triglyph and metope panels around the entire perimeter of the building. Photograph by the author.
