# **THE DUTCH REFORMED CHURCH NEWBURGH, NEW YORK**

Prepared for  
Newburgh Preservation Association's Dutch Reformed Church Restoration Committee

Prepared by  
Mesick Cohen Wilson Baker Architects  
Albany, New York

## **EXISTING CONDITIONS AND RECOMMENDATIONS**

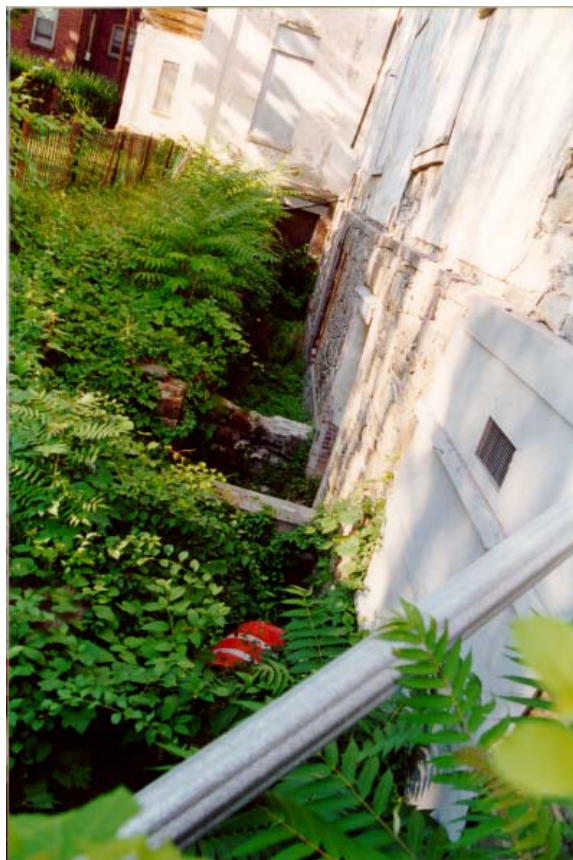
*Figure 14. West areaway looking north. Note excessive vegetation overgrowth and boarded window and door openings.*

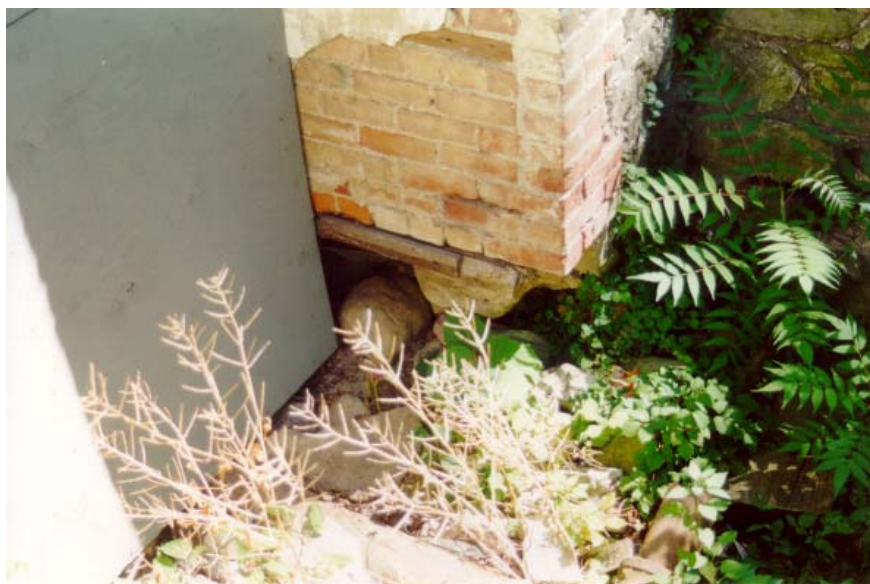
*Figure 15. Base of foundation wall deteriorated with large portions of missing stone in west areaway.*

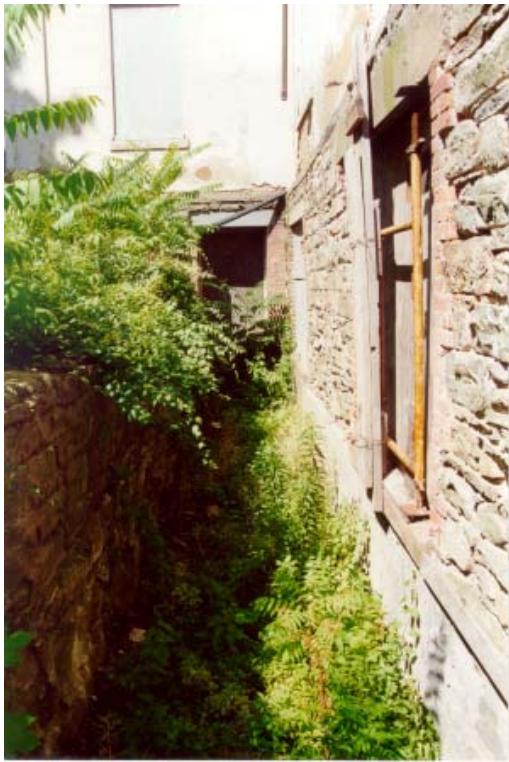
*Figure 16. West Areaway, note the jacks supporting lintel in window opening and cementitious parge coat along base of wall.*

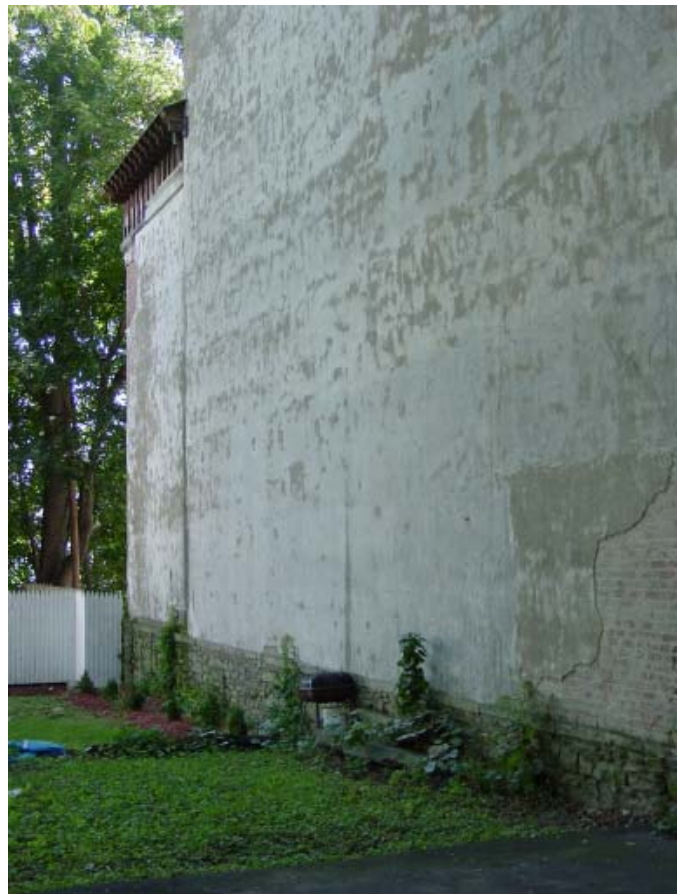
*Figure 18. North elevation. Note delaminated rendering exposing brick structure and overgrown vegetation.*

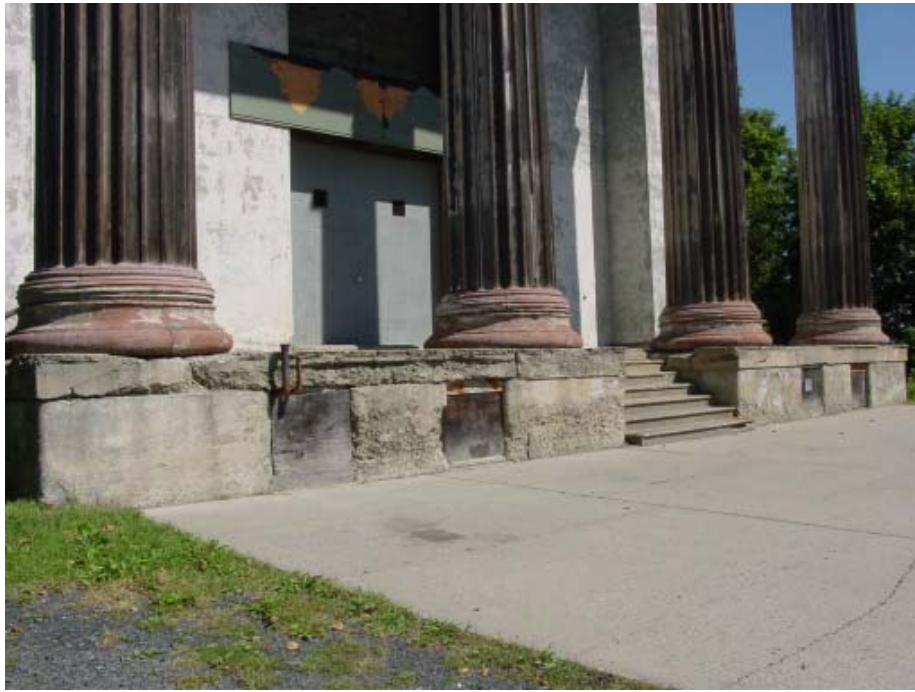
*Figure 19. Deteriorating concrete at south elevation portico. Column shafts have no paint coating to protect exposed wood from ultraviolet deterioration.*

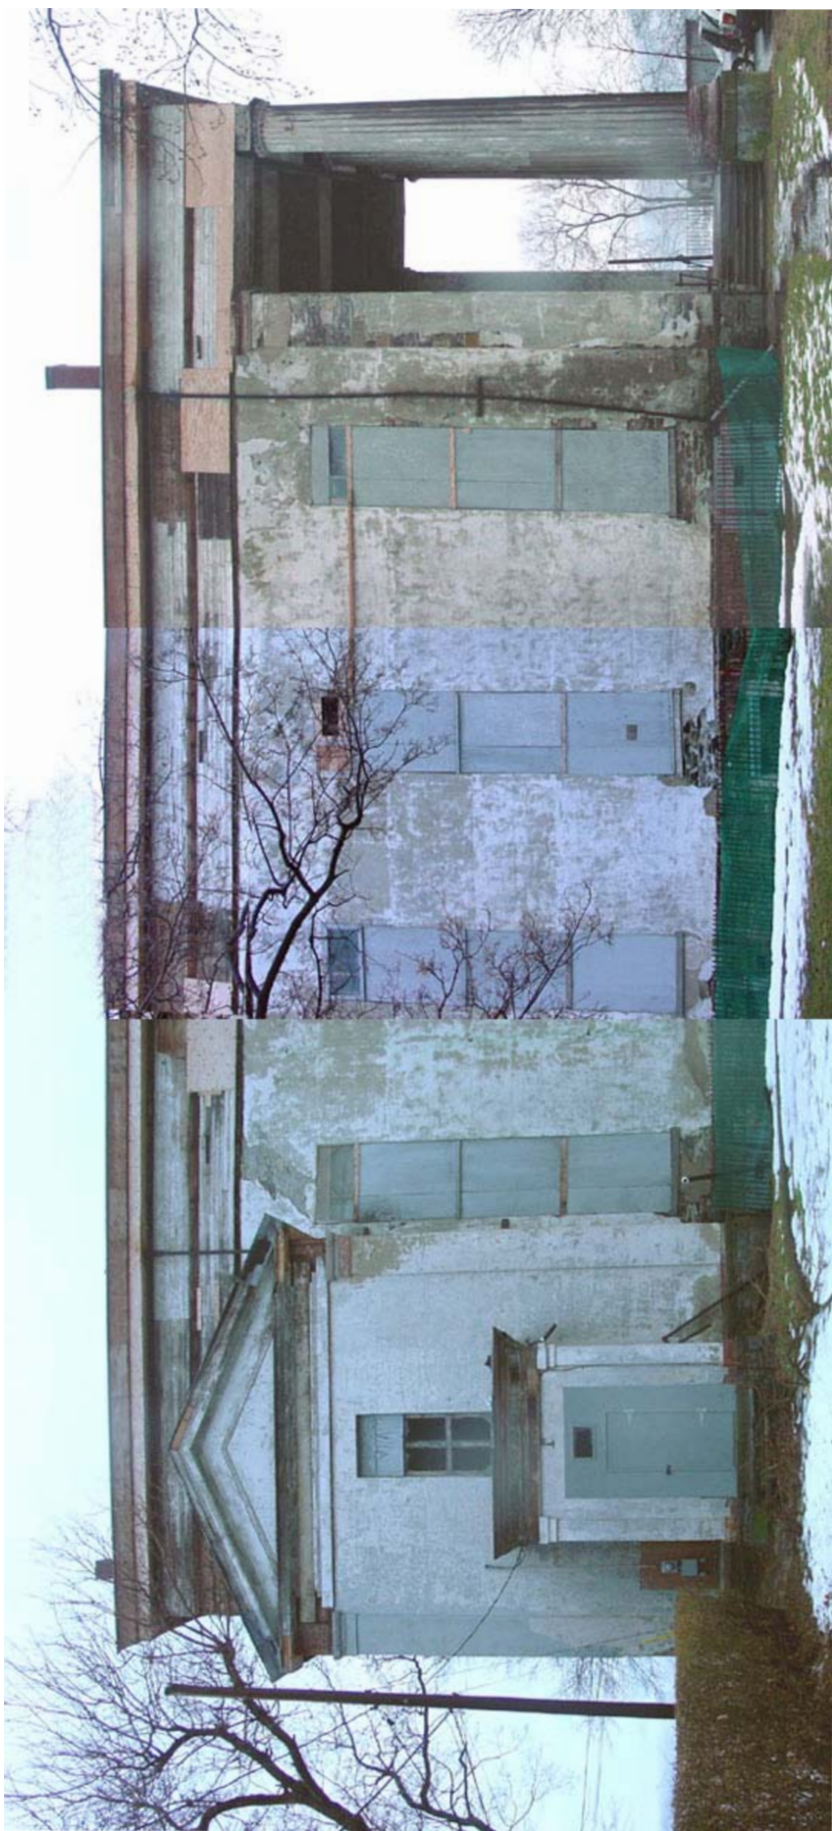
Figure 20. A collage of west elevation illustrates the deteriorated condition of the lime rendering, the subsidence of the center of the wall and the missing entablature elements.

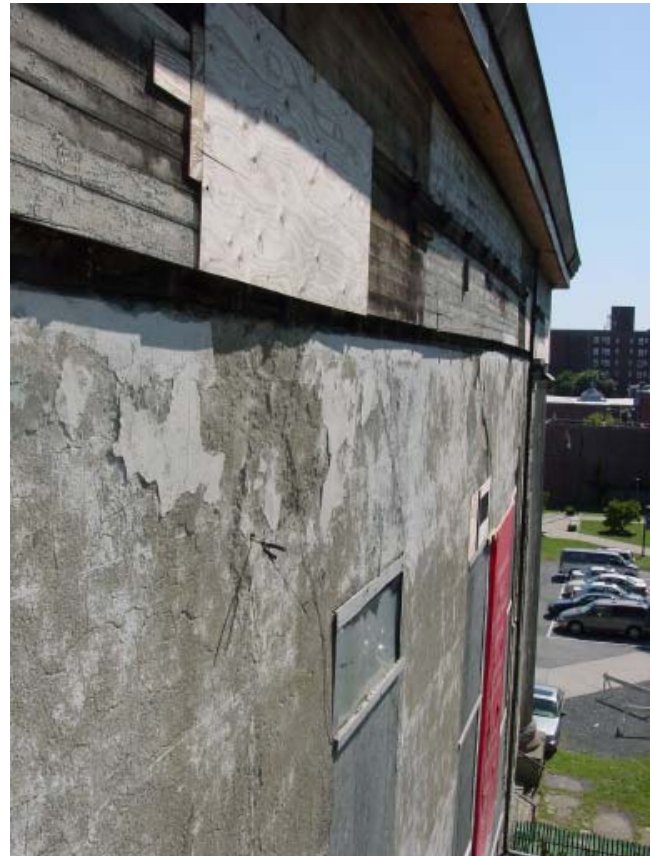
*Figure 21. View of west wall looking south. Entablature and rendered façade deterioration. The entablature molding has been removed and stored.*

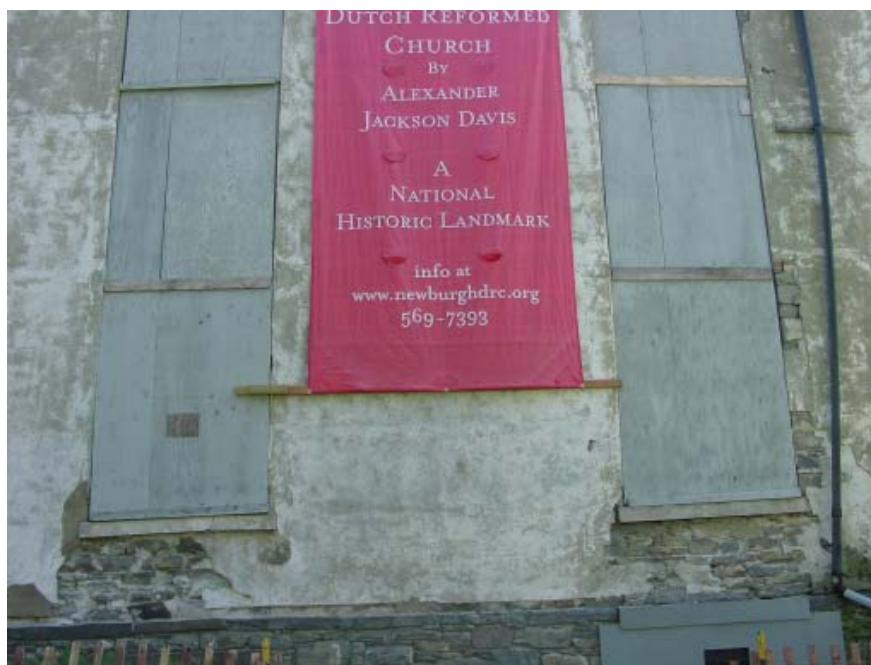
*Figure 22. Areas of spalled and missing rendering expose the rubble stone wall on the west elevation allowing for close inspection of the masonry system specified by A.J. Davis..*

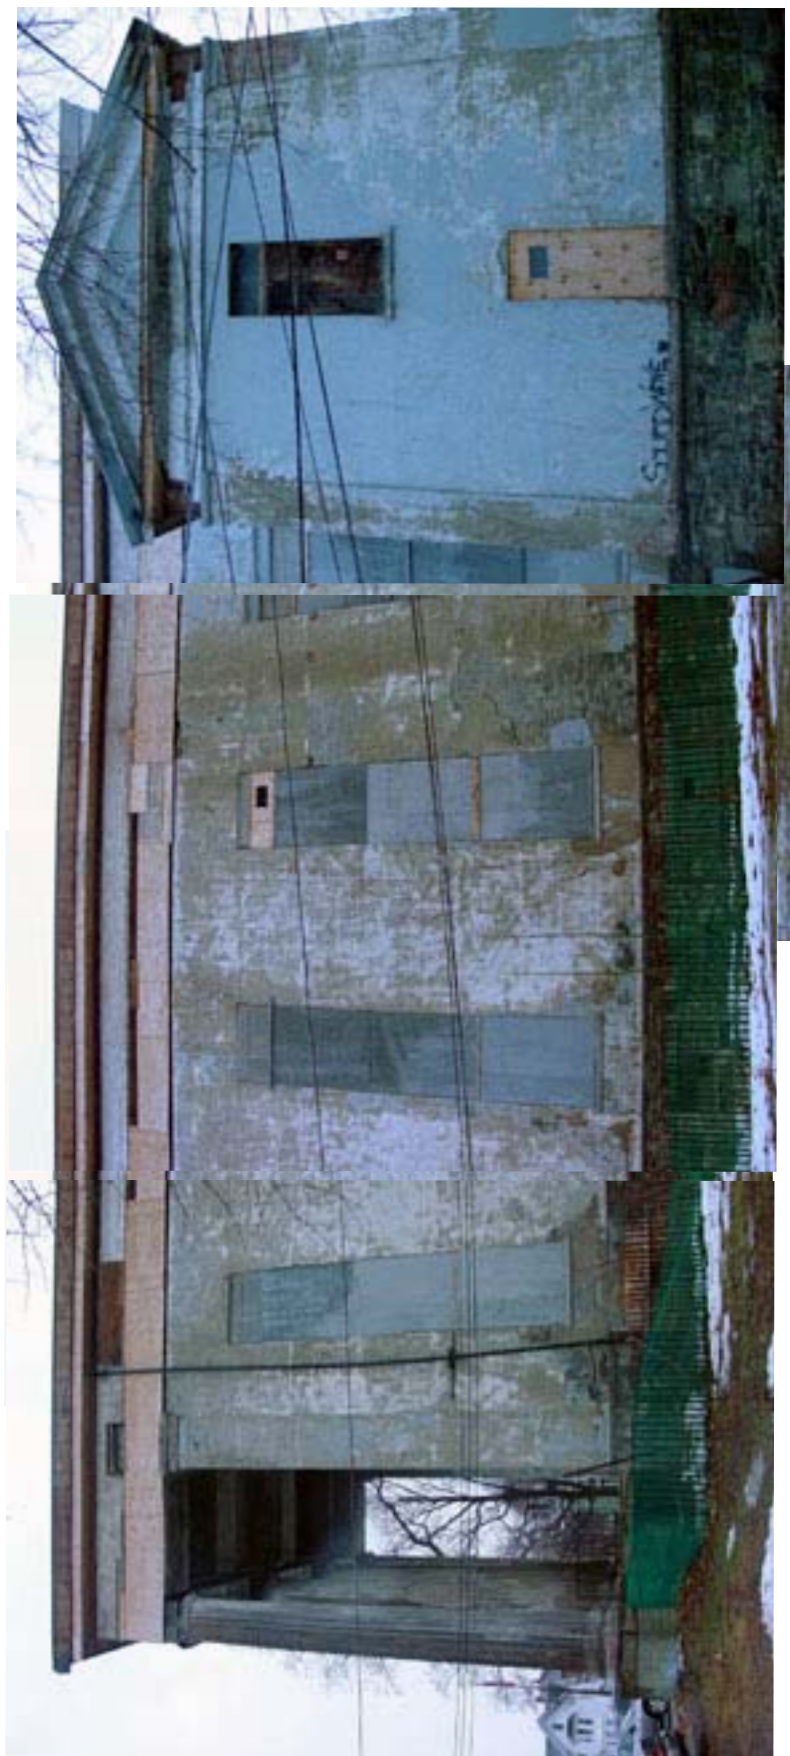
Figure 23. Collage of east elevation. Similar problems persist on the other long elevation of the Church, however, the wall has not subsided. Note the plywood covering the window openings and the spalling of the lime rendering,

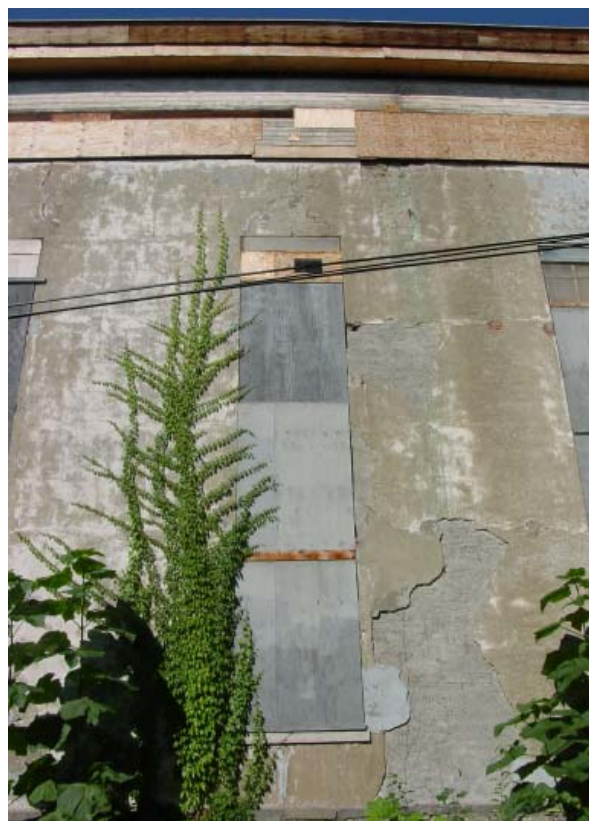
*Figure 24. Spalled stucco on east facade between window W23 and W24; note plywood covering portions of entablature.*

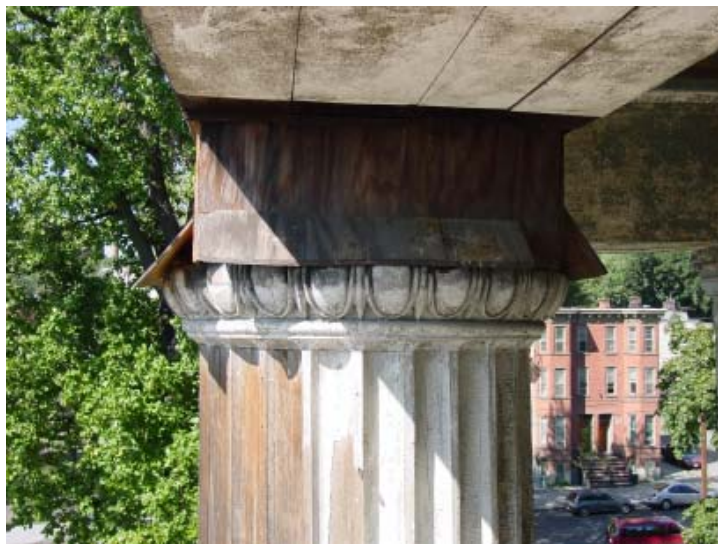
*Figures 26 and 27. Base, capital and shaft of Ionic columns. Note the traces of paint on the protected side of the column. The sandstone base was at one time painted, however, it is not known if they were originally painted. The remaining carved wood volutes are stored in the building interior. A master restoration wood carver will explore various alternatives for the restoration of the wood elements of the columns. Prescriptions should be developed for the conservation of the sandstone bases as well.*

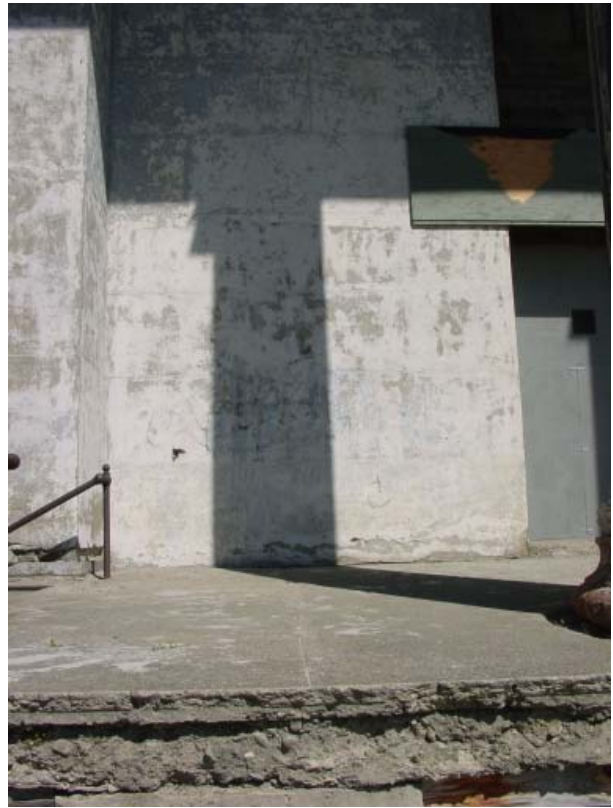
Figure 31. The protected lime rendering on the south wall illustrates the scribed ashlar pattern specified by Davis. Note the holes in and deterioration of the rendering at various locations in the photographs. Later coats of paint are peeling from the surface. Also note the spalling apparent on the concrete deck in the foreground.

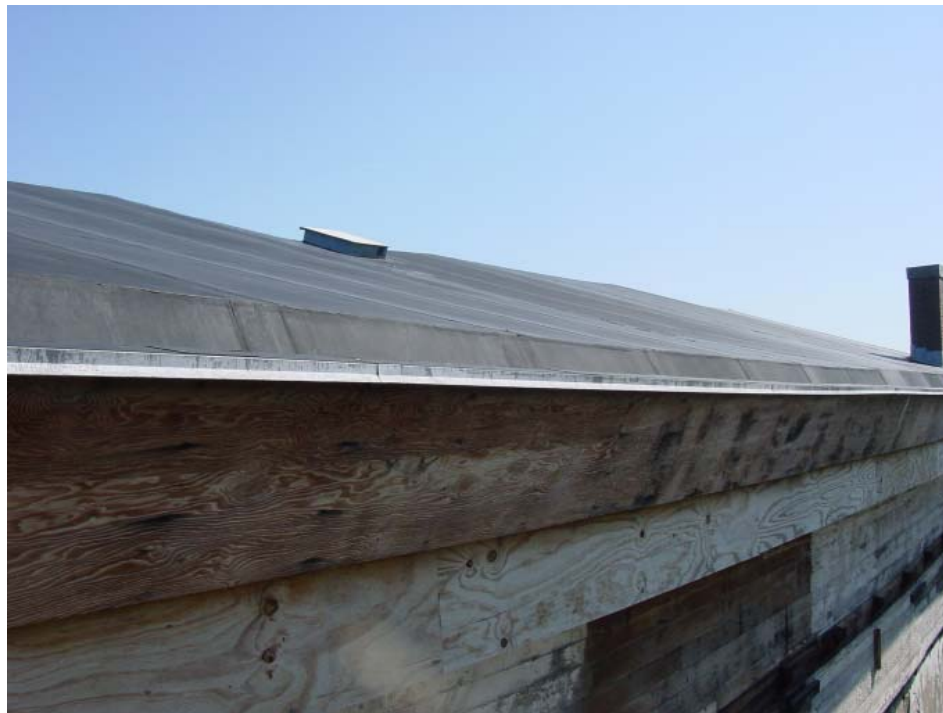
*Figure 33. View of the EPDM roof installed in the 1980s during the tenancy of the Hudson Valley Freedom Theatre. The temporary plywood gutters are largely ineffective, as leaders have become detached and water runs into the Areaways below. Note the saddleback in the roof at the hatch location. Further investigation into structural movement will be necessary to determine the appropriate treatment for the problem.*

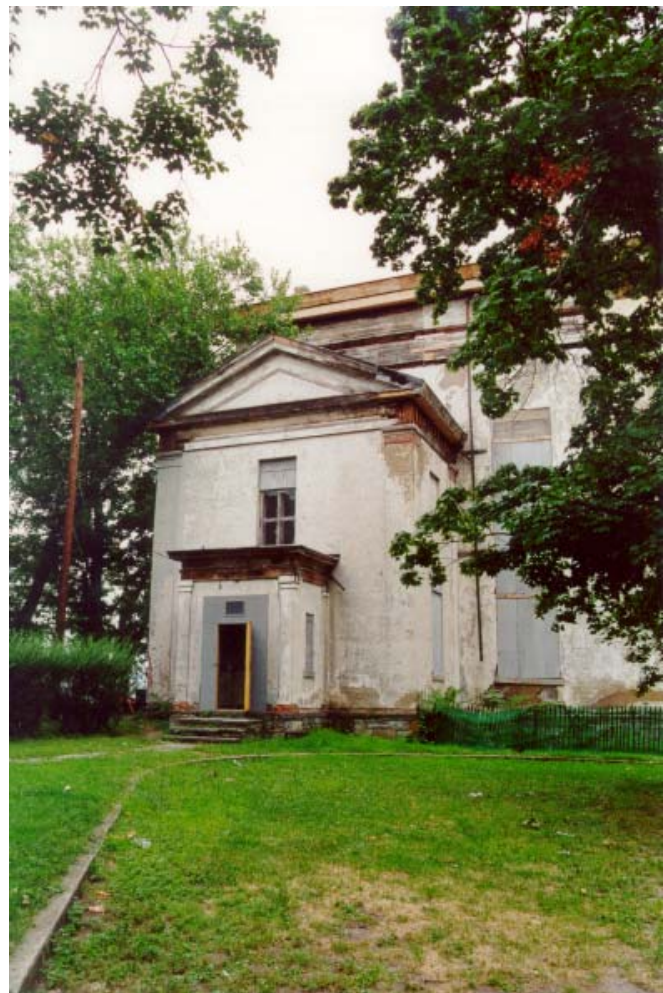
*Figure 34. West transept and entry. Note the missing portions of the entablature and the missing lime-based rendering that reveal the brick structure beneath. The brick masonry is indicative of the 1867-8 additions. The door has been removed and placed in storage.*

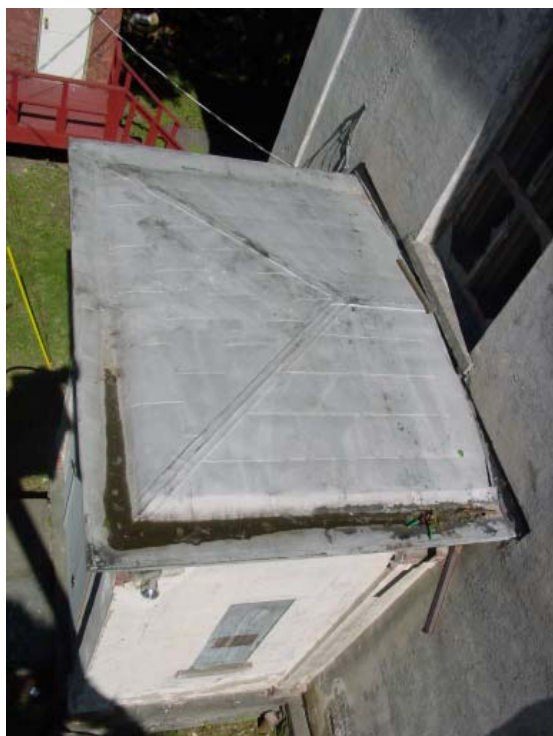
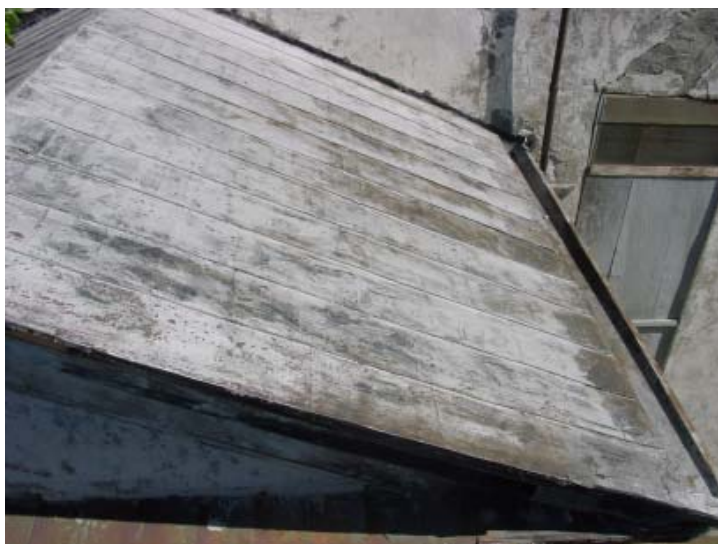
*Figures 35 (left) and 36 (above). West entry roof with aluminized coating. Although there is general wear, the roof does not need immediate repair. The roof of the west Transept is a flat seam metal roof very much in need of repair. The roof of the west Transept is standing seam metal. The pans have lost their protective coating and show signs of deterioration which may lead to leaks affecting the interior of the building.*

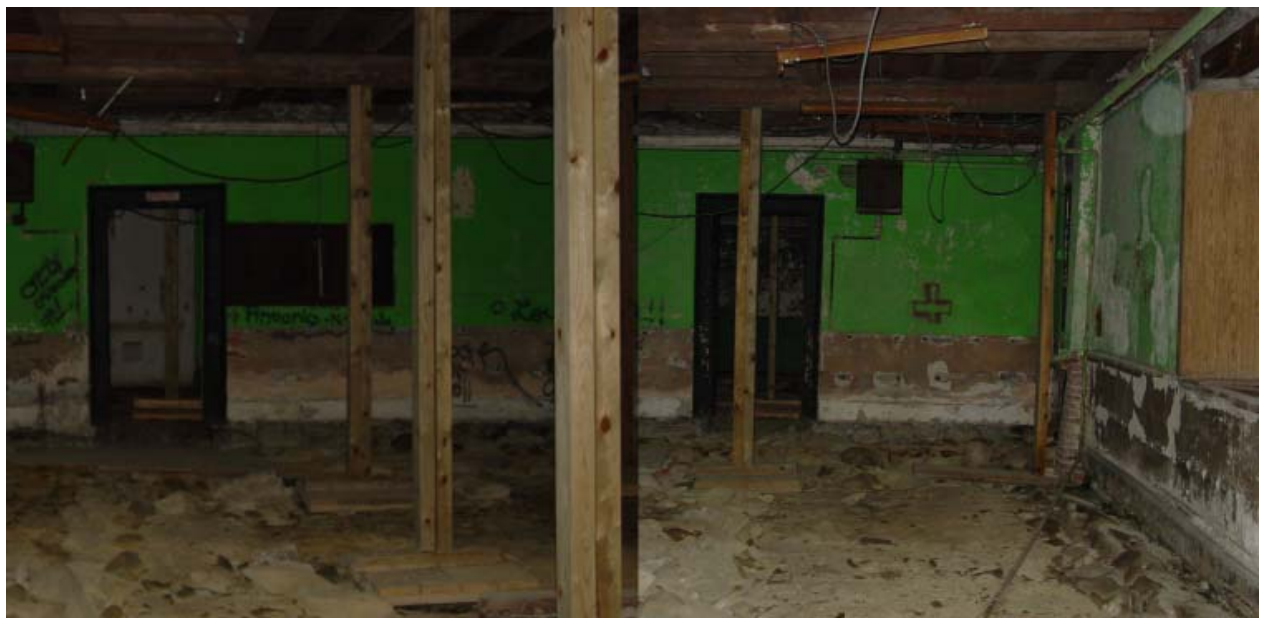
Figure 39. Collage of South wall of Sessions room. In the foreground can be seen the shoring and temporary footings installed by the National Parks Service in 2002 to stabilize the main floor. Note the absence of the floor and the ceiling framing.

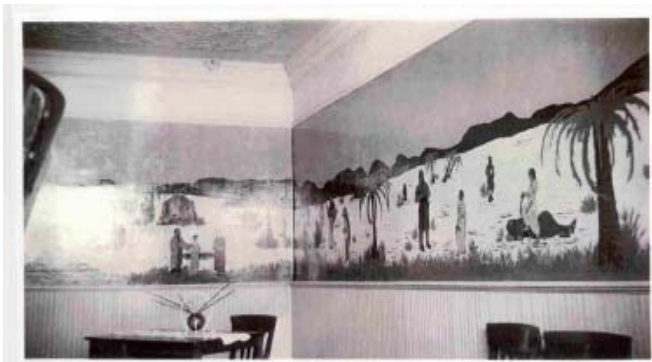
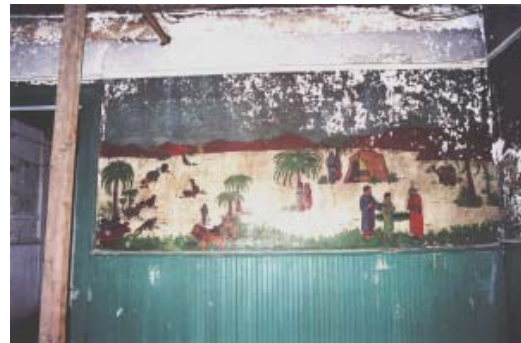
*Figures 41 and 42 . Historical photographs of the West School room mural in basement (left). Today the paint is peeling due to the humidity and temperature cycling. A choice must be made as to whether or not to preserve the mural painted sometime in the 20<sup>th</sup> century.*

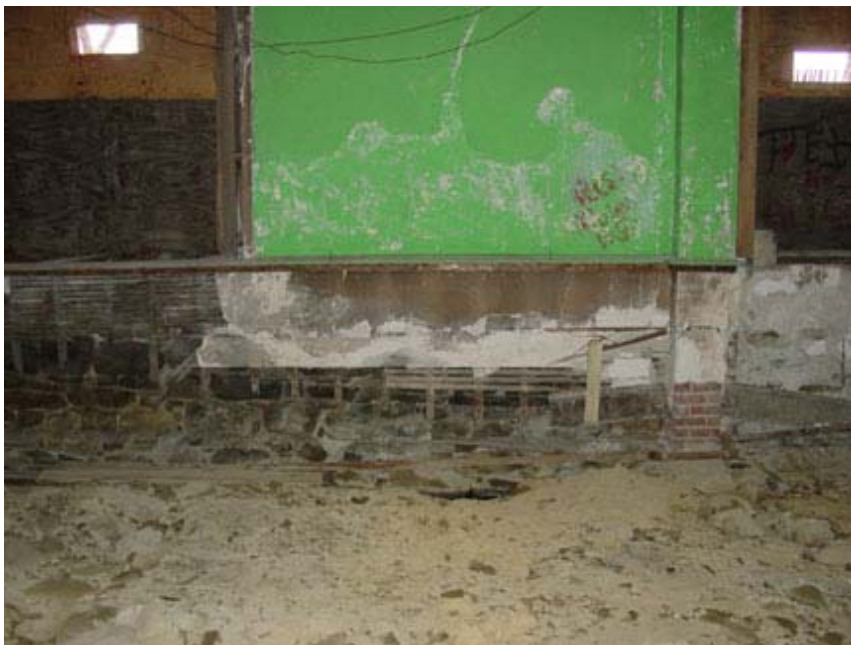
*Figure 47. The east wall in the Sessions Room is typical of the deterioration of the plaster walls and footings in the basement.*

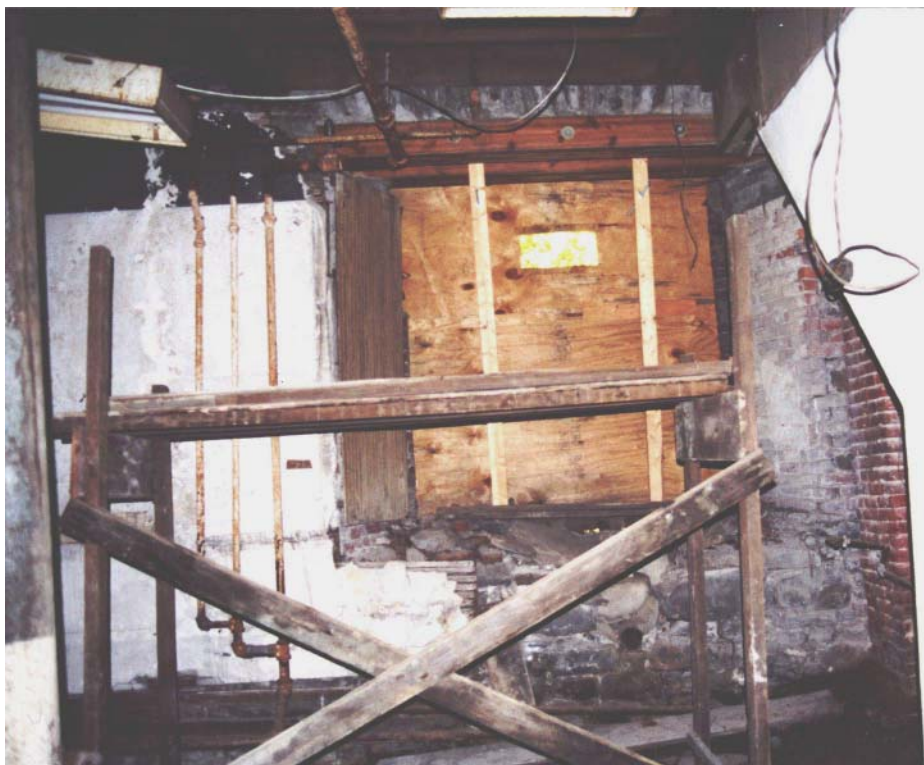
*Figure 48. The shored window at east wall of East School room is representative of the stabilization efforts undertaken by the National Parks Service in 2002.*

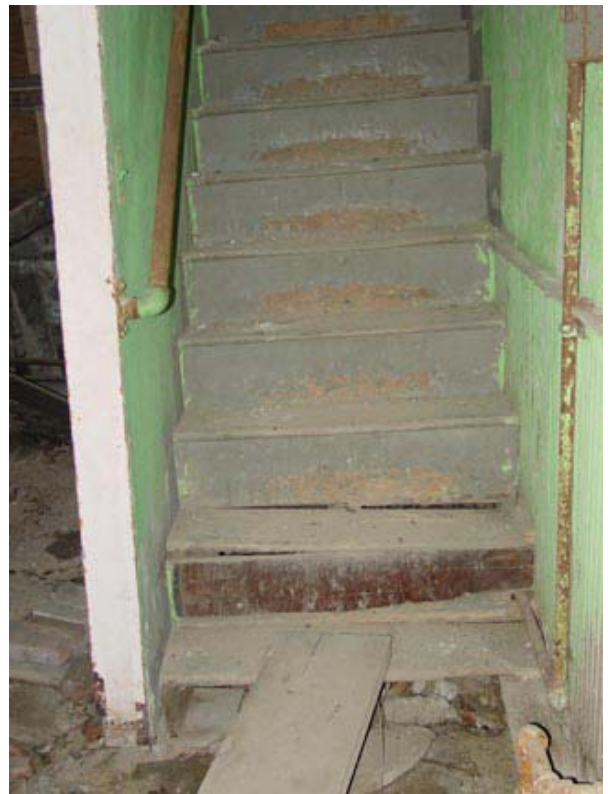
*Figure 49. Stairs connecting East School room to vestibule of main level. Communicating stairs between the levels should be installed to facilitate ease of movement through the building.*

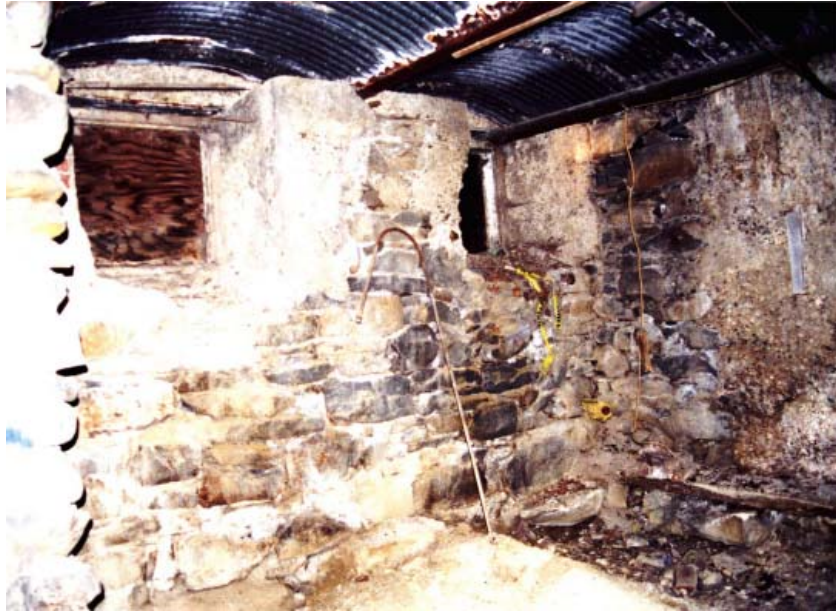
*Figure 50. View of the interior of south wall beneath the Portico illustrating the deteriorated condition of the steel beams supporting the corrugated metal jack arches installed in 1910. The piers beneath the columns are approximately 4'x4'; the walls between the piers are roughly 18" thick.*

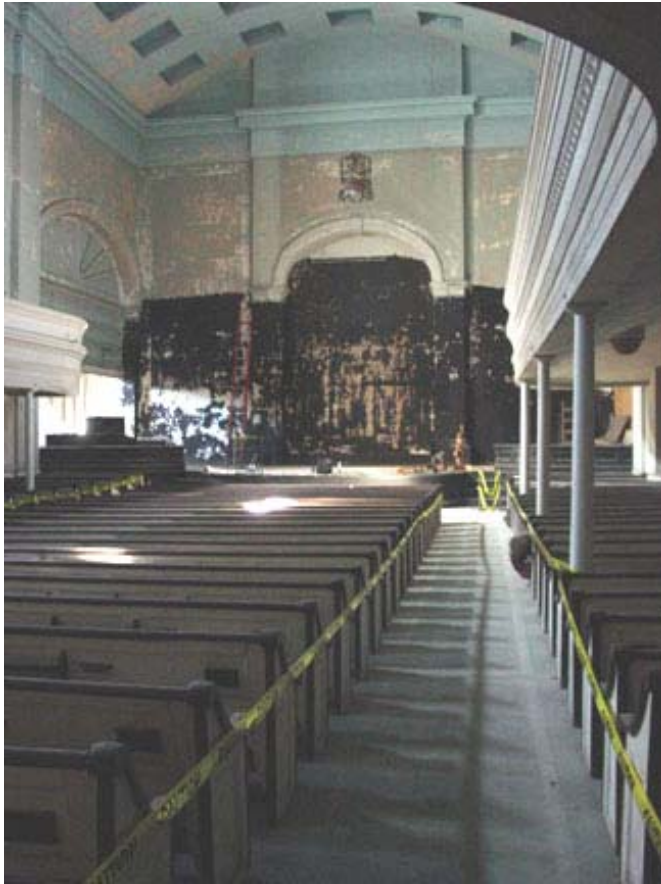
*Figure 51. North elevation of Nave also adorned with the DRC crest. The black paint is the result of the tenancy of the Hudson Valley Freedom Theatre during the 1980s. The aisles were infilled with a cementitious material to raise their level to that of the pews. Barely visible is shoring installed beneath the panels at the west Transept.*

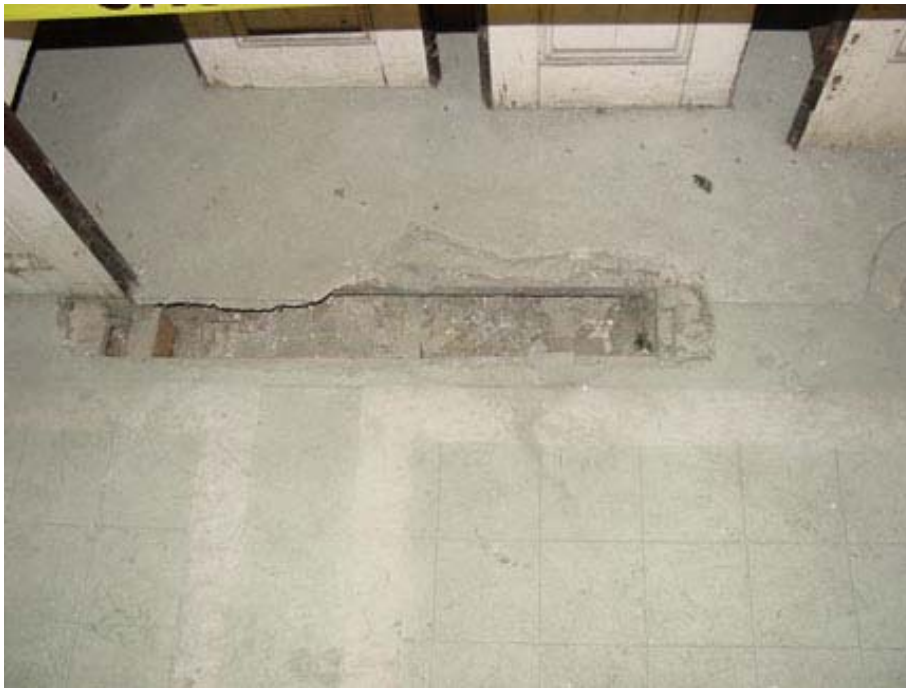
*Figure 53. The framing for the infill is visible due to the damage to cementitious flooring in the Nave. The aisle floors were scribed to mimic a tile pattern.*

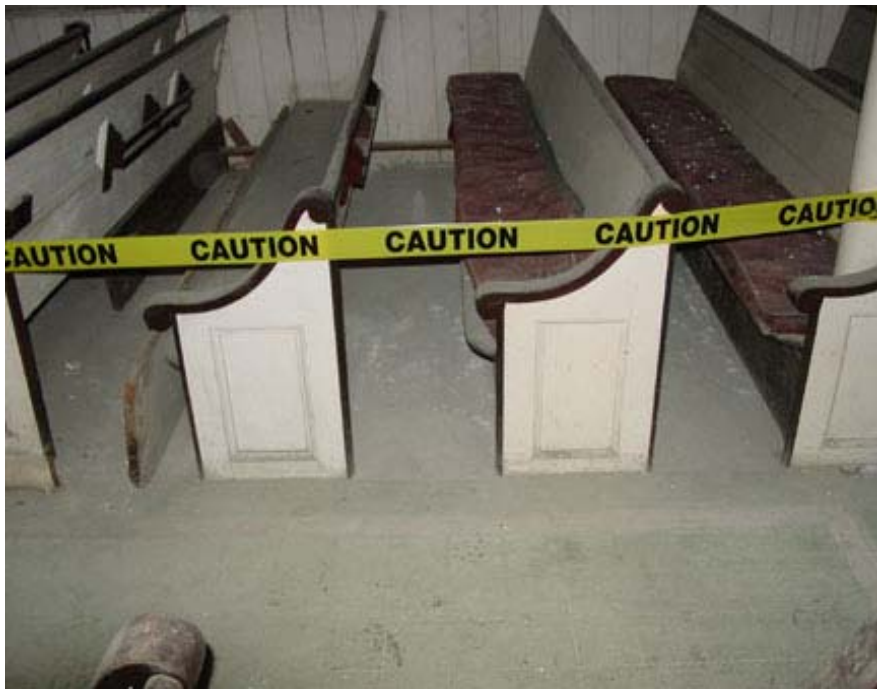
*Figure 54. The pews along east wall of Nave. Two iterations of the design exist in the building and can be identified by the molding profiles in the panels. Their bases have been submerged in the cementitious material to varying levels due to the settlement of the floors. Dutchman repair of the wood at the bases of the pews will be necessary as well as general stabilization and repair on those more damaged. Paint analysis, stripping, priming and repainting/restaining are all required.*

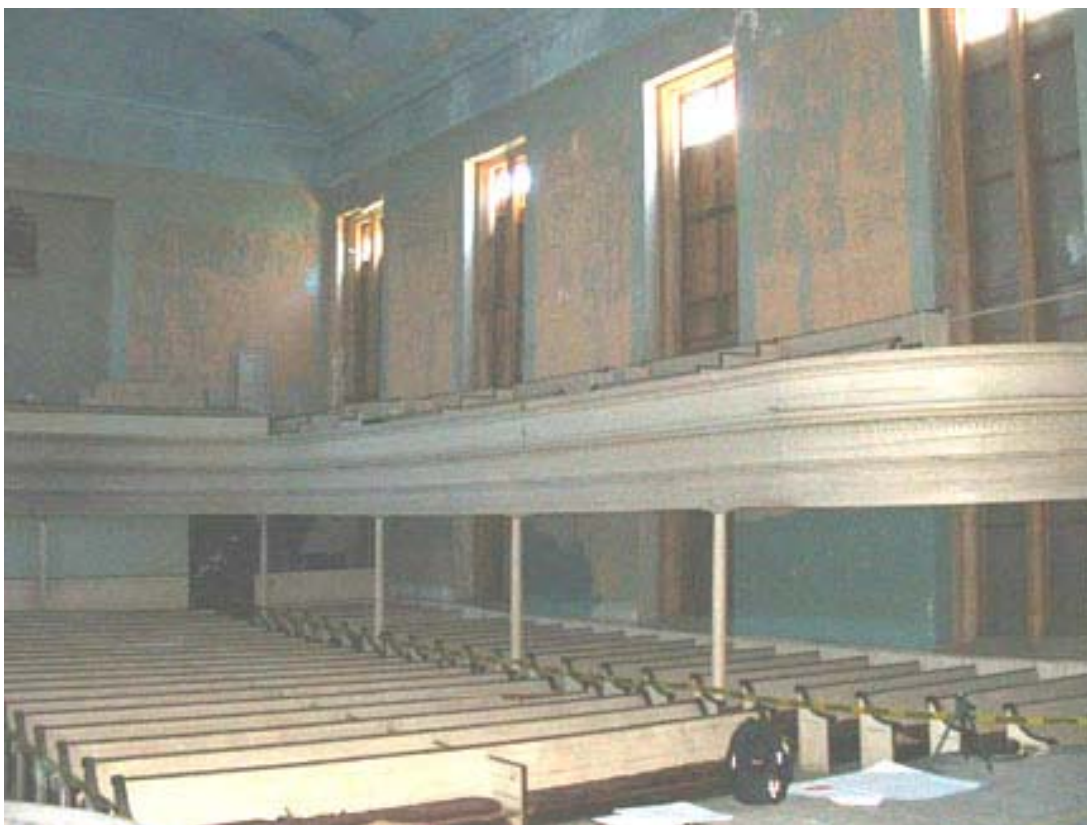
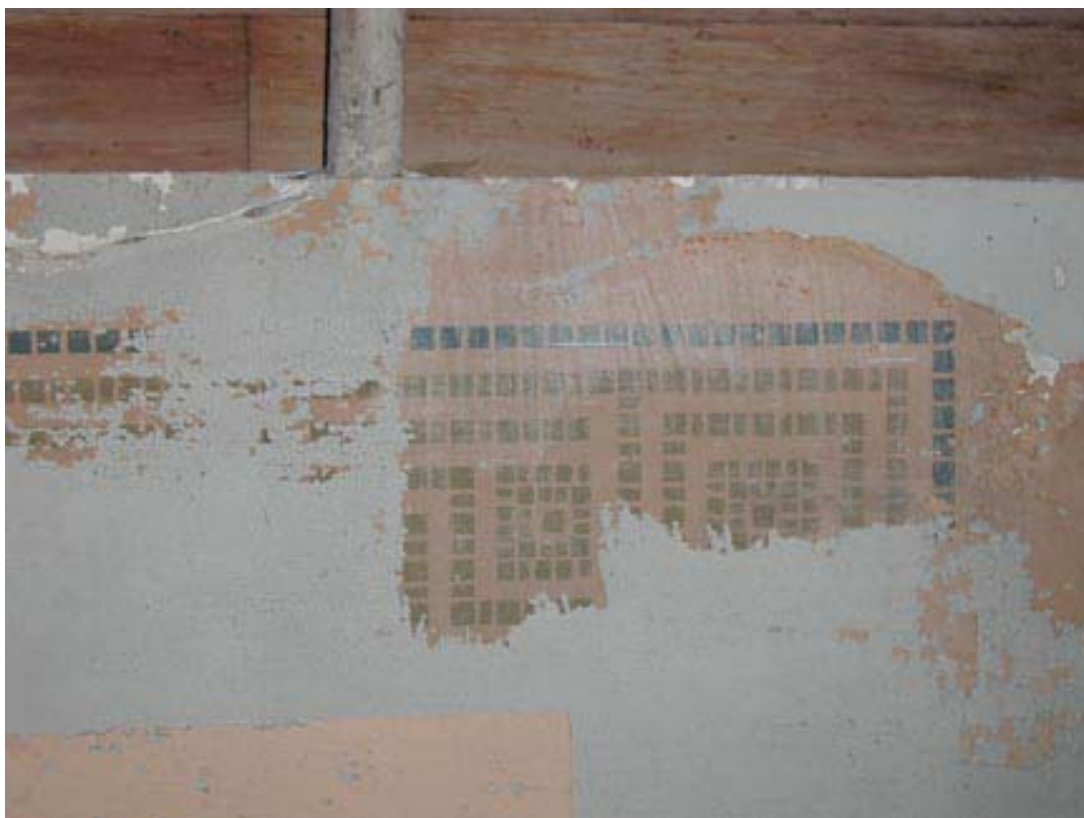
*Figures 55 and 56. View of west wall of Nave and gallery (above) Note the peeling paint layers that expose the 1906 stencil pattern (below).*

Prior to stripping the paint from the walls and woodwork, paint analysis should be performed to document the decorative schemes. At that time, the Committee must decide which scheme best suits the potential uses of the space and a comprehensive paint restoration program should ensue.

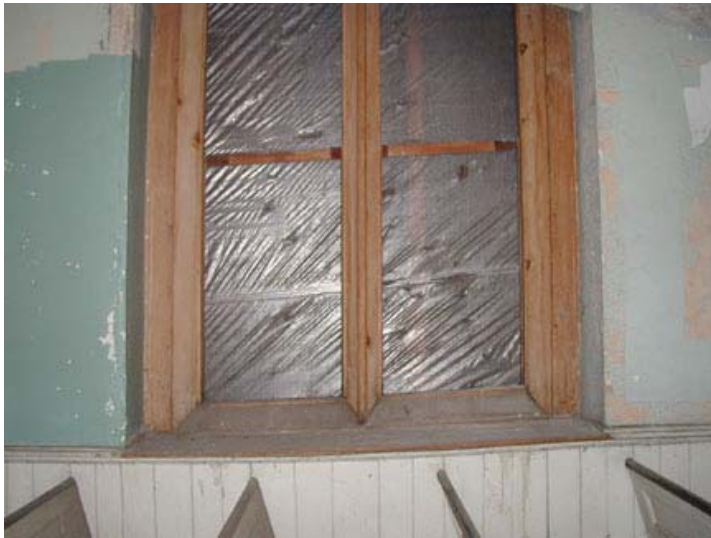
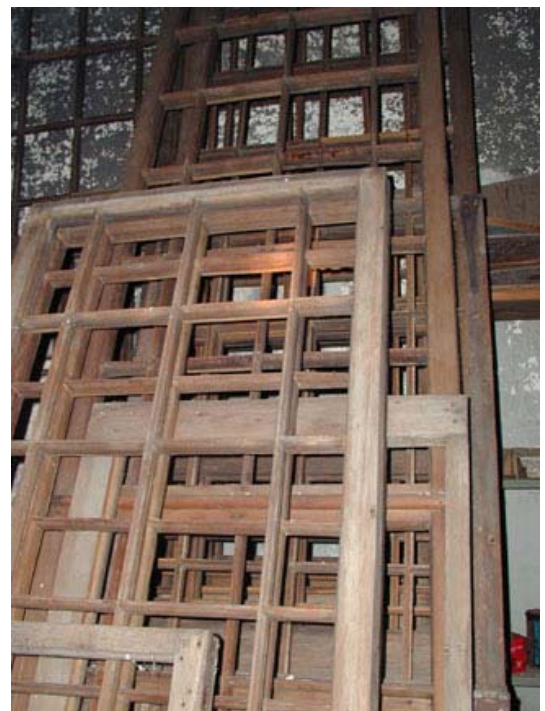
*Figures 60 and 61. The existing window frames were installed in 1867-8, reducing the size of the sash by half. (above) The remaining sash were stripped, broken glass removed and then stored in the east Transept.*

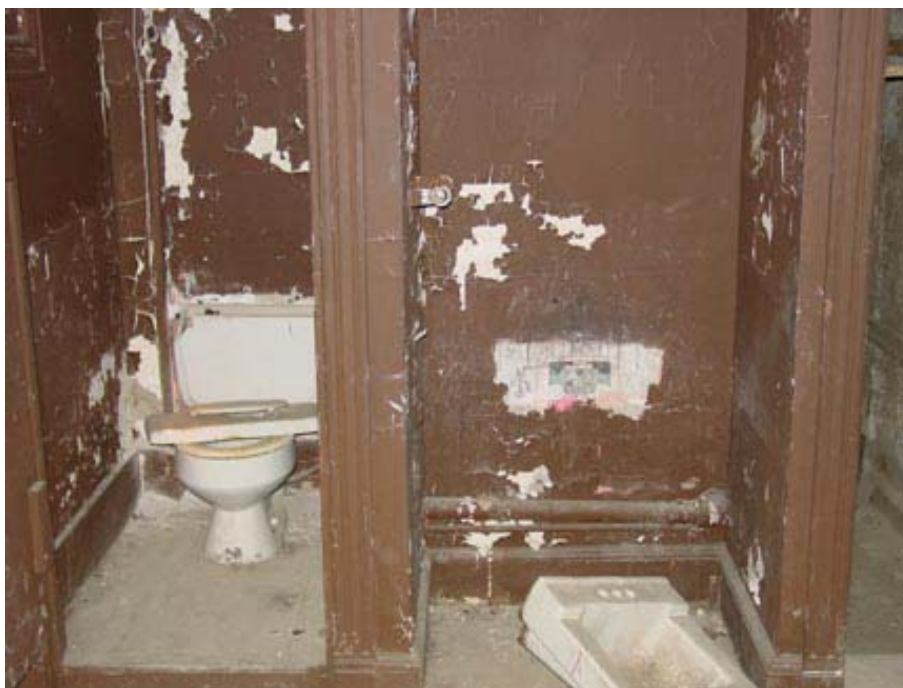
*Figure 72. Ladies toilet stall located under the Portico. None of the plumbing is functional at this time.*

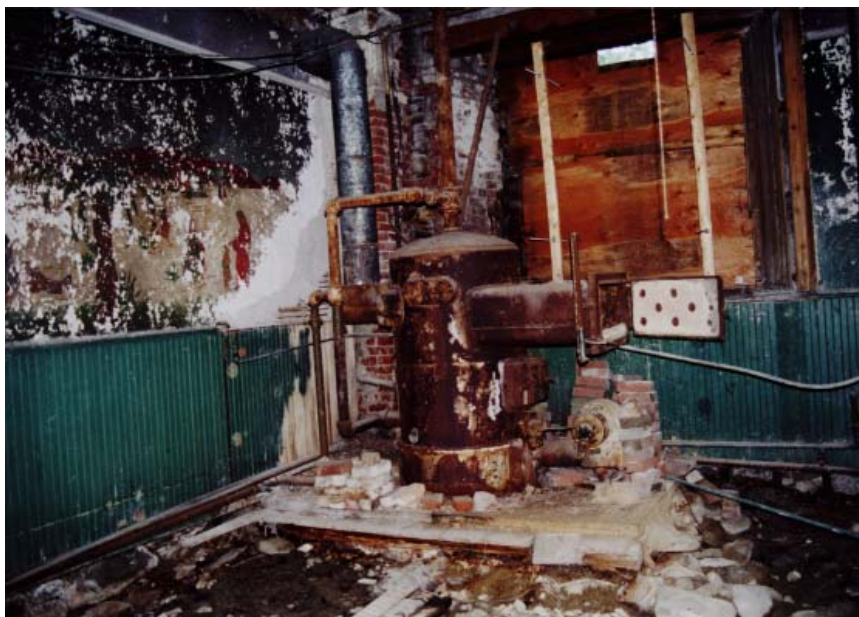
*Figure 73. Defunct furnace in west School Room.*
