HISTORIC STRUCTURE REPORT

AHIMAAZ KING HOUSE AND CARRIAGE HOUSE

February 15, 2008

Sullebarger Associates
1080 Morse Avenue
Glendale, OH 45246
(513) 772-1088

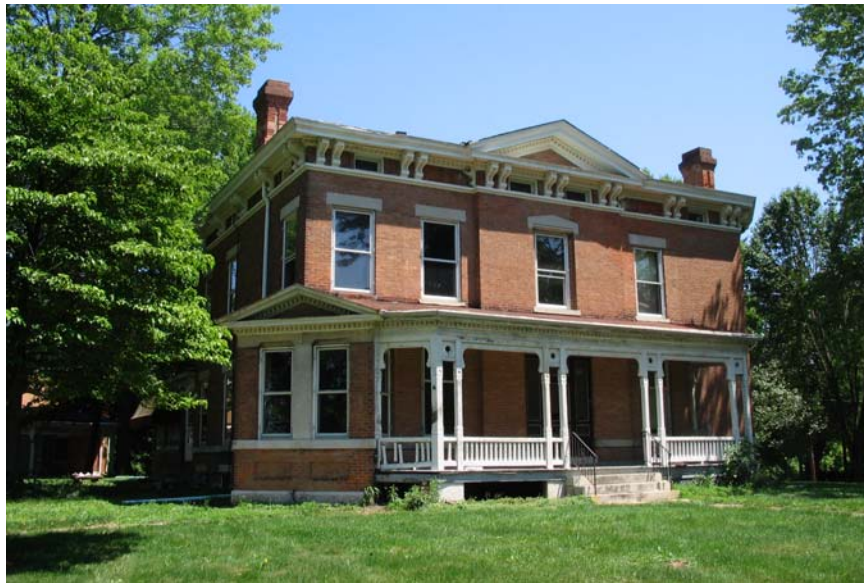
Photo 1. Front elevation, looking north

Located at 1720 East King Avenue, the Ahimaaz King property is a 65-plus-acre site in Kings Mills, a small, unincorporated community in the northeastern corner of Deerfield Township, in Warren County, Ohio. The King Property occupies the highest ground in the area (EI 784') on the west bank of the Little Miami River (EI 600'). The property includes a house, carriage house, small frame shed, barn, office building, and large frame shed. (This study focuses on the house and carriage house only.) The property is located at the northeast corner of the village, where Kings Mills Avenue takes a right-angle turn to the south; the house is on axis with the road. The house is set back about 150 feet from the street and accessed by a U-shaped concrete driveway which curves around the rear of the house. Historic views show the house surrounded by trees and a cast iron fence running along the street frontage. The fence and some trees were removed in 2006.

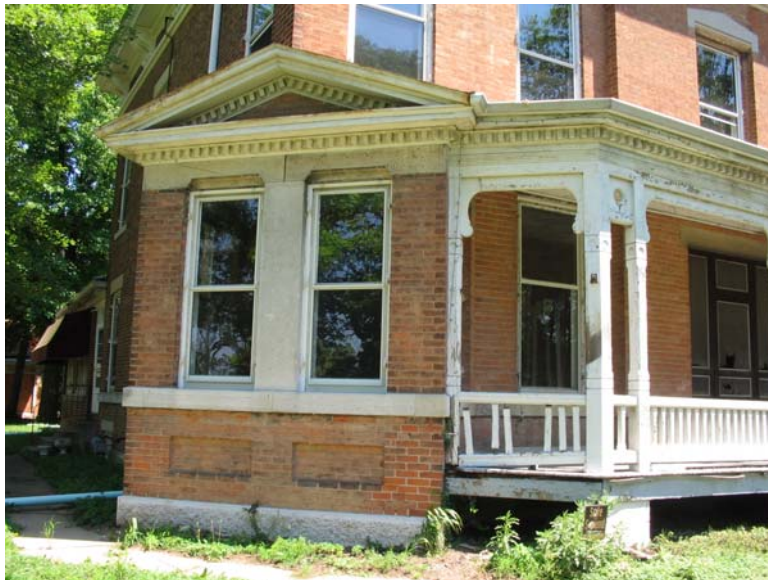
Photo 2. Southwest corner bay

The building would present a five-bay façade if the easternmost bay were not windowless. The front portion is essentially a two-story rectangular block with a two-story ell with a further one-story former summer kitchen connected on the rear, creating a telescoping effect. The envelope of the main block is expanded by a one-story diagonally projecting rectilinear bay at the southwest corner, a two-story angled bay on the southeast corner and porches on the front and sides. The design is an intriguing mix of formal symmetry of the Renaissance-based Italianate style and exuberant asymmetry of the Queen Anne style, which emerged in the Victorian era. The paired end-wall chimneys and central pediment at the roofline emphasize the symmetry. The projecting bays and asymmetrical porch treatment break out from the rectilinear constraints.

The structural system consists of masonry load-bearing walls and wood floor framing. The wood joists are full-sized 2- by 10-inch boards. The floor boards throughout are tongue-and-groove.

The hipped roof was originally standing-seam metal; it was replaced with asphalt shingles in the 1990s. The roof is crowned by a widow's walk enclosed by a balustrade of galvanized tin approximately eight by sixteen feet. Dentils decorate the pediments at the top of the wall, the diagonal bay and the cornice of the front porch. Paired scrolled brackets support the cornice. Six slender brick chimneys pierce the roof flush with the exterior wall--two on the east side of the house, two on the west and three on the north, including one on the one-story summer kitchen wing at the rear. The chimneys on the main house are tall and slender and have a textured, limestone band near the base, while the chimney of the summer kitchen is smaller, simpler and lacks the stone detail. The latter has a metal cap and two metal vents that serve the later conversion of the kitchen into a bathroom. Four of the chimneys are in good

condition; the two on the East side and the one over the summer kitchen are somewhat deteriorated. One chimney was removed to below the roof line after 1999.

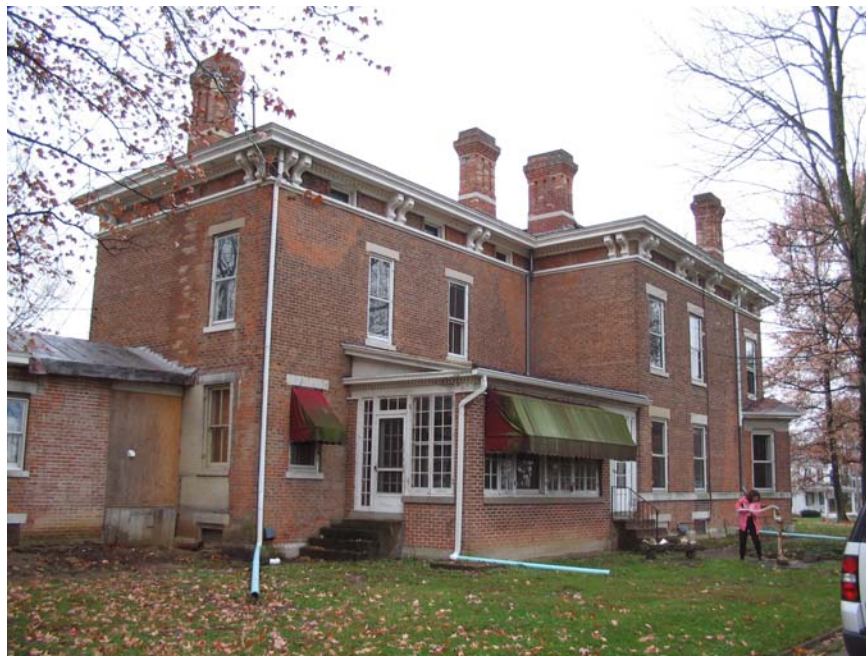
Photo 3. West and north elevations, looking southeast

The house has four porches—a full-width one-story porch on the front (south) elevation, a two-story porch and a one-story porch on the east elevation and a one-story solarium on the west elevation. The one-story, full-width, front porch, eight feet deep, has a wood deck, wood railing with chamfered square posts and balusters and decorative scrollwork. The stone slab steps have contemporary iron railings. A wood swing hangs from the porch ceiling on the east side. The two-story side porch is similar in design to the front porch, but less deep. A smaller one-story porch shelters a doorway near the rear. The original west porch has been replaced with an enclosed solarium with a concrete foundation and deck, brick walls and steel windows. A porch on the west side of the former summer kitchen was removed after 1999.

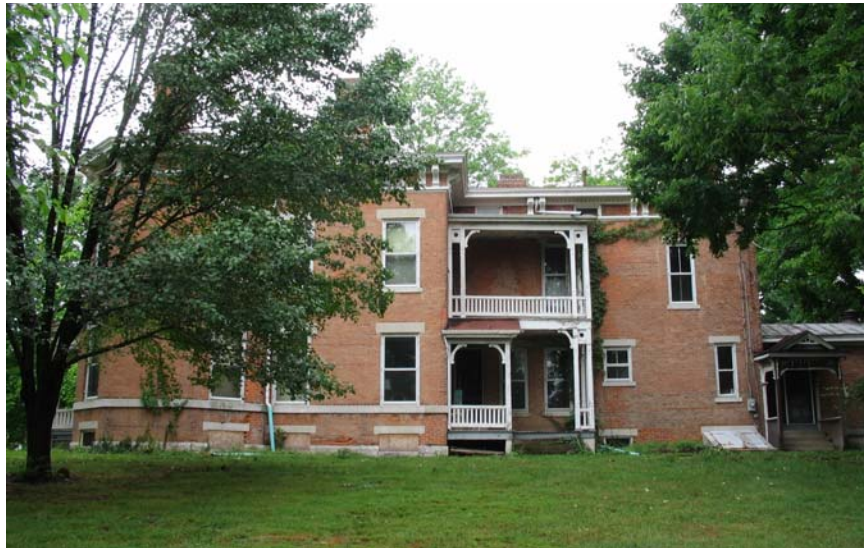
Photo 4. East elevation

There are three doors on the east elevation. The basement door has a limestone header and a wood batten door painted blue. To the south, a vinyl replacement door provides access to the laundry room between the kitchen and summer kitchen. The screen door features spindle work and decorative brackets in the corners. Farther to the south is a door to the dining room. Simple white-painted trim surrounds the door, as well as a limestone sill and header. The pine screen door retains its original finish, has a top and bottom rail, a hinge stile and a lock stile, two cross rails and a mullion stretching from the bottom rail to the bottom most cross rail. The door is identical to the two doors on the West side of the house, consisting of two vertical raised panels above the bottom rail, a horizontal raised panel between the cross rail and the lock rail, and a clear glass panel between the top rail and the lock rail.

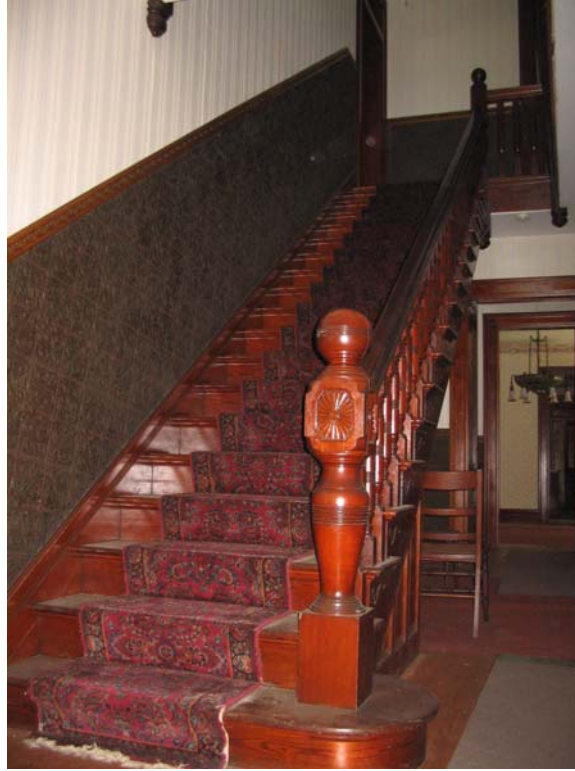
Photo 5. Stair hall, first floor, looking northwest

A large formal stairway in the center hall runs up the west wall to the second floor. The hall on the second floor runs from the front to the rear, where a back stair runs down to the kitchen. Four rooms flank the hallway—three bedrooms and a study. In the rear ell, are a full bathroom (original to the house), servant's quarters, a cedar closet, and an enclosed stair to the attic.

The main stair is built primarily of pine; the newel post and spindles appear to be walnut. The newel post at the bottom of the stairs is intricately carved and features a starburst pattern. Newel posts anchor the corners of the railing; drop finials hang from the ceiling below in line with the newel posts on the floor above. The turned spindles resemble the profile of the newel posts. All of these elements retain their original finish.

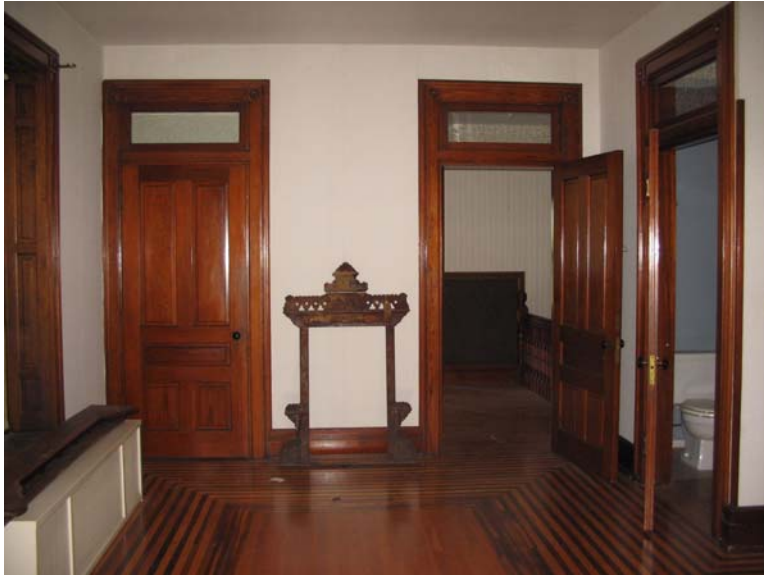
Photo 6. Master bedroom, looking west

The bedrooms upstairs in the front of the house have the same patterned oak flooring as the floor below. The southeast master bedroom has an inlaid border of alternating wood species, which skirts a half-bathroom added in the inside corner. The back hall has pine, but the small, northwest bedroom has the same oak flooring as the front.

The floor is slightly worn. The floors in the rest of the house were refinished during the 1990s.

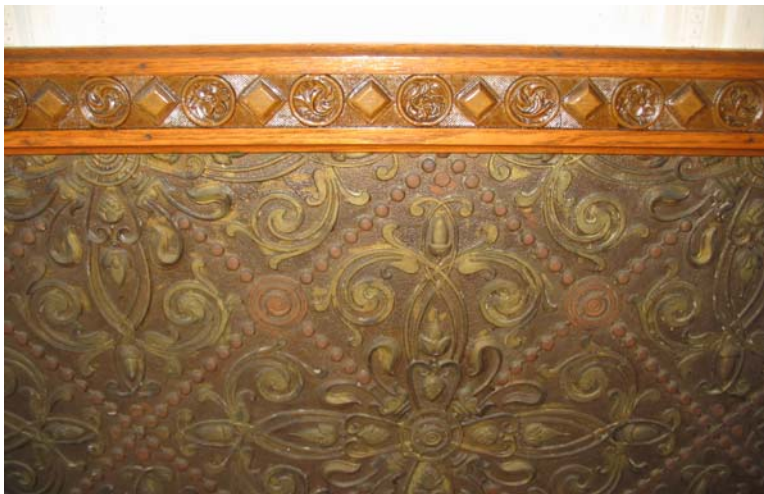
Photo 7. Lincrusta detail

All the interior walls are plaster on wood lath, and many were repapered in the 1990s. Original Lincrusta-Walton wainscoting covers the walls in the front hall on the first and second floors. Four-feet-high, this wainscoting is brown in color, to imitate leather, and is unpainted. A decorative wood molding, which appears to be machined or embossed with rosettes, tops the wainscoting. Original plaster ceilings survive only in the small passage to the dining room and in the nook off the hall on the second floor. The coved ceilings are intact and show evidence of being covered with wallpaper that has been painted. Most ceilings were covered with drywall in the 1990s to mask their deterioration. The ceiling in the kitchen is tongue-and-groove wood planking, added in the 1990s.

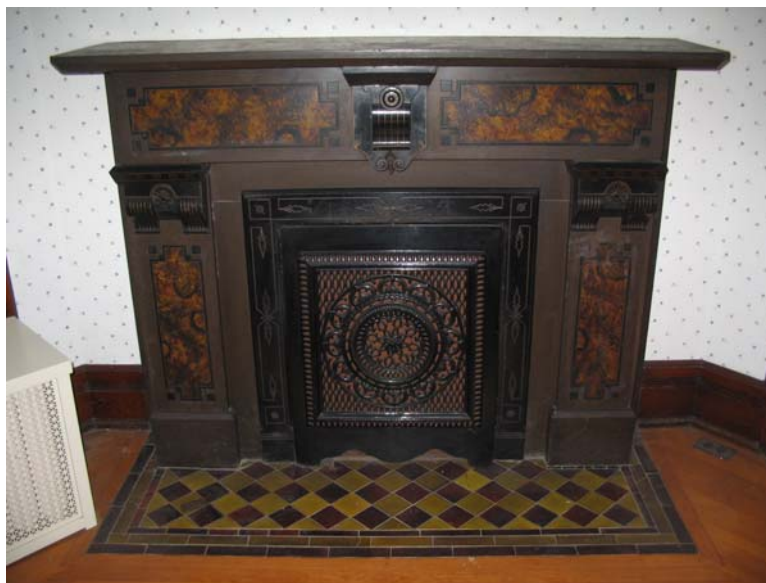
Photo 8. Fireplace mantel, east parlor

Most rooms feature a fireplace with a marbleized slate mantel and grate. The fireplace in the west parlor is extremely delicate with its theme of stylized flowers reminiscent of the aesthetic movement of the 1880s. The tile hearths feature tile in dark saturated colors. There is a hierarchy of ornateness in the mantels that corresponds to the function of the rooms. The public rooms on the first floor have the most ornate mantels; they also vary from front to back or by the sex of the occupants. The ladies parlor in the southwest corner has a more delicate design with a flat incised floral motif outlined in gold and tile with raised floral pattern. The library has an altered fireplace flanked by built in book cases.

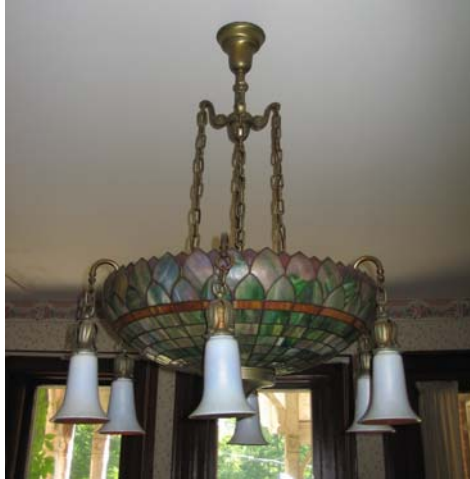
Photo 9. Dining Room, chandelier

The house retains a few of its original gas lighting fixtures throughout, and a gas pump remains in the basement. Each room had a centered ceiling fixture. Original fixtures have been stored in the attic. The chandelier in the dining room consists of a domed shade of opalescent glass with six bell-shaped pendant lights around the perimeter. The colors of the glass, ivory with greenish streaks and orange bands, are typical of the 1920s. Although the chandelier is not made by Tiffany, it is quite handsome.

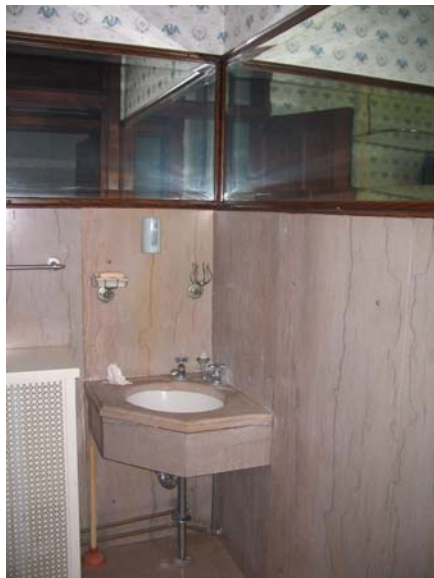
Photo 10. Bathroom, 2nd floor

The building has four bathrooms. One of the second-floor bathrooms appears to be original while two others appear to be early additions, and one is recent. The central bathroom on the second floor, probably original to the house, has a marble floor and wainscoting. Fixtures include a wall-mounted marble corner sink with an oval porcelain bowl and separate chrome faucets, and a cast-iron, claw-foot tub with a recently added shower ring. The toilet is a replacement; the original wood commode is stored in the attic, along some other early chrome fixtures. Copper water lines run from the tub, behind the toilet and over to the sink, which fits into the corner directly in front of the door. On the east wall are mounted a chrome cup holder, soap dish and towel bar, all in the Victorian style.

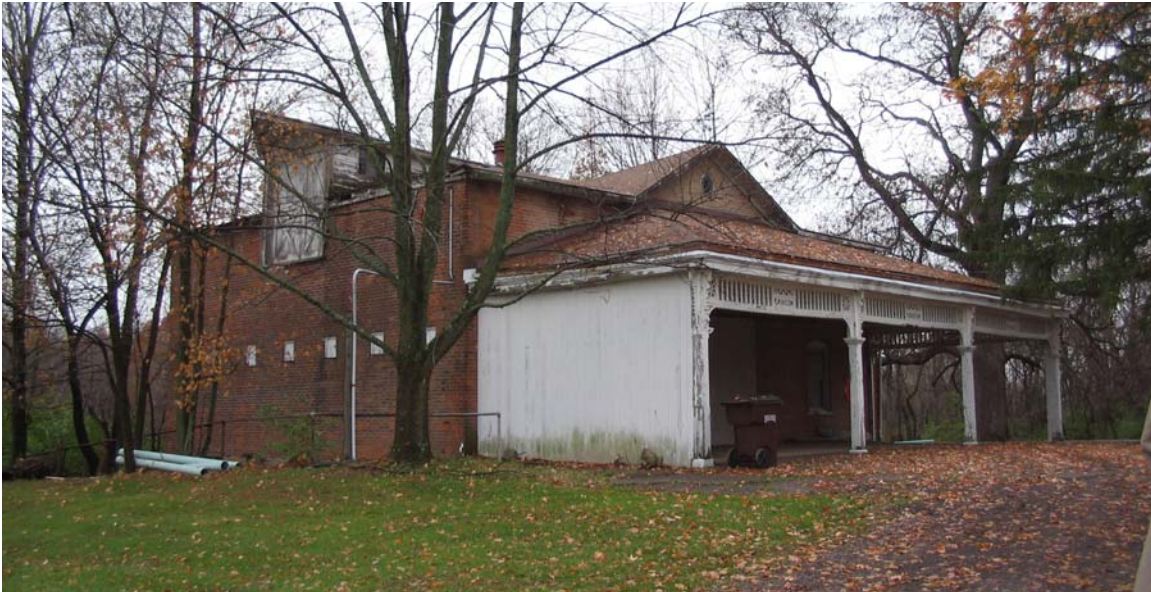
Photo 12. Carriage House, south and west elevations

Reached by a U-shaped concrete drive which turns behind the house, the carriage house/barn is a substantial red-brick structure with an ashlar stone basement and a cross-gabled roof covered mostly with asphalt shingles. The roof has a steep center gable and a cross gable that ends in a hoist to the left.

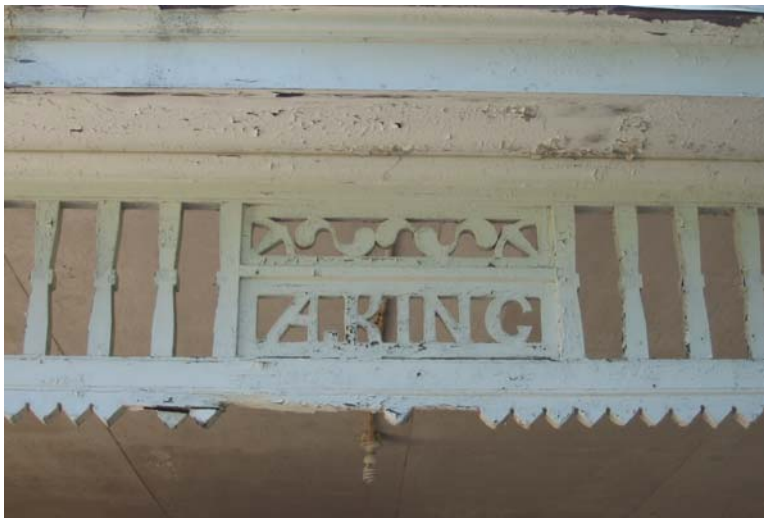
Photo 13. Carriage House, south porch detail

A wood-frame porch, a later addition, extends across the front, divided by wood posts into three bays and enclosed on the sides. The porch has a hipped roof and a shed-roofed porch with elaborate spindle work, which features starburst motifs in the corners of each bay. In the center of each bay, a rectangular panel includes the name, "A. King" in cut-out letters and a vine motif above.

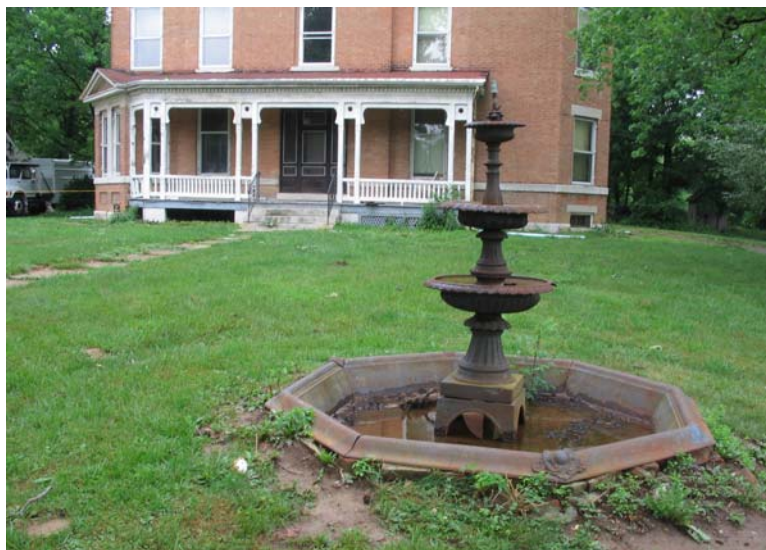
Photo 14. Fountain, looking north

A few original landscape features survive, including a three-tiered cast-iron water fountain on the south lawn, which appears in photographs dating from the 1890s. The fountain retains its basin, which is decorated with four Italianate cartouches. On the west side of the house, there are two rough stone benches in the yard, a cast-iron water pump, and a stone mounting block along the driveway. A rough stone monument installed by the Kings Mills Civic Club, carries a bronze plaque from the old iron bridge that once spanned the Little Miami River, reading "1913, built by the Oregonia Bridge Company, Lebanon, Ohio," and listing the names of the three county commissioners, auditor and engineer. Two smooth stone hitching posts with iron rings originally stood in front the iron fence along the road; they have been salvaged and stored on the property. All eight of these historic landscape features are contributing objects and should be retained.
