**PETALUMA & SANTA ROSA RAILROAD TRESTLE
PETALUMA, CALIFORNIA
HISTORIC STRUCTURE REPORT**

PAST Consultants, LLC
Petaluma, California
Creegan + D'Angelo Engineers
San Francisco, California

November 30, 2007

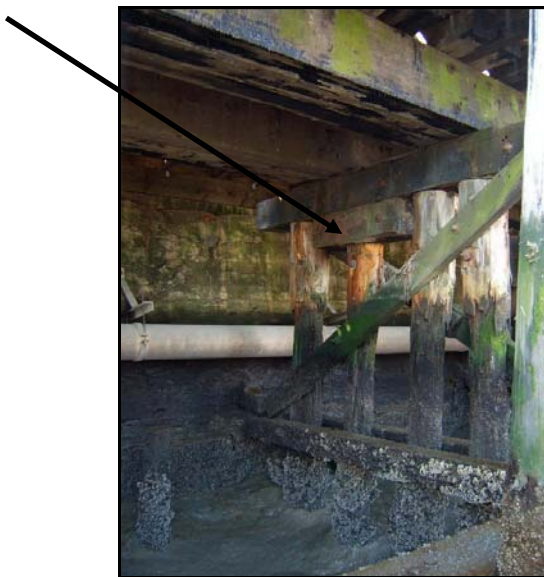
Bent-cap configurations vary depending possibly upon whether the driving of piles too deep into the riverbed necessitated the addition of shims, or where pile tops were decayed and cut off during various repair cycles, causing the need for the installation of an additional bent-pile cap. **Figure 12** is a photograph of a typical bent with an additional pile cap over the second pile from the left.

The fender piling, running along the full length on the river side of the Trestle, is an independent structural system designed to protect the structure from collisions with waterway traffic. The system consists of 14-inch piles driven directly into the riverbed, connected by a pair of longitudinal 3"x10" Douglas fir boards, bolted together at regular intervals. Some of the fender piles have galvanized steel caps to protect from moisture infiltration (**Figure 13**).

Figures 12 and 13. The left view shows a typical bent, or "pier," with the addition of a second pile cap, shown by an arrow. On the right, a view of fender piling, taken from just inside the east abutment, looking northwest. (PAST Consultants, LLC Photos)

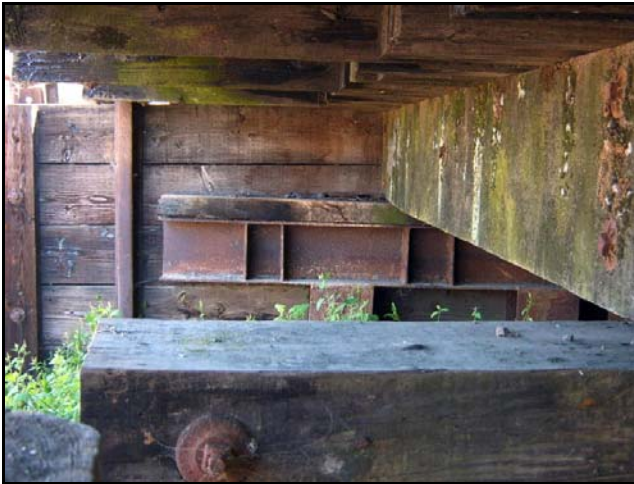
Abutment configurations vary at the east and west ends of the Trestle. The west abutment, likely the original abutment for the structure, is composed of timber logs. The east abutment, composed of sawn timber elements, was retrofitted with steel sections at a subsequent date (**Figures 14 and 15**).

Figures 14 and 15. Views of the east and west abutments, respectively. Structural repairs to the east abutment include installation of steel supports. (*PAST Consultants, LLC Photos*)

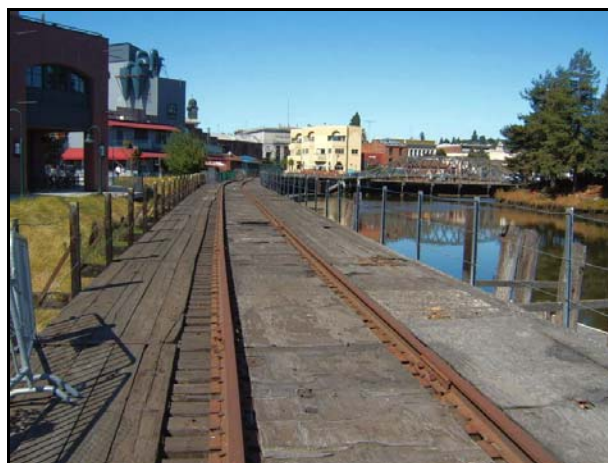
All deck boards have been replaced in the 1960s and 1970s. The railings on the deck were installed during this time. Plywood has been installed over the ties and deck boards (**Figure 16**).

Figure 16. Deck view taken from east abutment. Note the railings, replaced deck boards, and plywood. (*PAST Consultants, LLC Photo*)

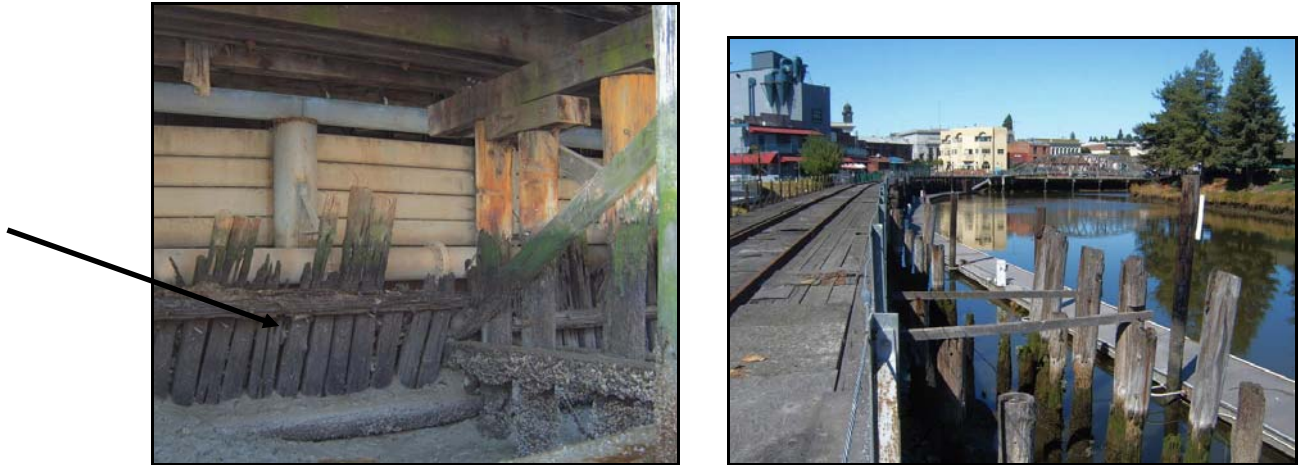
As discussed in previous chapters, the Trestle’s site is the location where the earliest shipping traffic docked in Petaluma. Remnants of the original wharf piles, as well as the original timber retaining wall system are visible at low tide (**Figures 19 & 20**).

Figures 19 and 20. Views of previous shipping-related structures. The left image shows remnants of the original wharf timber retaining wall (arrow). This location beneath the old McNear mill building is where slope instability problems have occurred. The right image depicts wharf piles at the Trestle’s southeast end that are no longer in use. (PAST Consultants, LLC Photos)

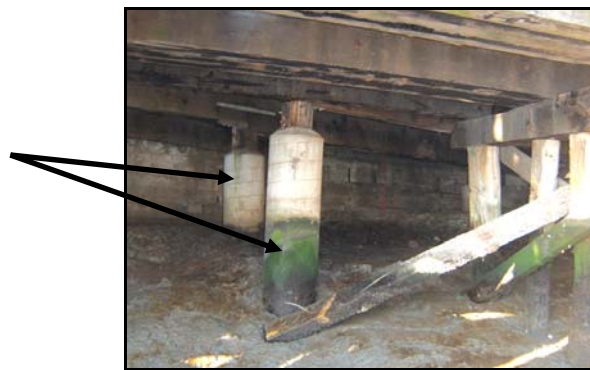
The south river bank, at approximately Bents 14 – 19, bears evidence of significant slope movement, necessitating recent installations of a new retaining wall (visible in **Figure 19** above). In addition, various piles have been wrapped with concrete to stabilize the walkway between the Trestle and the old McNear mill building, now the Apple Box Restaurant (**Figure 21**).

Figure 21. Example of piles wrapped in concrete, near the old McNear mill. (PAST Consultants, LLC Photo)

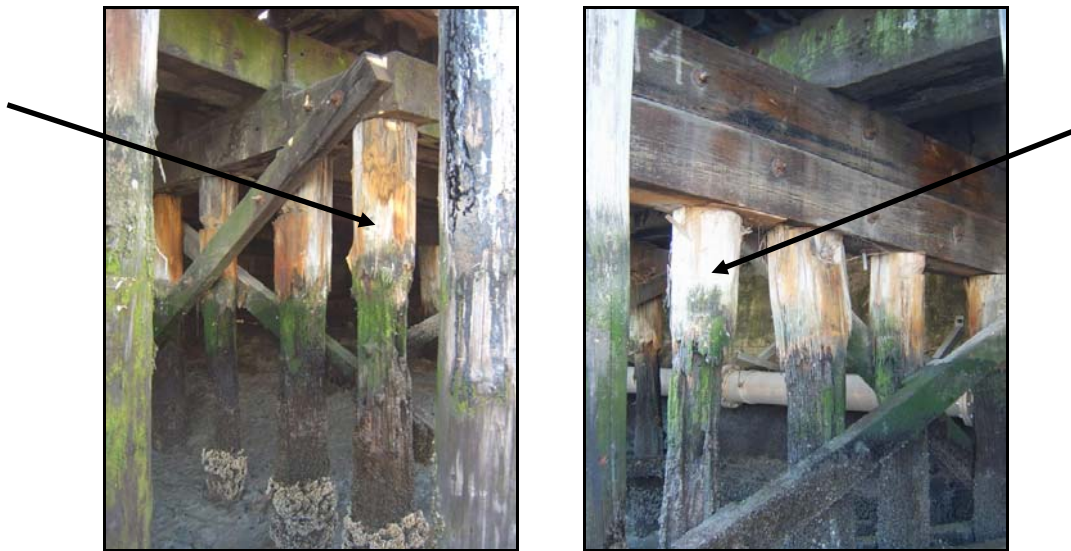
As detailed in the Limited Structural Assessment Report presented in Appendix A, the piles are in fair to poor condition throughout the structure, due to the effects of marine borers and fungus, both of which attack the wood throughout the intertidal zone, or the zone along the pile's length that is subjected to continuous wetting and drying as the tide levels fluctuate. Piles were rated on a four-level scale: 1) Good; 2) Fair; 3) Poor; 4) Beyond Poor (see Appendix A). The majority of the piles fell within the fair and poor classifications. It should be noted that piles rated fair are still decayed considerably and carry a significantly limited structural capacity (**Figures 22 & 23**).

Figures 22 & 23. Photographs representing pile conditions. The rightmost pile in Figure 22 (arrow) is rated “poor,” the pile to its left rated “fair.” The leftmost pile in Figure 23 (arrow) is rated “beyond poor;” the remaining piles visible in Figure 23 are rated “fair.” (*PAST Consultants, LLC Photos*)

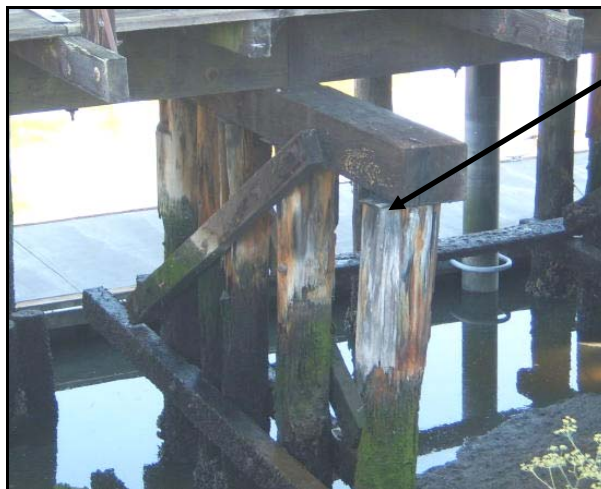
The decades of little or no maintenance to the Trestle have accelerated the deterioration to the piles for several reasons. First, the tops of piles where they meet individual bent caps are not flashed to prevent water intrusion. This typically is a poor, cheaper construction detail and allows water to infiltrate the piles through their end grain where they are most vulnerable. In more sound trestle construction, the pile tops would be flashed with sheet metal (as in some of the extant fender piles, **Figure 13** of previous chapter) to prevent moisture intrusion. This construction detail was not carried out on the Petaluma Trestle. When water migrates down the pile caps, it enters the tops of the piles along their end grain, migrates through the wood pores and causes deterioration. Second, as movement of the various bents has occurred over time, the tops of the piles have become exposed even further, thus accelerating decay (**Figure 24**).

Figure 24. Exposed pile top at interface with bent cap, indicated by arrow. (PAST Consultants, LLC Photo)

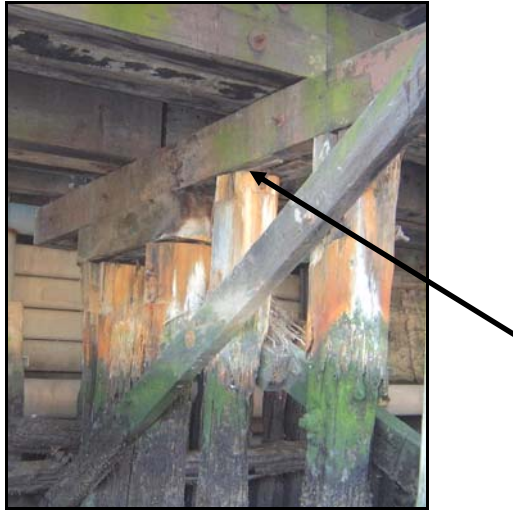
It appears that pile top decay has been a continuous problem in the lifecycle of the Trestle, as numerous pile caps display shims or the installation of additional pile cap beams to level a particular bent after the decayed pile tops are cut off (**Figure 25**).

Figure 25. Various repairs at the pile tops, installed to level the bent. Repairs include an additional pile cap section installed over the two leftmost piles and shims installed on the right two piles, indicated with an arrow. (PAST Consultants, LLC Photo)

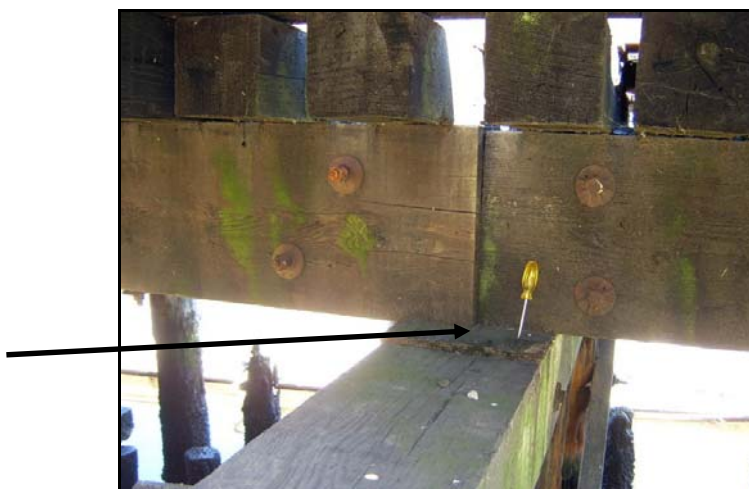
Two sets of stringers, placed horizontally, span between the bents and support the rails and the Trestle deck. Each set of stringers contains three 8"x18" timber members bolted together, their joints staggered along the length of the Trestle. It appears that various stringers were reused from other construction projects, as holes are observed in numerous locations where previous hardware had been installed. The stringers are in fair to poor condition, largely due to the effects of moisture migration through the deck, down the timbers, and depositing where the end grains of the stringers are exposed (**Figure 26**). Decay of the stringers also occurs as a result of water

Figure 26. Typical wood deterioration where a pair of stringers meet atop the bent. The screwdriver is placed through a deteriorated shim (arrow) between the pile cap and the stringers. (*PAST Consultants, LLC Photo*)

migration through the deck and down the face of the stringer allowing fungus and rot to attack the wood where the moisture cannot dry out. Resistograph tests of the stringers, as well as hammer-sounding of individual stringers, reveal voids in stringers that appear sound from the outside. The decay of the stringers represents one of the primary reasons that the Trestle must be rated considerably lower for structural capacity.

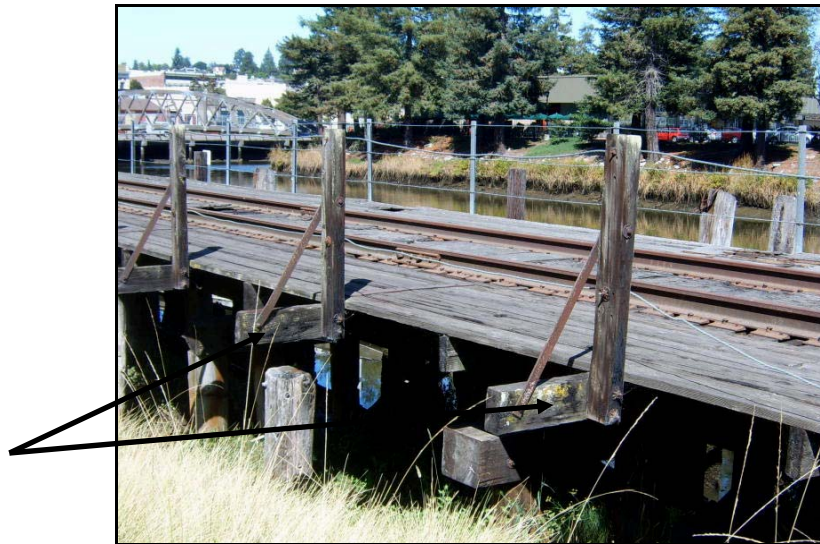
A system of 4"x 8" outriggers and floor joists, spaced at approximately eight feet on center, supports the walkways on either side of the Trestle's deck. On the north (or river) side, the deck joists are cut off flush with the edge of the Trestle; on the south side the joists protrude beyond the Trestle's full-width, hence the use of the term, "outrigger," to describe this structural member supporting the walkways (**Figure 27**). These wood structural elements are in fair condition based on inspection of them from below the Trestle deck, where water infiltration was observed through the ends of the wood members. Based on examination of historic photographs, it is possible that the outriggers were installed with the deck railings in the 1960s and 1970s. The railings do not appear in historic images that predate the 1970s (see **Figures 10 & 11**).

Figure 27. South rail connected to outriggers (arrows). The north rail is mounted to floor joists cut flush with the north face of the structure. (*PAST Consultants, LLC Photo*)

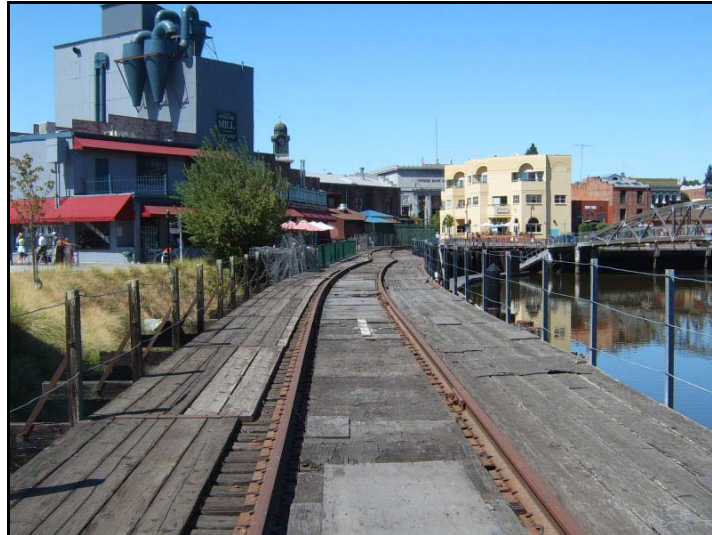
railing is designed as a steel post-and-cable system mounted to individual deck joists. These railing systems are extant on the bridge deck today (**Figure 28**).

Figure 28. View of deck from east abutment, showing railings, ties, and non-historic deck boards and plywood. Note the bowed tracks at the top of the image adjacent to the McNear mill buildings, where slope instability and other factors have caused lateral movement of the Trestle. (*PAST Consultants, LLC Photo*)

The individual railing elements are in good condition.

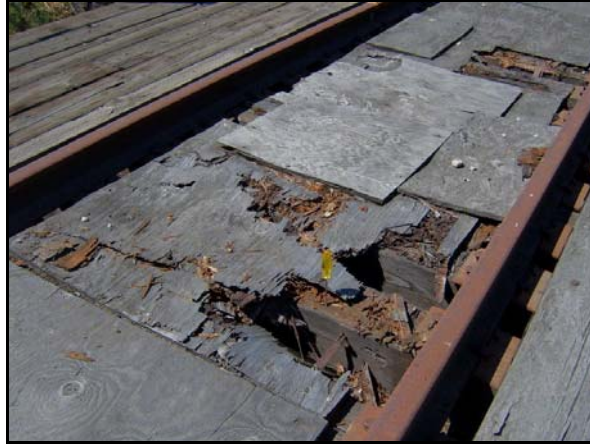
The non-contributing individual deck boards were likely installed in the 1970s and are in poor condition. Originally, deck boards would have been flush with the rails to allow for loading and unloading of cargo with various wheeled, hand and push-carts (**Figure 28**). Plywood was installed on the bridge deck periodically to alleviate potential safety hazards to those walking on the deck. The plywood is in poor condition and is contributing to additional decay of the railroad ties and stringers: the plywood forces moisture to be trapped between the plywood and the individual ties and it prevents adequate ventilation and drying of the stringers below, accelerating the levels of decay in both the ties and stringers.

It should be noted that individual ties were only inspected where the plywood could be lifted from the deck. Thus, it was difficult to ascertain the condition of the ties; it appears that approximately 20% of the ties suffer from wood decay and will have to be replaced. The most common decay mechanism appears to be the plywood installed over the deck (**Figure 29**).

Figure 29. Deteriorated ties beneath the non-historic plywood. (*PAST Consultants, LLC Photo*)

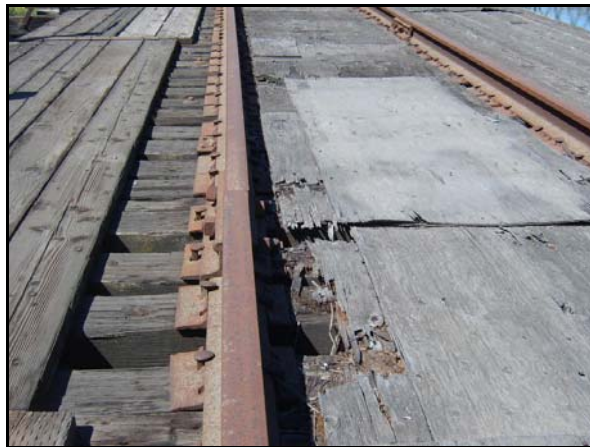
With the exception of the bow in the rails where lateral movement has occurred (approximately between Bents 14 and 19), the rails and tie mounting plates appear to be in good condition, with typical areas of surface rust, which should be relatively easy to clean and remove. Rails will likely have to be realigned and the connecting plates secured during rehabilitation (**Figure 30**).

Figure 30. Typical view of rails and rail connecting plates. (*PAST Consultants, LLC Photo*)

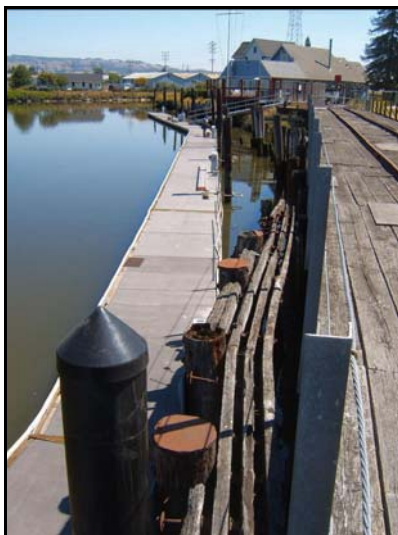
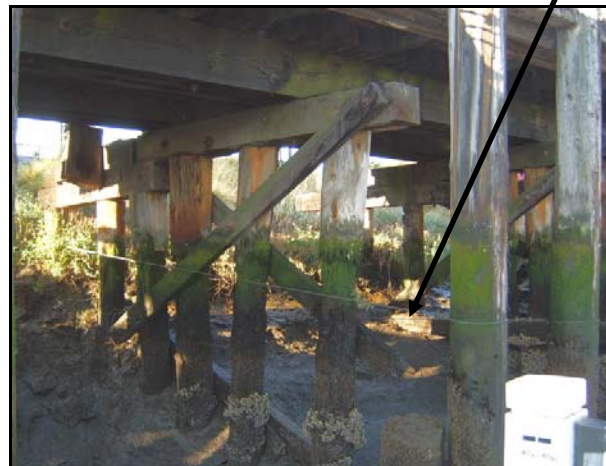
The fender pile system consists of a series of piles installed immediately adjacent to the end, load-bearing pile on the water side of each bent. Paired tie beams, approximately 3”x14”, connect the fender piles together longitudinally along the length of the Trestle. This system, intended to “float” immediately adjacent to the Trestle, is deliberately designed to be an independent system. In the event that an impact between a ship and the fender piles occur, the damage historically would occur to the fender piles rather than to the Trestle structure itself. The fender piles were also used as tie-offs for the various docking vessels. Originally, the fender piles protruded above the level of the Trestle (see historic photographs). Today, the fender piles have been cut off, capped with galvanized metal, and left to move and decay (**Figure 31**). Since these piles are not structural and may not have been driven as deep as the structural bent piles, periodic dredging reportedly has caused individual fender piles to lean into the water. These piles have been stabilized using cables to tie them back (**Figure 32**). Although the fender piles were an original part of the Trestle’s design, they are not structural and no longer serve their intended purpose, as a new floating dock has been installed north of the Trestle.

Figures 31 & 32. Photographs showing the condition of the fender pile system. The left view, taken from the deck, shows the pile tops and tie beams moved away from and below the deck. The right image depicts the cables installed to tie back two fender piles, indicated by an arrow. (*PAST Consultants, LLC Photos*)
