OVERVIEW

The Christman Company is receiving LEED® (Leadership in Energy and Environmental Design) certification in two categories: The Christman Building’s core and shell project, and for the firm’s headquarters commercial interiors project, which occupies roughly half the building.

THE CHRISTMAN BUILDING: A CASE STUDY

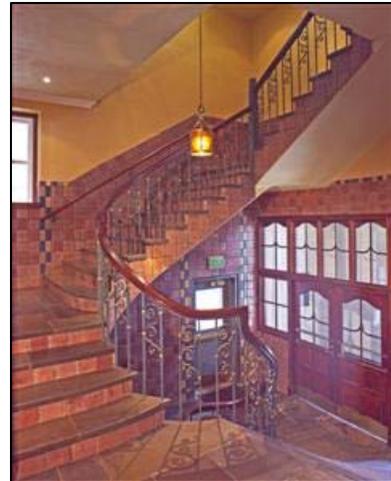
Restoration of historically significant building features included the main entrance doors and plaques, the mica shade light fixtures and Pewabic wall tiles in the main hall, and the light fixtures and verdigris bronze handrail finish in the stairwell and lower level.

All of the preservation work on the building was approved by the State Historic Preservation Office and the National Park Service to ensure that standards protecting the National Register building were upheld. Restoration of historically significant building features included the main entrance doors and plaques, the mica shade light fixtures and Pewabic wall tiles in the main hall, and the light fixtures and verdigris bronze handrail finish in the stairwell and lower level. Other restored and reused building components included door hardware, wood trim, wood windows, and floors in the entry and historic stair made of Bluestone or black and white linoleum. Bricks salvaged from the removal of the penthouse were used to patch exterior walls. Benign products, such as citrus strippers, wet grinding, and low VOC coatings, were used to restore historic finishes, such as the walnut paneling in the executive offices on the first floor. All plaster walls were restored, using several restoration techniques.

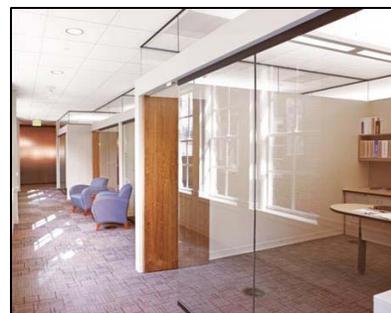
The lighting energy savings are projected to be 27%. Use is controlled by occupancy sensors in private offices and stairways, programmed timers in common spaces, daylighting dimming controls, and individually controlled task lighting.

The design took advantage of large perimeter windows to provide daylighting to 92% of occupied spaces building-wide and outside views to 90% of the occupants in the Christman headquarters. Additional background lighting is provided by high efficiency fixtures and T-5 fluorescent lamps with a very high color rendering index (CRI). All workstations have individually controlled multi-level task lighting. The lighting system energy savings are projected to be 27%. Use is controlled by occupancy sensors in private offices and stairways, programmed timers in common spaces, daylighting dimming controls, and individually controlled task lighting.

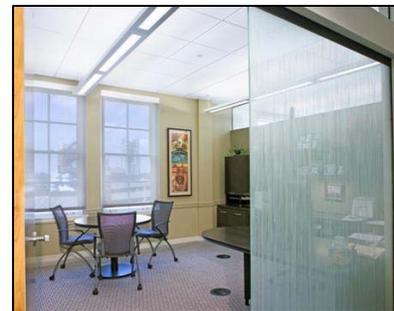
Large windows provide daylighting to 92% of occupied spaces building-wide and views to the outside for 90% of the occupants in The Christman Company commercial interior.

Large windows provide daylighting to 92% of occupied spaces building-wide and views to the outside for 90% of the occupants in The Christman Company commercial interior.
