HISTORIC STRUCTURES REPORT THE FISHER MANSION

PREPARED BY:
Kent Brough
Soon-Ju Kwon
Shalae A. Larsen
Paul Nielsen
Sara Staffanson

UNIVERSITY OF UTAH
COLLEGE OF ARCHITECTURE +
PLANNING

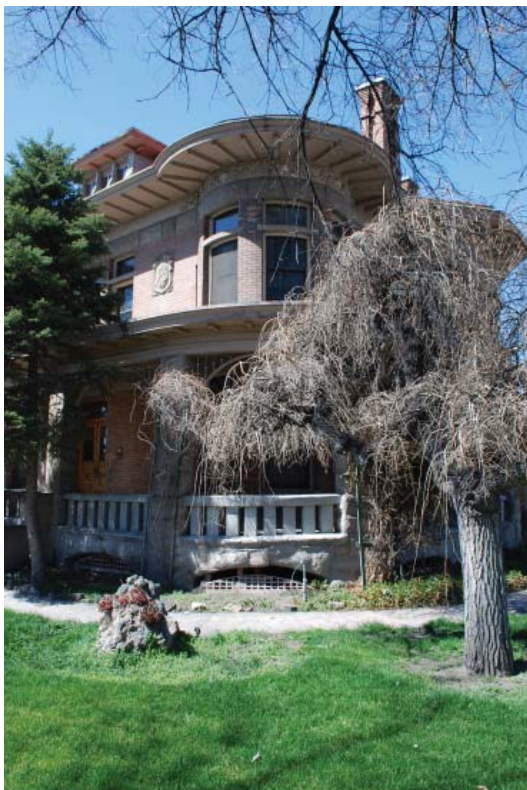
5. View of south-east stone spigot and weeping mulberry tree.

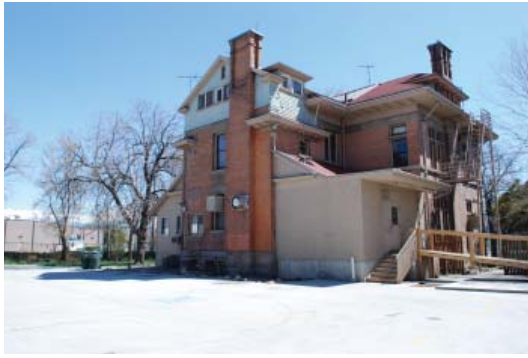
6. North view of main house looking south, showing expansive paving in back-yard area.

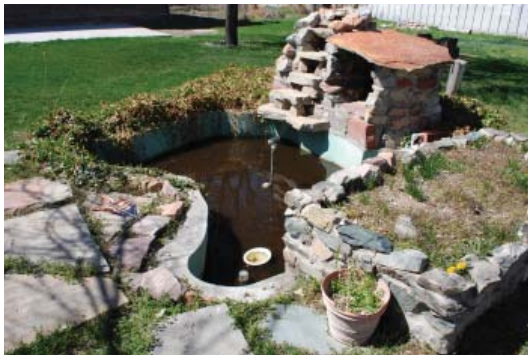
8. View of pond/fountain feature.

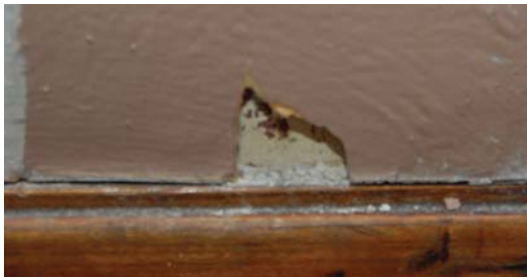
11.

Walls – The original wood wainscoting is intact. Its condition is fair with some scratches, and the baseboard is heavily scuffed. Above the wainscoting the wall surface is painted over embossed paper. Samples would have to be removed to determine the total layers of wall surface, and what the original wall surface would have been.

Doors & Windows – The room has three windows located in a curved bay in the southeast corner of the room. The windows are curved to match the curvature of the bay. The hardware and cords appear to be intact except the middle window that is missing its pulleys. The pulleys may have been removed, or simply covered over. All the doors and door hardware are intact and in good condition.

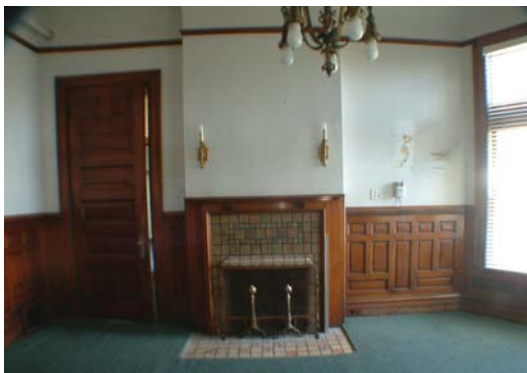
17.

Ceiling - A fire protection system has been added to this room and visible pipes and sprinkler heads hang just below the ceiling surface.

Doors & Windows - The room has three windows located on the east wall. All three windows have a bottom sash that is operable. The upper sash appears to be a fixed transom. All the doors and door hardware are intact and in good condition.

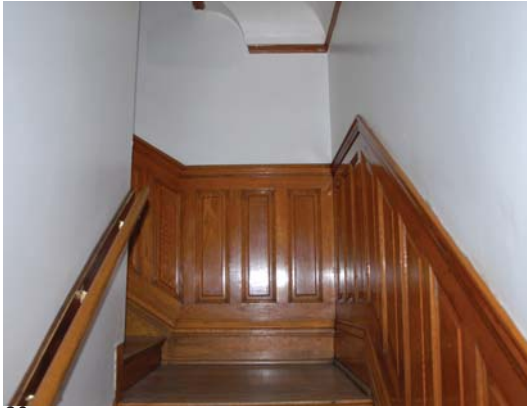
23.

Walls - The original wood wainscoting is intact. Its condition is fair with some scratches, and the baseboard is heavily scuffed. Above the wainscoting, the wall surface is painted over some type of embossed paper. Samples would have to be removed to determine the total layers of wall surface, and what the original wall surface would have been.

Ceiling - A fire protection system has been added to this room and visible pipes and sprinkler heads hang just below the ceiling surface.

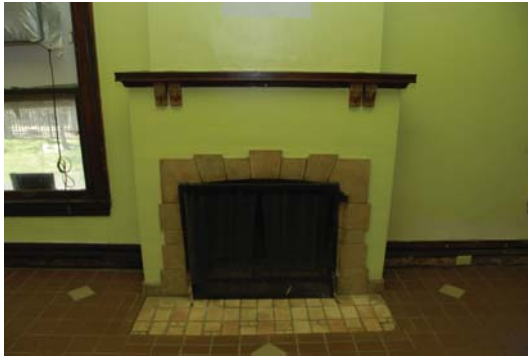
27

Ceiling – The ceiling is coved, continuing the same wall surface as previously described. There are significant signs of plaster damage just below the surface. A fire protection system has been added to this room and visible pipes and sprinkler heads hang just below the ceiling surface.

Doors & Windows – The room has three large south-facing windows. The center of these windows consists of one large sash with a fixed transom above. The sash appears to be operable, but there are no pulleys or signs of pre-existing pulleys. The two side windows are double hung sashes with a fixed transom above. These windows have a type of pulley that uses a spring-loaded metal tape instead of a cord and weight system.

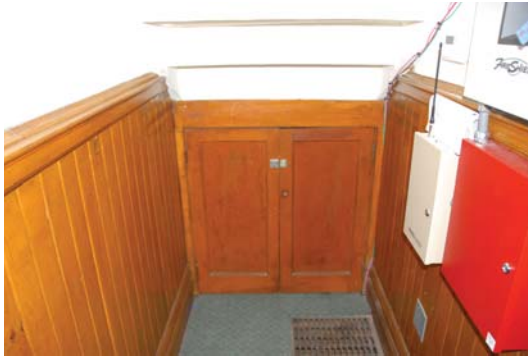
43.

Closet Under Stairs -

Original doors/woodwork/wainscot/hardware. Evidence of re-plastering under stair/ceiling

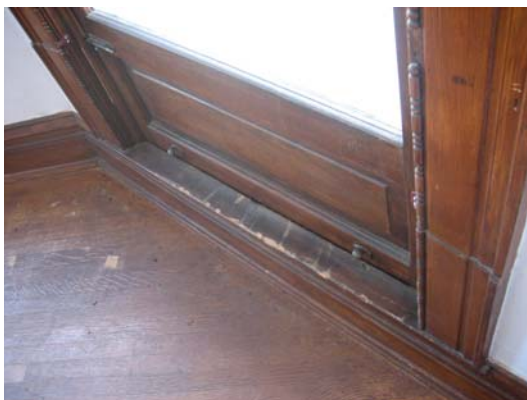
60.

Floor – The wood flooring is original and has some scratches (image 60).

Doors and windows – The room has three windows located on the east wall. Two of the windows have a bottom sash that is operable. The frame of the third window on the right side has been modified to allow maintenance access to the porch roof (image 60). The upper sash appears to be a fixed transom.

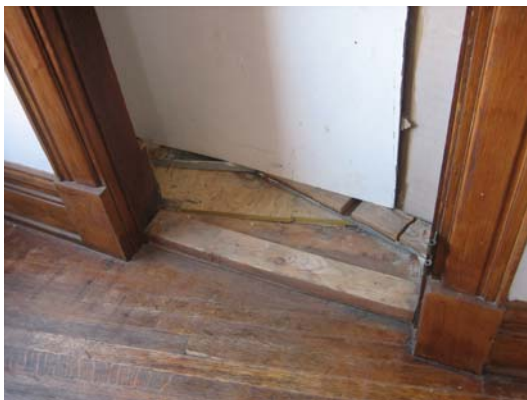
62.

Doors and windows – The window to the right does not close completely.

General notes – This room was renovated to accommodate this bathroom. Removal of the bathroom elements may reveal the original layout and purpose of this space.

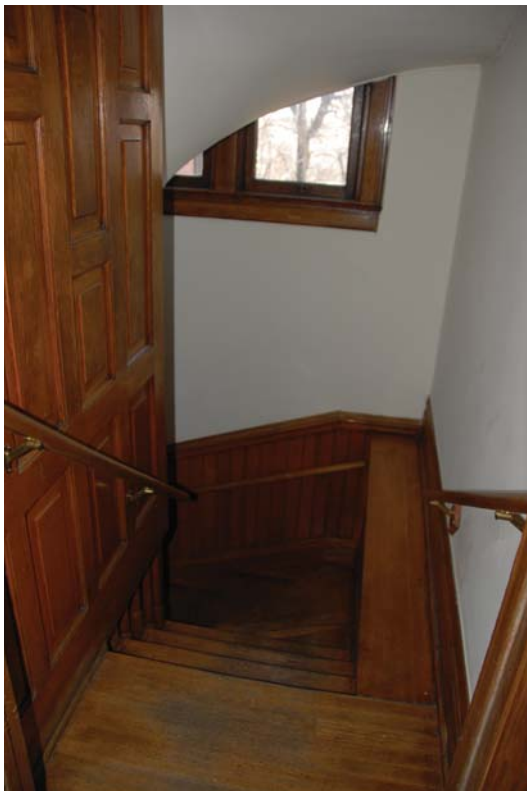
67.

Ceiling- A fire-suppression system has been added to the space and has pipes and sprinkler heads that are visible just below the ceiling surface.

Doors and windows – A door frame has been added to the stairway leading up to the attic. The door that sat in this frame no longer exists. The pocket door is missing its original hardware. A new door has been installed at the top of the grand stairs.

Stairs to Attic – The wood flooring is original and has some scratches. A post is missing but is lying on the floor to the side of the stairs.

General notes- This room has been significantly changed from its original condition, especially around the stairway.

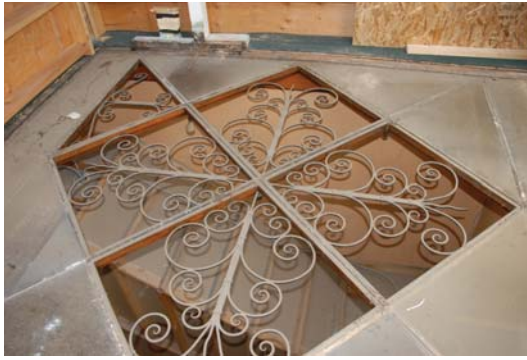
68.

Skylight Screen – The decorative iron screening above the grand staircase (image 68) has been covered by a makeshift stage for several decades. It is missing several of its opaque glass or fiberglass panels. The ironwork is in good condition. A banister (image 69) against the wall still exists and speaks to the existence of a railing around the skylight.

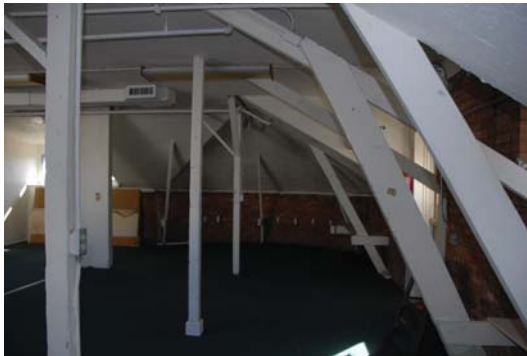
70.

Walls – The existing wall is the original brickwork (image 71). The white wooden projections extend to the exterior as the eaves of the roof. Some project into the room to meet supporting rafters. It is unclear if the other beams projected further into the room originally or if they have always been cut flush with the brick wall. There are many loose bricks and some are missing. The mortar is also coming loose in several areas throughout the wall.

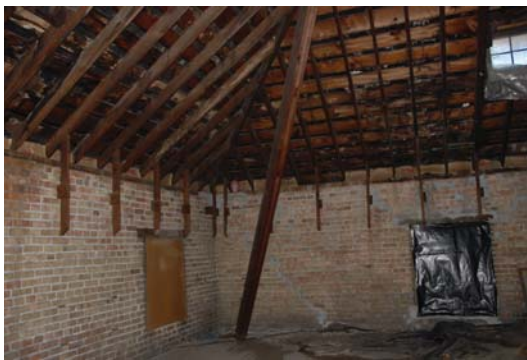
83.

The attic level is seriously deteriorated. The plaster in the two south loft rooms is nearly saturated with moisture and falling off the lath surface.

The holes in the roof are apparent. Birds are roosting in the roof rafters of the main loft area.

The roof structure itself appears to be sagging and should be evaluated by a structural engineer.
