# Replicating the John J. Earley Concrete Mix to Restore the Nashville Parthenon

ILENE R. TYLER

**Laboratory analysis and prototype testing determined an accurate match of the materials used to restore the Nashville Parthenon.**

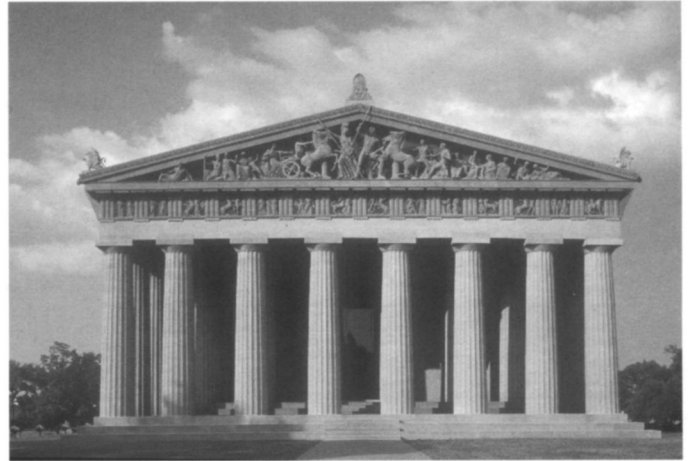
Fig. 2. West elevation, 2002, completed restoration. Photograph by Gary Layda, courtesy of the City of Nashville.

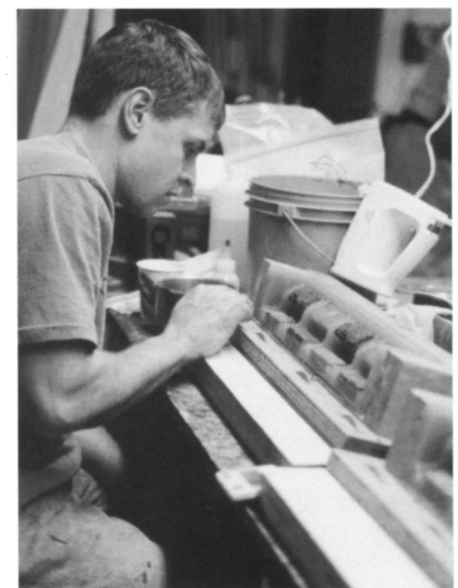
Fig. 6. J. B. and Sons craftsman delicately lays or "butters" the red and blue colored grout into the mold. Photograph by the author.

Crushed ceramic tiles in two graded sizes were used to achieve the colored detail in the blue and red pre-cast pieces. The other elements of the mix were

generally the same as for the buff mix, although pigments were omitted, and the Acryl Set was increased for the tiny details to 1:1 with water. Acryl Set was added to the mix design to provide better adhesion of the pebbles into the matrix and to increase the air content. It did not affect pourability, but did improve the workability of the mixes and weather-resistance of the finished castings. Pigment was added to soften the effect of the white cement and create as close a match as possible to the extant material adjacent to the restoration work areas. Since the original formulas are lost, the intent was to match the weathered appearance of the original Earley mix with the new material.

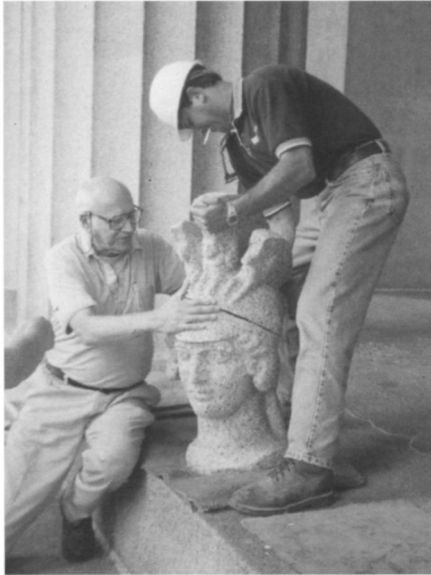
Fig. 7. Dr. Kreier and Ken McAbee from Western Waterproofing test the mating of two pieces of the Athena sculpture before inserting anchoring steel and lifting her into position. Photograph by the author.

Like the original Pentelic marble sculptures for the Parthenon in Athens, the sculptures for the pediment of the Nashville Parthenon were created by artists. To restore the sculptural concrete elements, artists were enlisted to prepare the clay models in situ, from which reinforced molds were created. The restoration sculptors worked with respect for the artwork of the original artists, and with just as much attention to historic precedence. The prepared molds were transported to Philadelphia, where Dr. Kreier and his crew prepared test plaster castings, tested the aggregate casting mix, and executed the cast-concrete final pieces. They were delivered to the site in batches for review and approval prior to installation (Fig. 7). Sev-
