# **THE DUTCH REFORMED CHURCH NEWBURGH, NEW YORK**

Prepared for  
Newburgh Preservation Association's Dutch Reformed Church Restoration Committee

Prepared by  
Mesick Cohen Wilson Baker Architects  
Albany, New York

## **EXISTING CONDITIONS AND RECOMMENDATIONS**

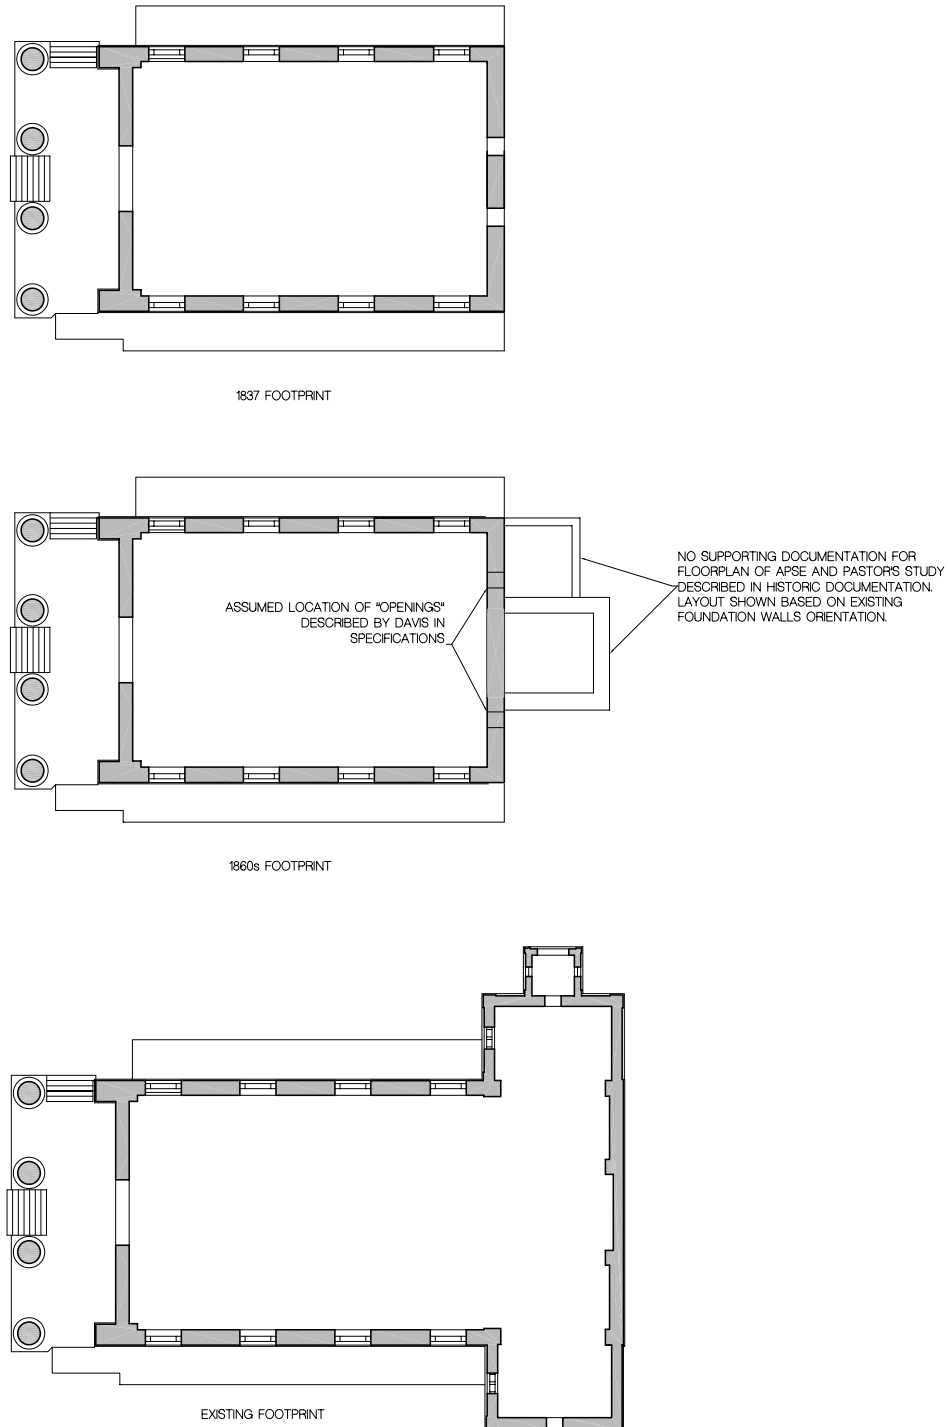
Following its initial construction, the Dutch Reformed Church underwent subsequent alterations to the footprint and interior layout. A diagram illustrates the possible construction history of the building, detailing the most significant alterations made to the building throughout its history. The diagram (Figure 13) is based on physical evidence as well as archival information gleaned from the Church Consistory minutes and newspaper reports. The original building footprint was rectangular with a portico at the south elevation—a rectangular volume with a gable roof. The lantern was removed due to structural stresses it imposed on the roof trusses in 1843. An apsidal recess was added in 1860 at the north end that connected to a Pastor's Study. There are two possibilities for the layout; one being a large recess following the stage walls in the basement that was divided between the apse and the study. Another wall extends from the stage wall toward the west; its function is unknown. In 1868, the north wall was extended and transepts were added to the west and east. The area under the east Transept was never excavated, but a small mechanical room was built under the west Transept. The last major change to the exterior of the building was the replacement of the wood framed portico deck with concrete and steel in 1910.

*Figure 13. Possible construction sequence for The Dutch Reformed Church beginning in 1835 with Davis' original plan at the top. The 1860 addition of the apse and study in the middle is problematic as there is no detailed descriptive documentation of the work. The existing floorplan was built in 1867-8 . Only the first floor is shown.*

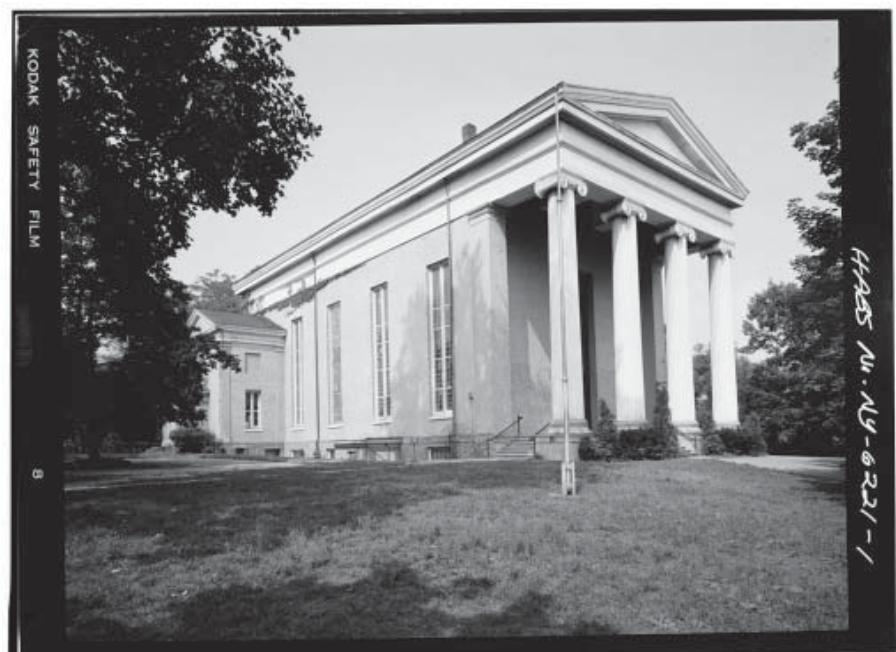
Two short stone rubble walls remain in the west Areaway, on either side of the door opening, and run perpendicular between the foundation wall and opposite retaining wall. Early photographs, though not the earliest, show an enclosed entrance at the location of the existing short walls. (Figure 17) Significant amounts of vegetation within the Areaway conceal any other structural remains that may exist. Since the photographs available show the enclosure to be a later addition, it is not a priority for reconstruction; the remaining stone footing may be removed for unobstructed access within the Areaway.

*Figure 17. West elevation taken during Historic American Building Survey in 1967.*

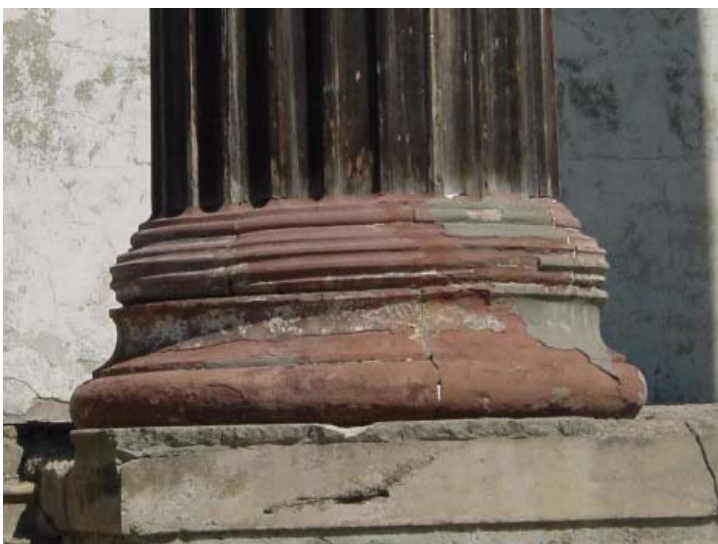
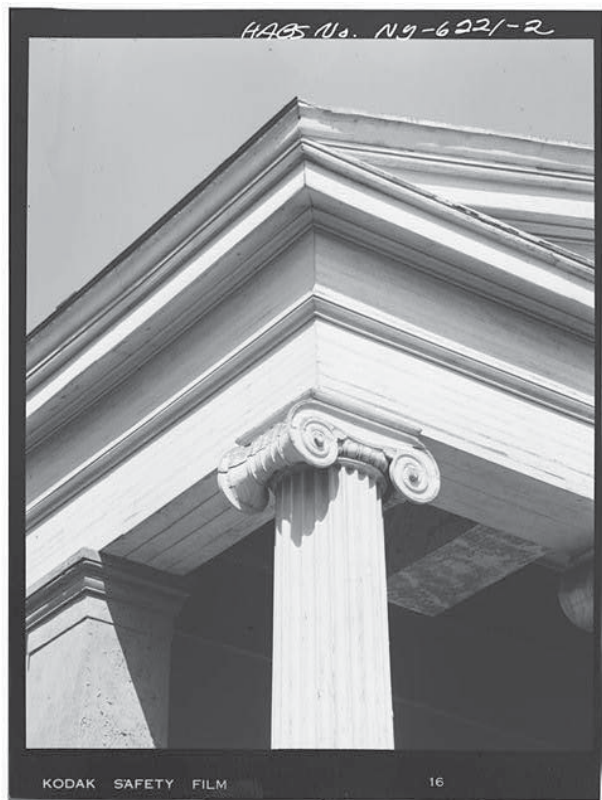
*Figures 28, 29 and 30. The design of the volutes is based on engravings from Stuart and Revett's Antiquities of Athens (see History). The HABS photograph above shows their graceful relationship to the column shaft. Right, detail of volute, and below, sundry capital pieces in the storage room.*

Egg and dart carvings at the base of the column capitals remain, although the Ionic volutes were removed in 1990 and replaced with plywood boxes. (Figure 26) Several of the original volutes are currently stored in the east Transept “treasure room”. The volutes should be restored and reinstalled in their original location. Existing volutes with minimal deterioration may be salvaged, while those with more significant damage may be replaced with newly carved pieces created by an experienced craftsman. The use of historic materials and technologies is preferred. Modern irreversible methods should not be considered (i.e. epoxy repair).

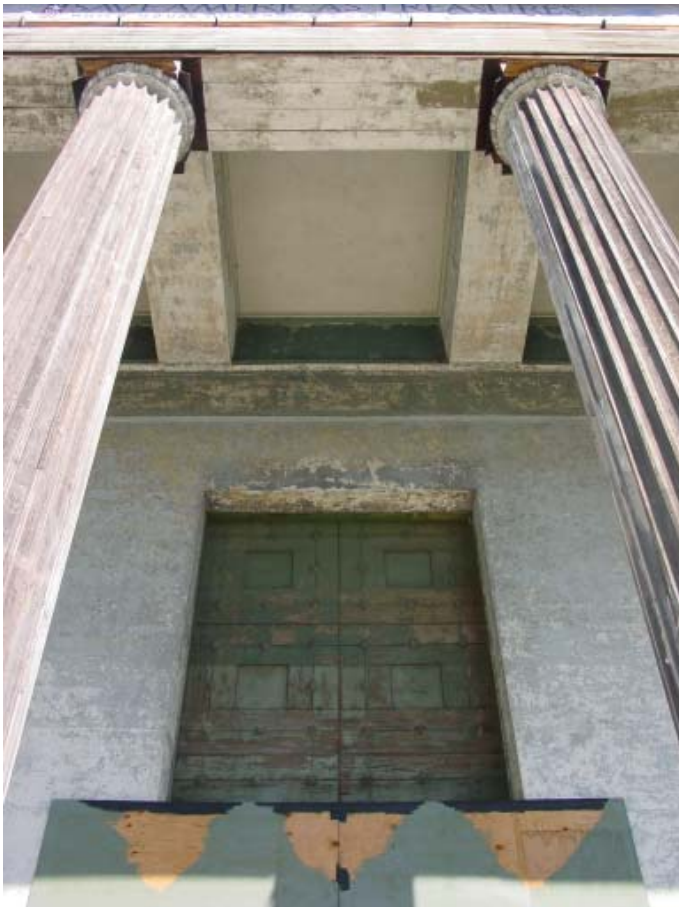
Paint on the deeply recessed ceiling surfaces is also delaminating. (Figure 32) Traces of paint remain and the surfaces appear to be in good condition. As with the façade, paint analysis should be performed to determine the historically accurate color for repainting.

Figure 32. The false beams of the portico mimic the ancient temples of Greece. They are constructed of plaster and lath. The wood panels above the door are reminiscent of Davis' design for the French Protestant Church in New York City. It is believed that the original doors on the exterior were pocket doors that were removed during the 1867-8 building campaign. The paint on the surface of the panels is a blue-green.

Parks Service Hyde Park site. Further research should be done to either locate or recreate the original doors. Davis used his own design for the French Protestant Church as a precedent for the entry.. (See Figure 3) Use of the drawings would likely give an accurate description of the 1835 doors.

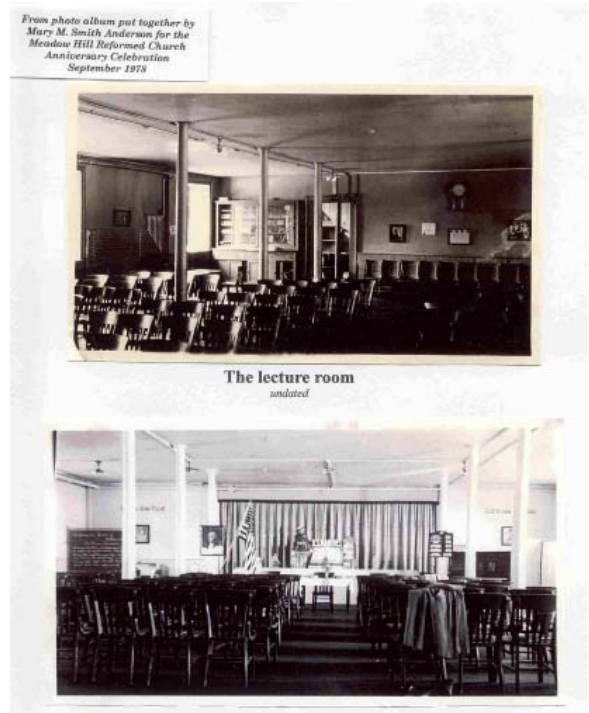
Figure 38. Historical photographs of Sessions room, front (bottom) and rear (top), from a DRC publication. Note the original tapered columns and the later beaded board wainscoting. The floor and ceiling are entirely missing today.

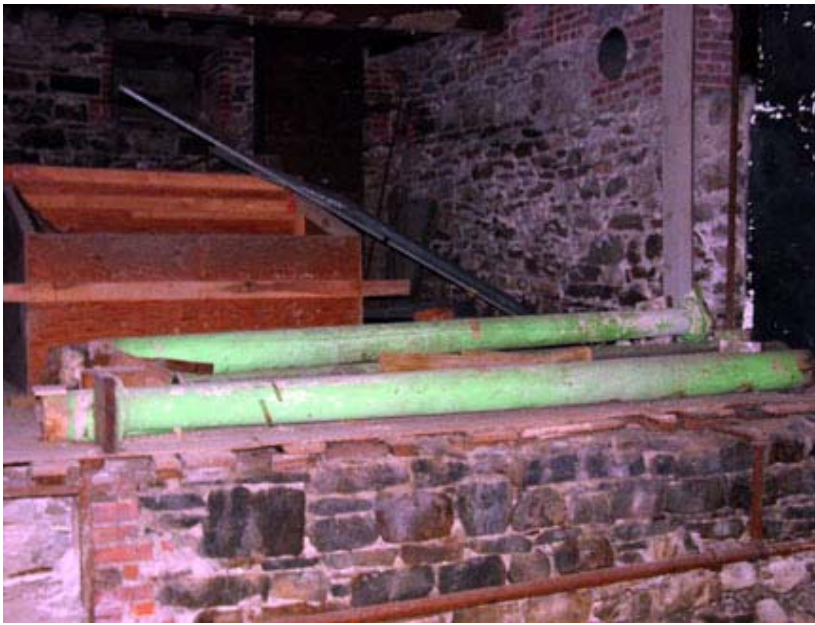
*Figure 40. Original wood columns currently stored on basement stage. The columns should be restored and reused in the Sessions Room. The stone wall visible on the right was likely part of the 1860 building campaign that addressed the acoustical problem of the Nave upstairs by creating an apsidal recess and Pastor's Study.*

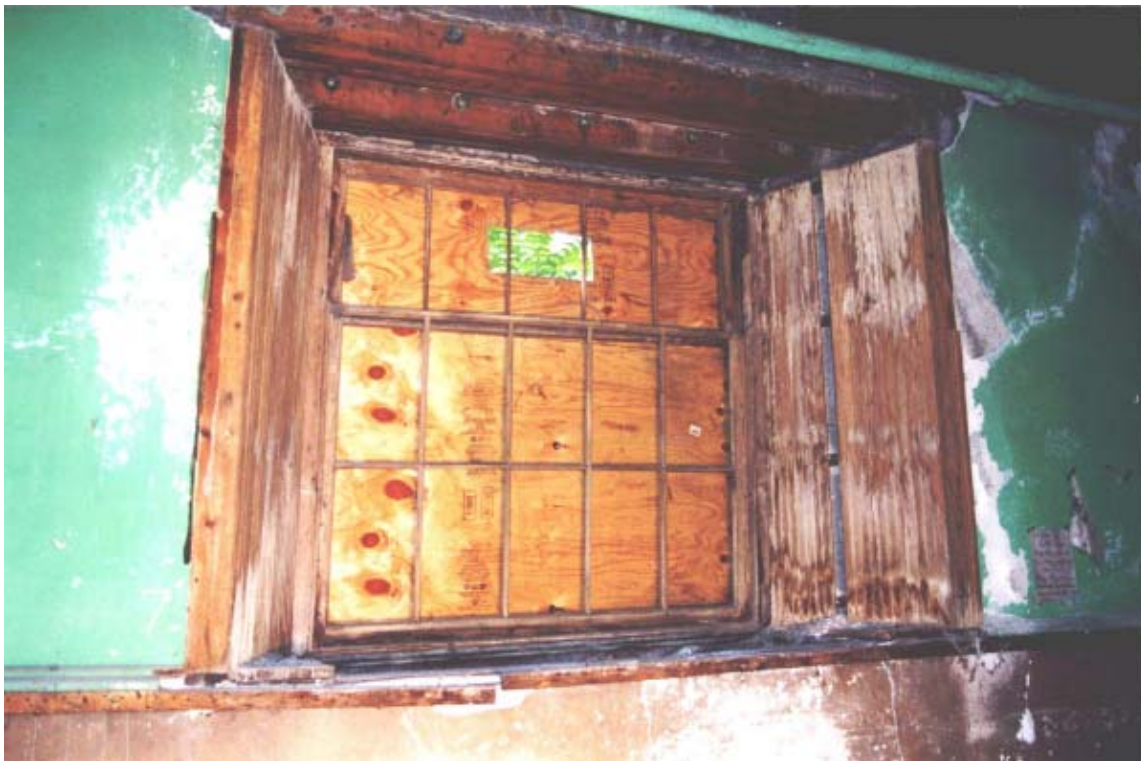
*Figure 44. The basement window at northwest corner of Sessions Room is the only example in situ of the historic sash and frame likely original to the building. Note the modern wood headers installed to stabilize the opening. The beaded board is likely not original to the Davis design of the building. The deep recesses open onto the Areaways to the east and west.*

Wood elements such as the window sash and frames should be restored, replacing missing elements where necessary; the glazing should be reinstated using laminated glass to reduce the potential for breakage due to the questionable neighborhood in which the building is located; and all hardware, sash cords and weights should be repaired and restored.

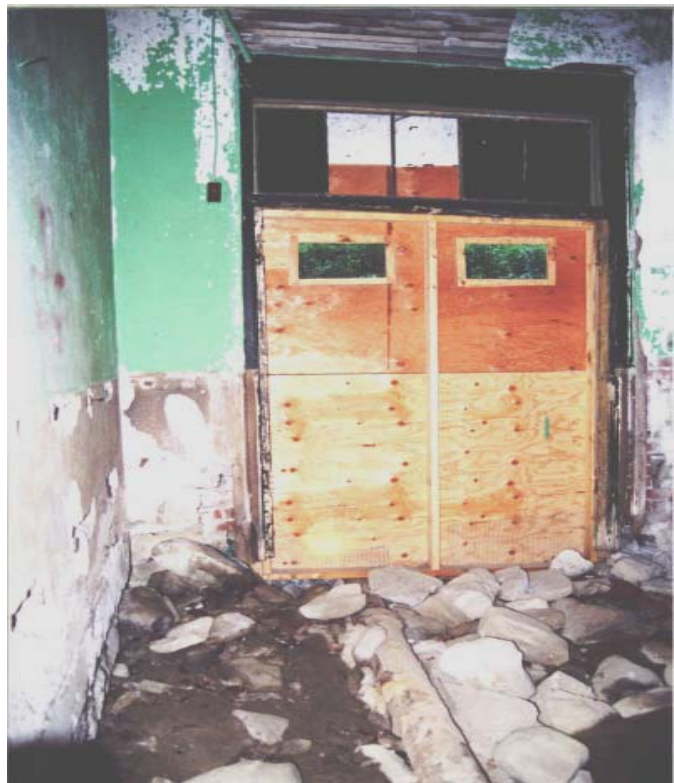
*Figure 45. The door opening at west wall of Sessions Room gives clues to the size and configuration of the historic doors installed in 1867. The transom lights are similar to those in the Vestibule on the main floor. The doors once opened onto a passageway between the east and west Areaways that gave access to both the School Rooms and the Sessions Room.*

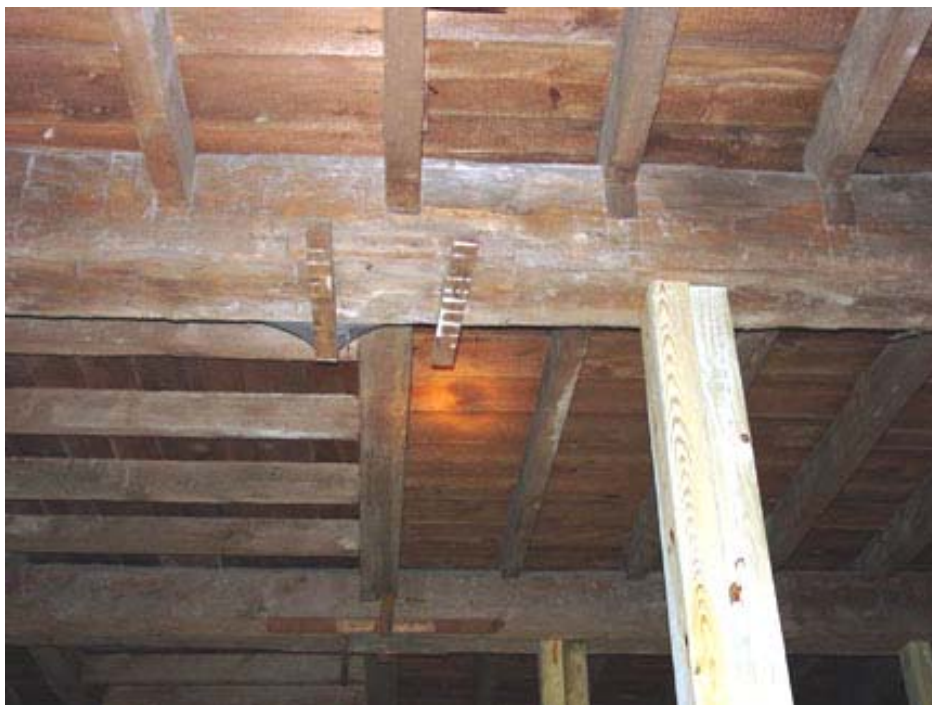
*Figure 46. Framing of main level viewed from basement. Note the short joists beneath the aisles to the left of the photograph. The aisles were 4" below the pew areas according to Davis' specifications. The furring strips indicate the original position of the columns.*

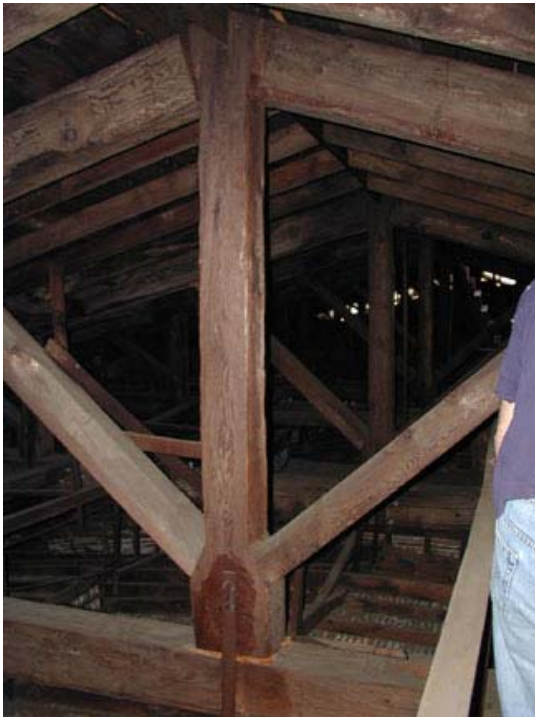
*Figure 59. King post truss in attic. The metal straps are a later stabilization effort. (left)*

The king post trusses that carry the roof and plaster ceiling structure are similar to those Davis designed for the French Protestant Church in New York City. The timbers show some signs of deflection having been braced with metal straps, but there is no movement at the present time. However, the trusses over the Nave should be periodically monitored. The trusses over the Portico must have shown significant failure at some point. Several truss assemblies have been installed spanning the Portico during the last quarter century. The new trusses are sound.

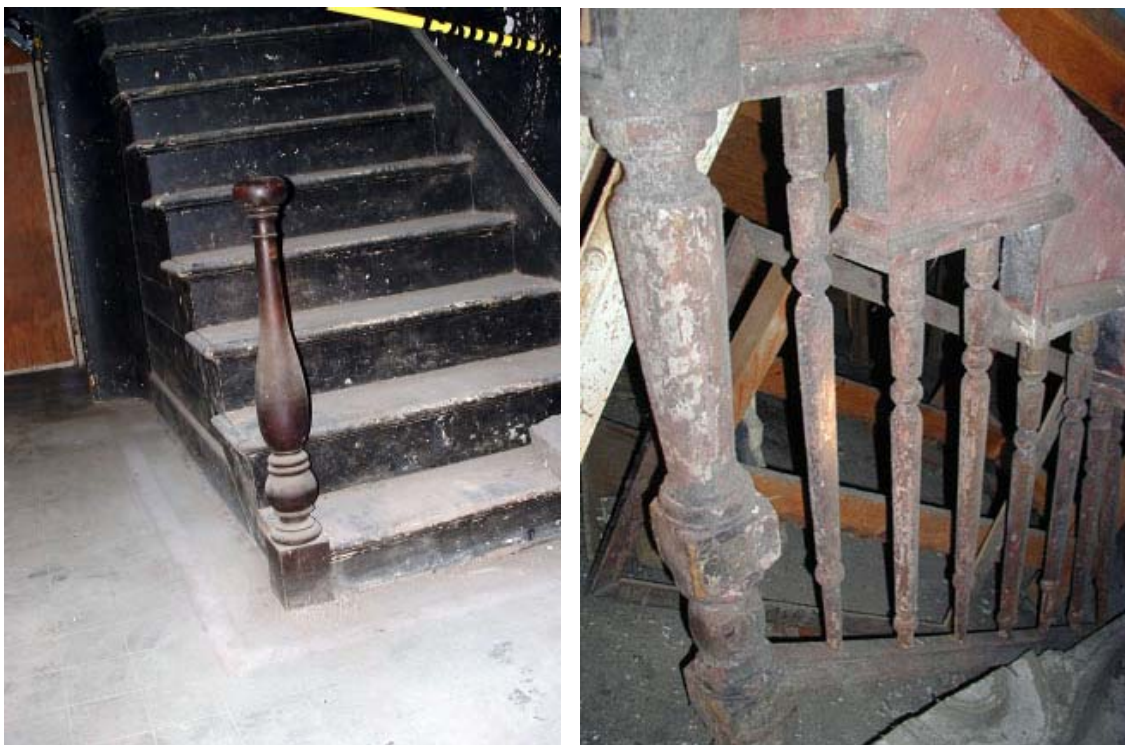
The two stairways leading from the Vestibule on the south up into the galleries are in a severe state of disrepair. The railings are entirely missing and only the newel posts remain. Pieces of the balusters and railings are stored in the east Transept, however much is still missing. Remnants of the railings on the wall side are in evidence at the top of the west stair. The nosings of many of the treads have come off, as have the tread returns that anchored the balusters.

*Figure 64 and 65. Stair leading from Vestibule to the east Gallery is original to the building. Remnants of the balusters and rails are stored in the east Transept.*

All surviving elements from the stair should be assembled and missing elements replaced.

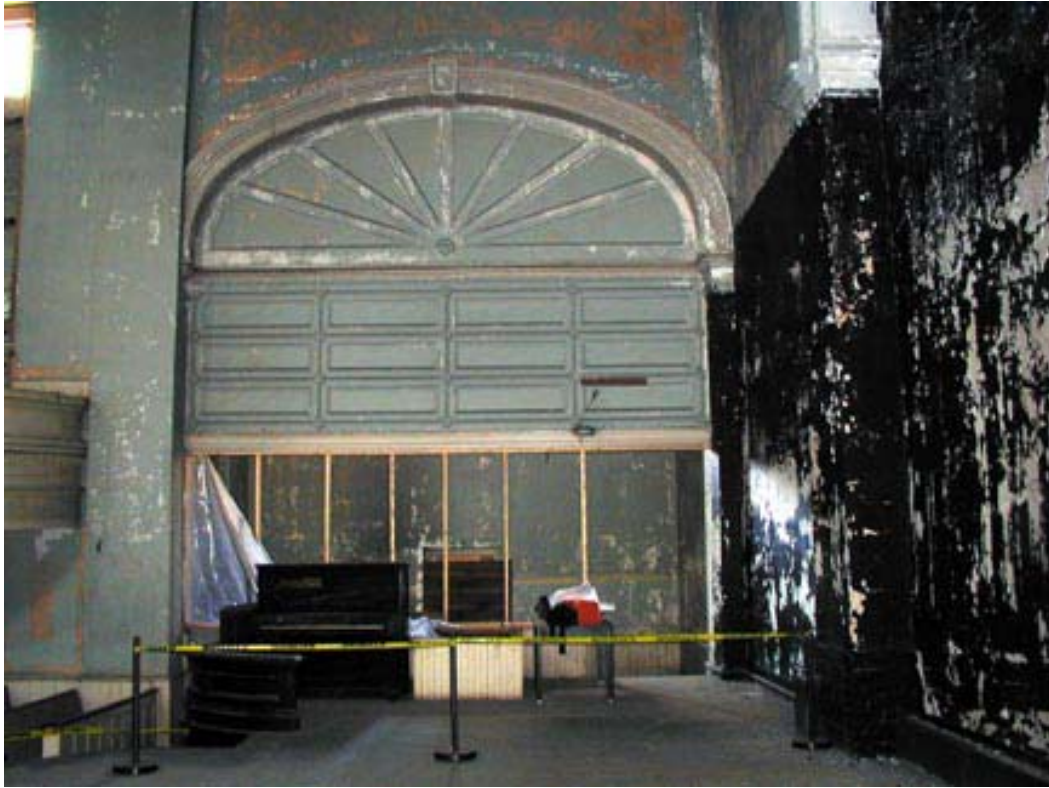
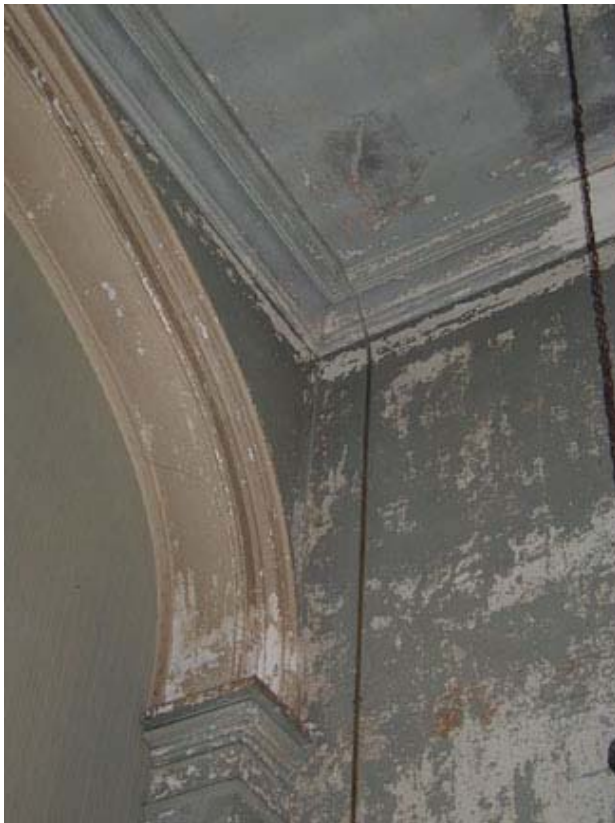
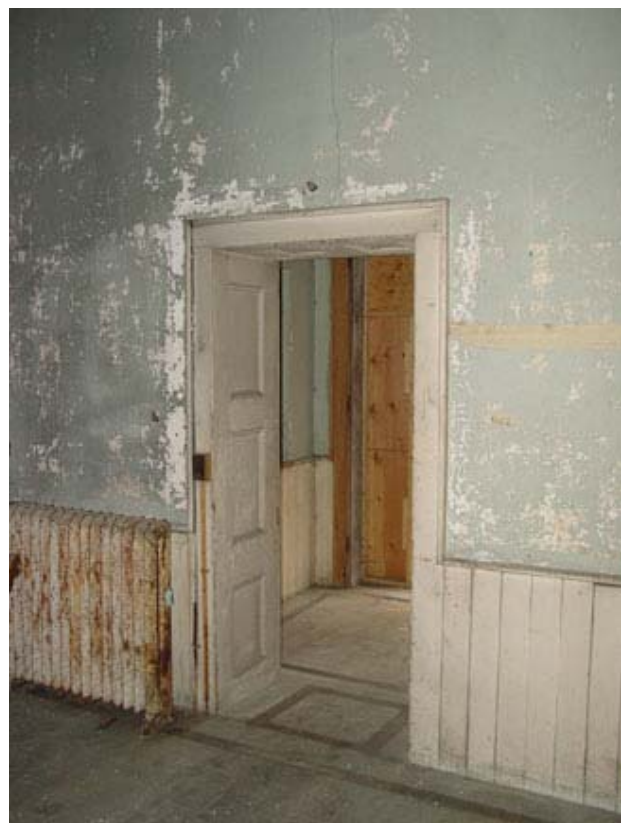
Figures 66, 67 and 68. Details of the Transepts. Above is the decorative screen designed by George Hanley. Note the shoring installed by the National Parks Service below the screen. Lower left, detail of run plaster moldings in west Transept. Lower right, doorway into west Entryway. Note the paneling on the door jam and the wainscoting that wraps around the entire space of the main floor.

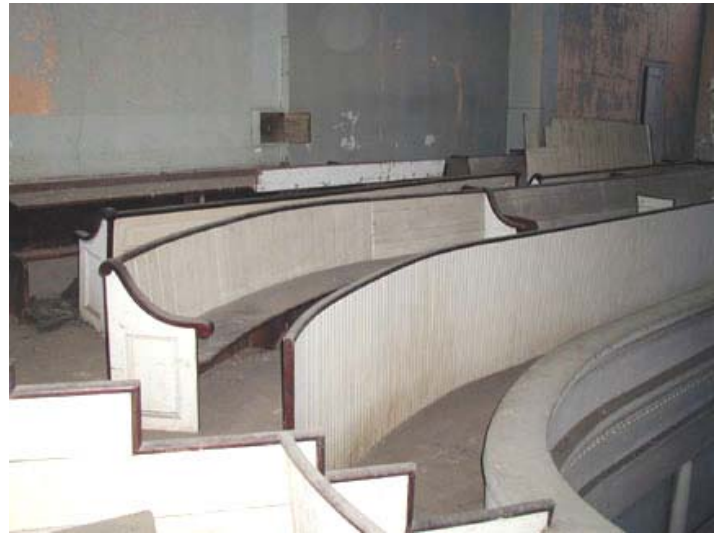
*Figure 70. Ledge at west wall supporting gallery framing. The rubble stone masonry walls step in 6" twice over their height, once at the basement level and once at the Gallery level. The Gallery is tipping away from the wall. Its stabilization is a priority.*

The first priority in the repair of the gallery is to stabilize its structure. It has been greatly compromised due to the settling of the interior column footings on the basement. The west portion of the gallery has pivoted toward the center, pulling away from the exterior wall. The settling at the middle section of the west perimeter wall exacerbates the condition.

As the foundation problems are rectified, the gallery should be brought back into alignment as far as possible without disturbing their integrity or the integrity of the exterior walls. The gallery structure should be monitored during the realignment process and the basement columns installed once the gallery is stabilized. The wood framing of the gallery should then be reattached to the wood ledger that rests on the ledge where the outer wall diminishes. Any debris should be removed prior to the work on the ledge.

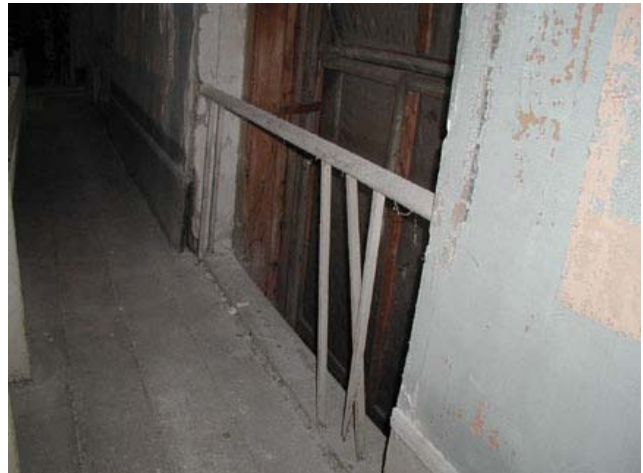
*Figure 71. At one time, railings with 3/4" square balusters were inset into each of the tall window openings at the gallery level. They functioned as guardrails and should be reinstated according to the remaining evidence.*

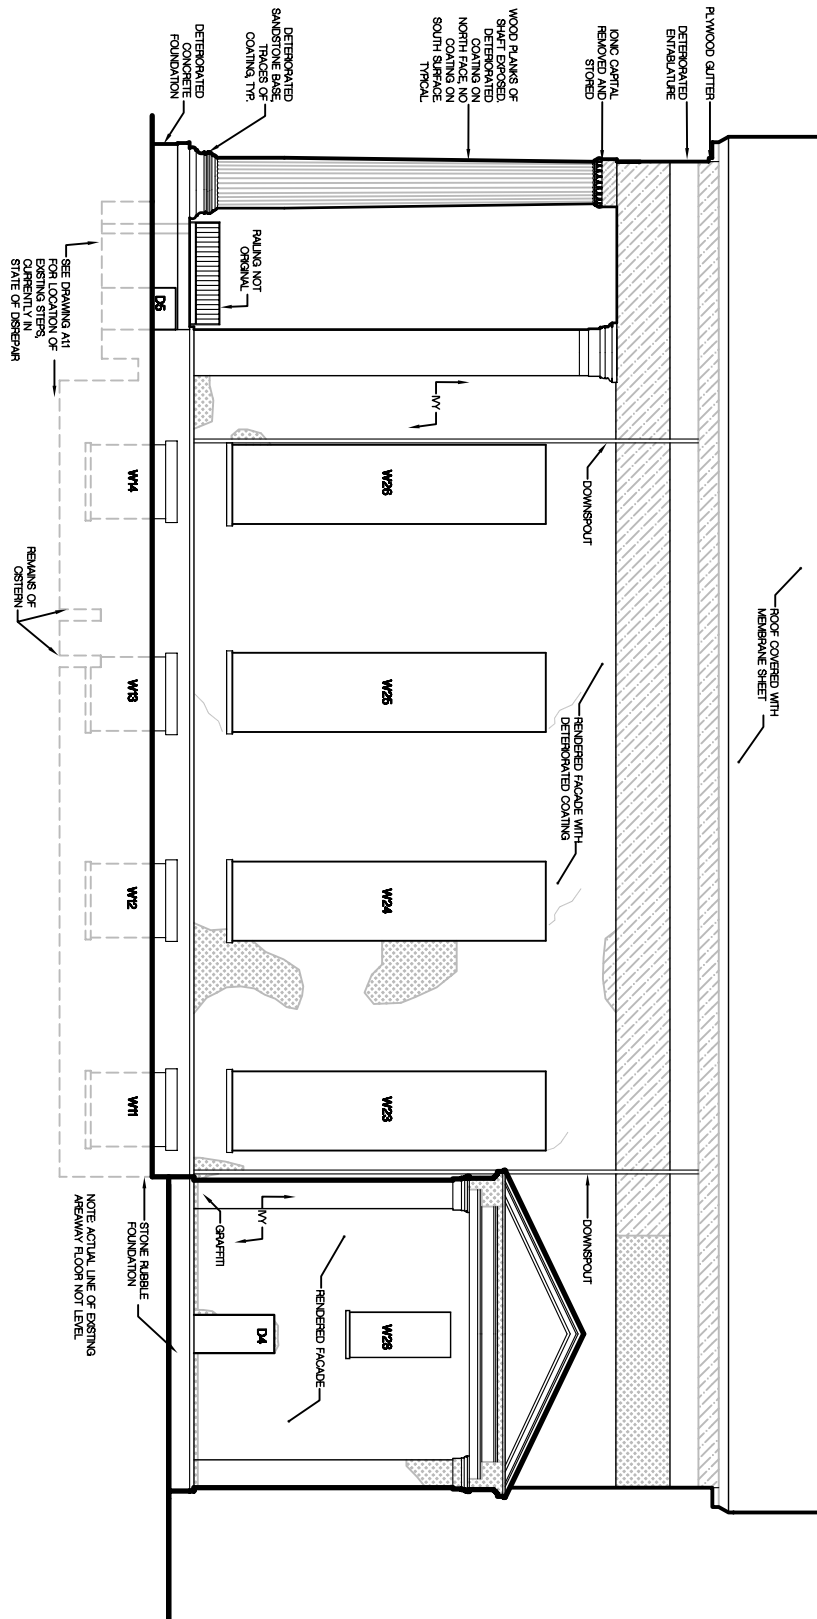
1 EAST ELEVATION- EXISTING CONDITIONS  
A2.4

NOTES:  
1. ALL WINDOW AND DOOR OPENINGS COVERED WITH PLYWOOD.  
2. SEVERE DETERIORATION OF EXISTING MASONRY (HATCHED).  
3. GENERAL STUDIO DETERIORATION OVER FACADE WITH AREAS OF COMPLETE STUDIO LOSS NOTED BY HATCH.
