**PRESERVING A TERRA COTTA CORNICE BY MAKING EVERY UNIT COUNT:  
PEASE AUDITORIUM CASE STUDY**

- Eastern Michigan University, Ypsilanti, MI
- National Register listed in 1974

- Constructed in 1914
- Architects: Smith, Hinchman & Grylls
- Live performance and campus events, excellent acoustics
- Renovated in 1959 and 1994; exterior work deferred...

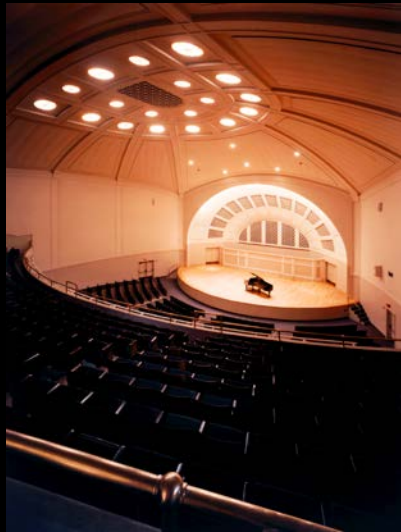
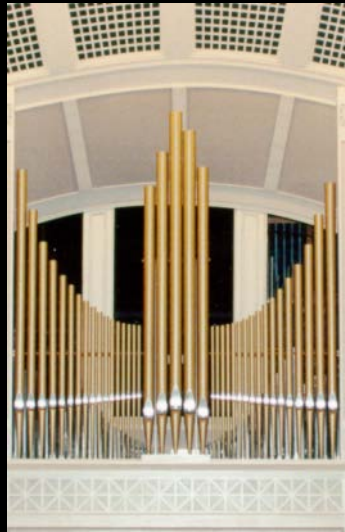
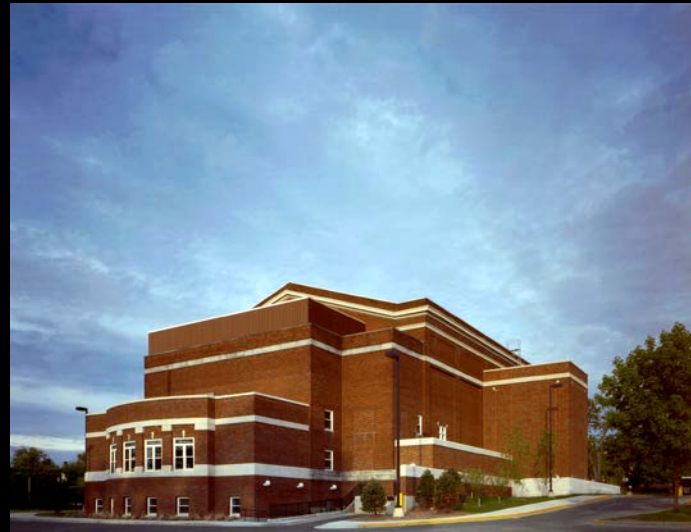
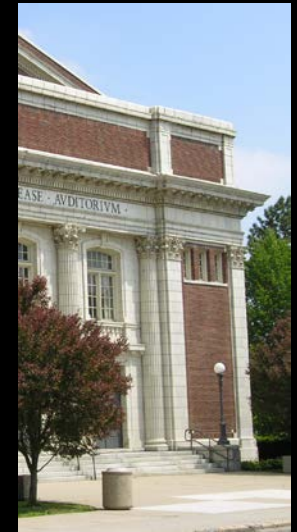
- Water infiltration damaged interior plaster
- Quick fixes and bad repairs
- Concerns about public safety

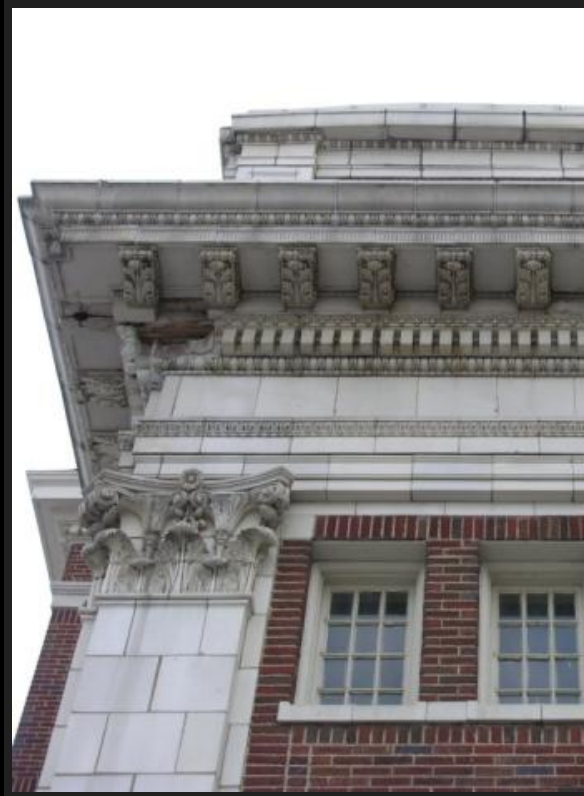
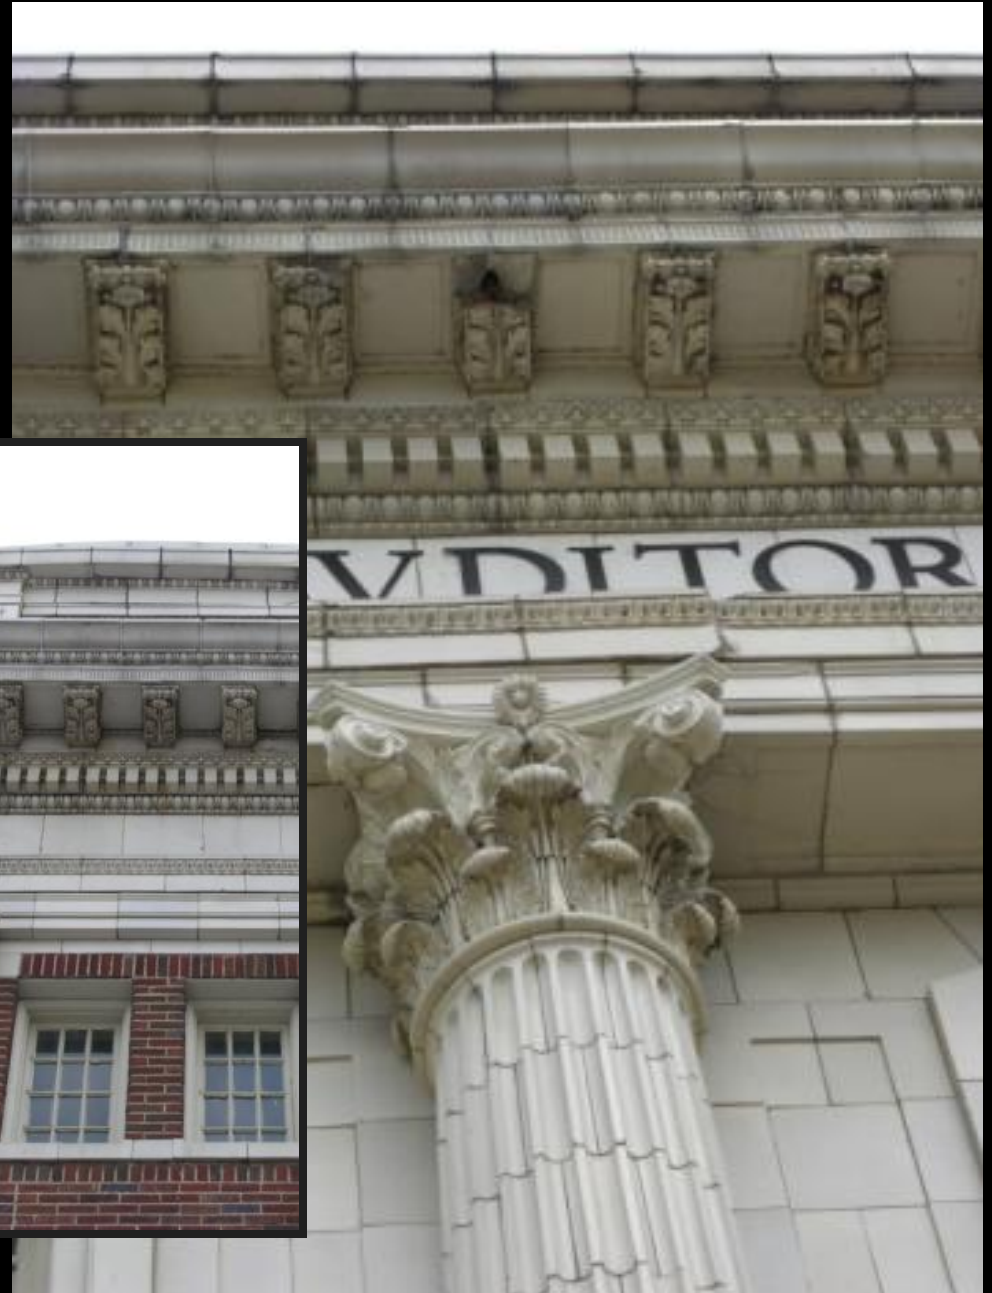
- Large piece of Terra Cotta cornice fell to the ground
